# Cement Plant at Durkee, OR

- Severe corrosion in the baghouse and fan.
- Original epoxy coating failed shortly after start up.
- Silicone coating applied next failed in less than six months
- FlueGard-225 Test Plate installed August 2002.
- Inspection of plate on Feb. '03 showed good results, made first FlueGard application March '03 to 2 compartments.
- Full inspection on September '03, results are impressive, coated compartments and fan housing in perfect shape. Applied FlueGard-225 to two more compartments and exit duct.
- Final 10 compartments coated with FlueGard-225 during May 2004 with the plant in service.
- Stack to be coated during next shutdown, later in 2004.

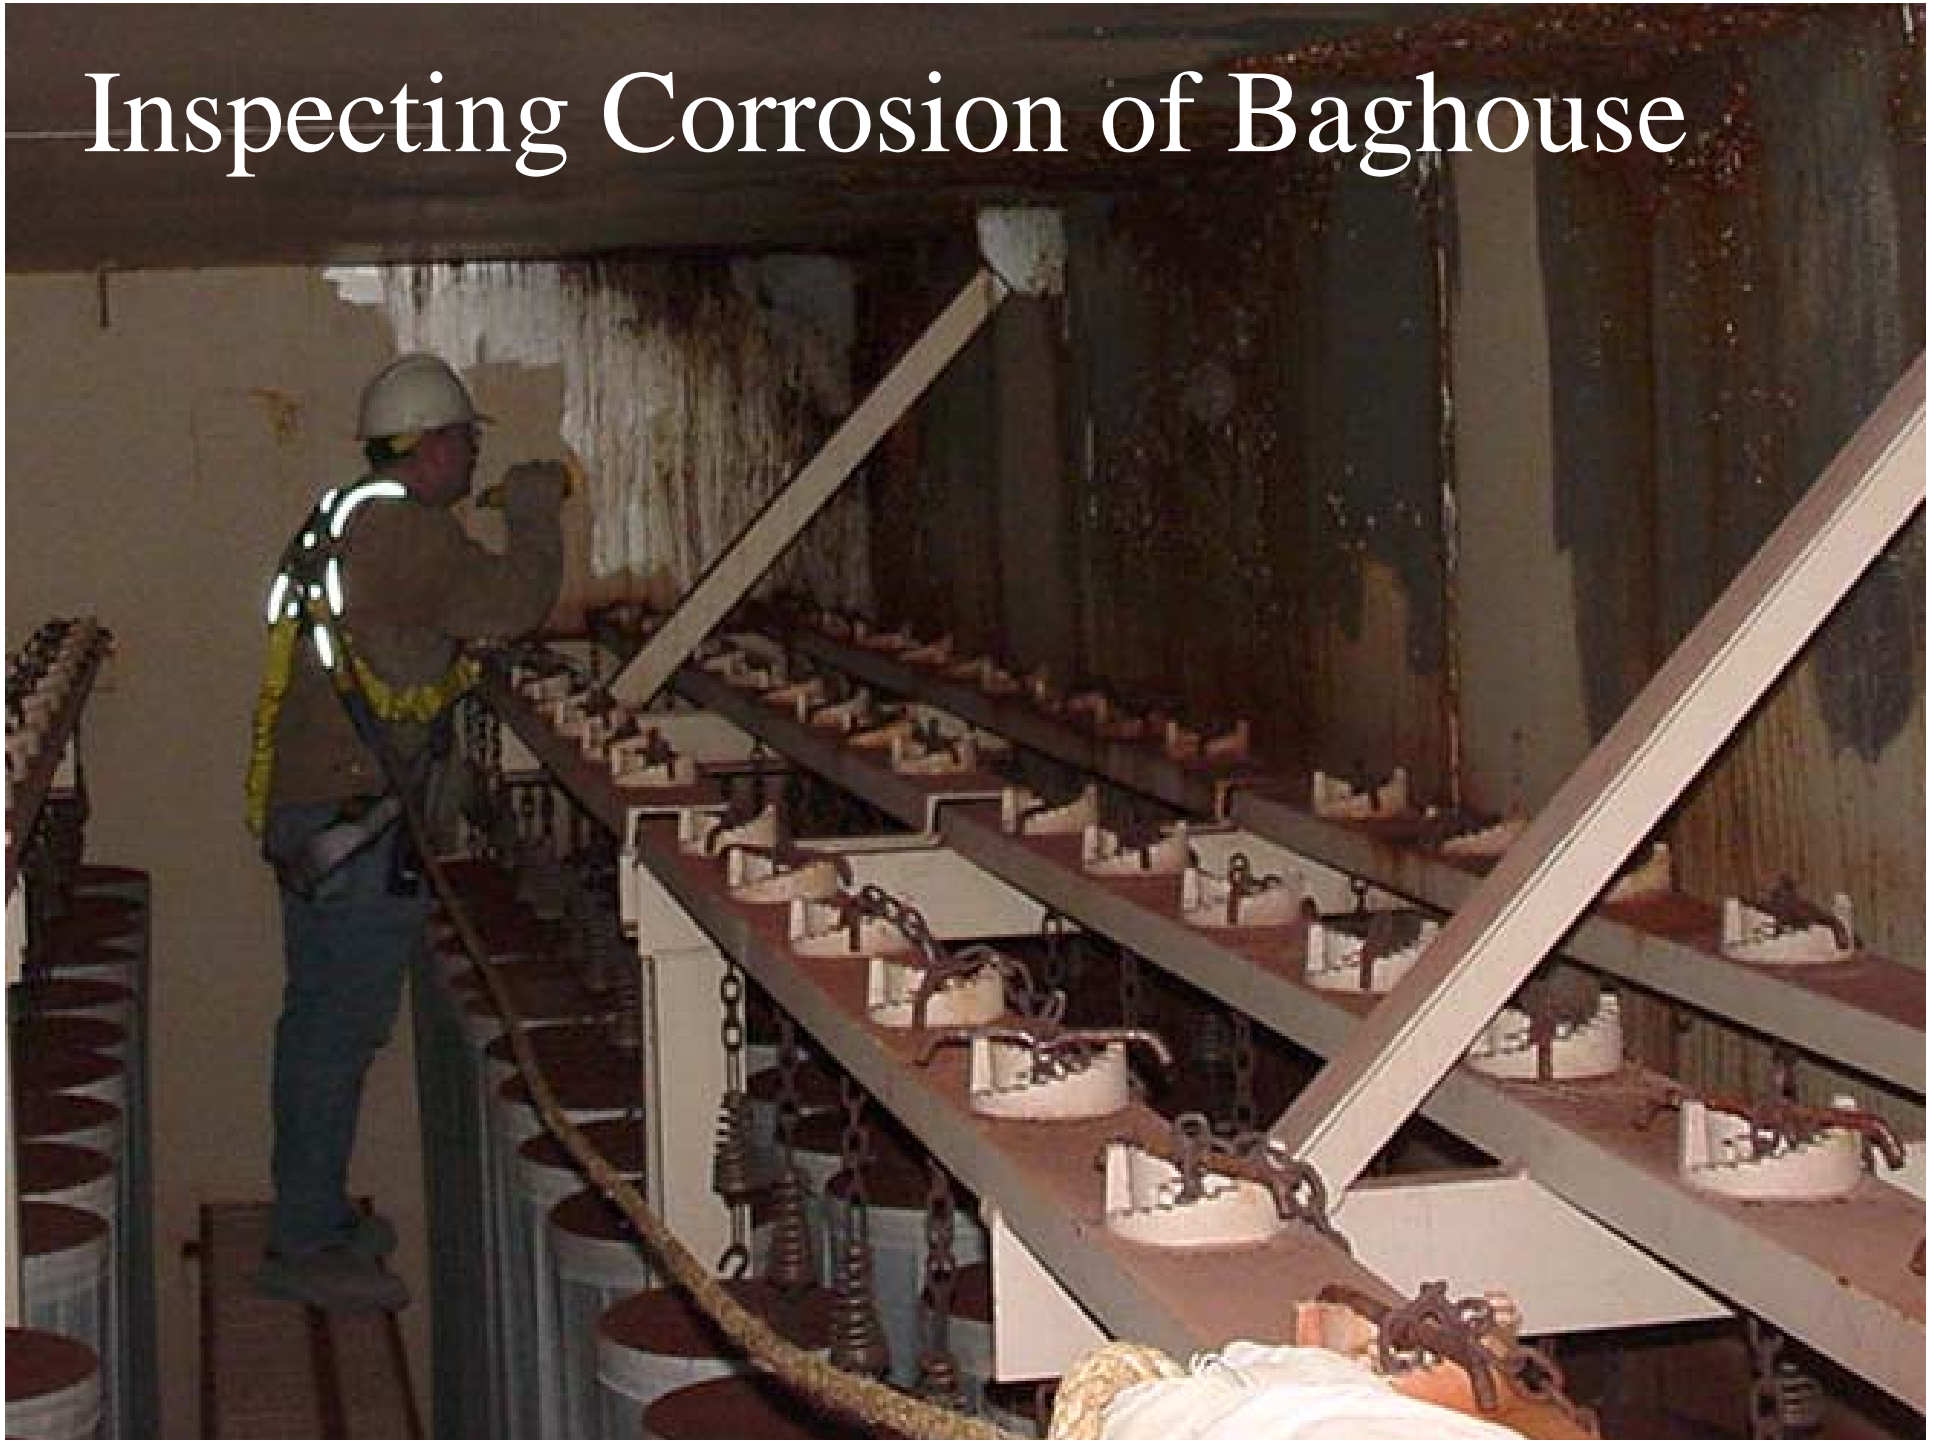
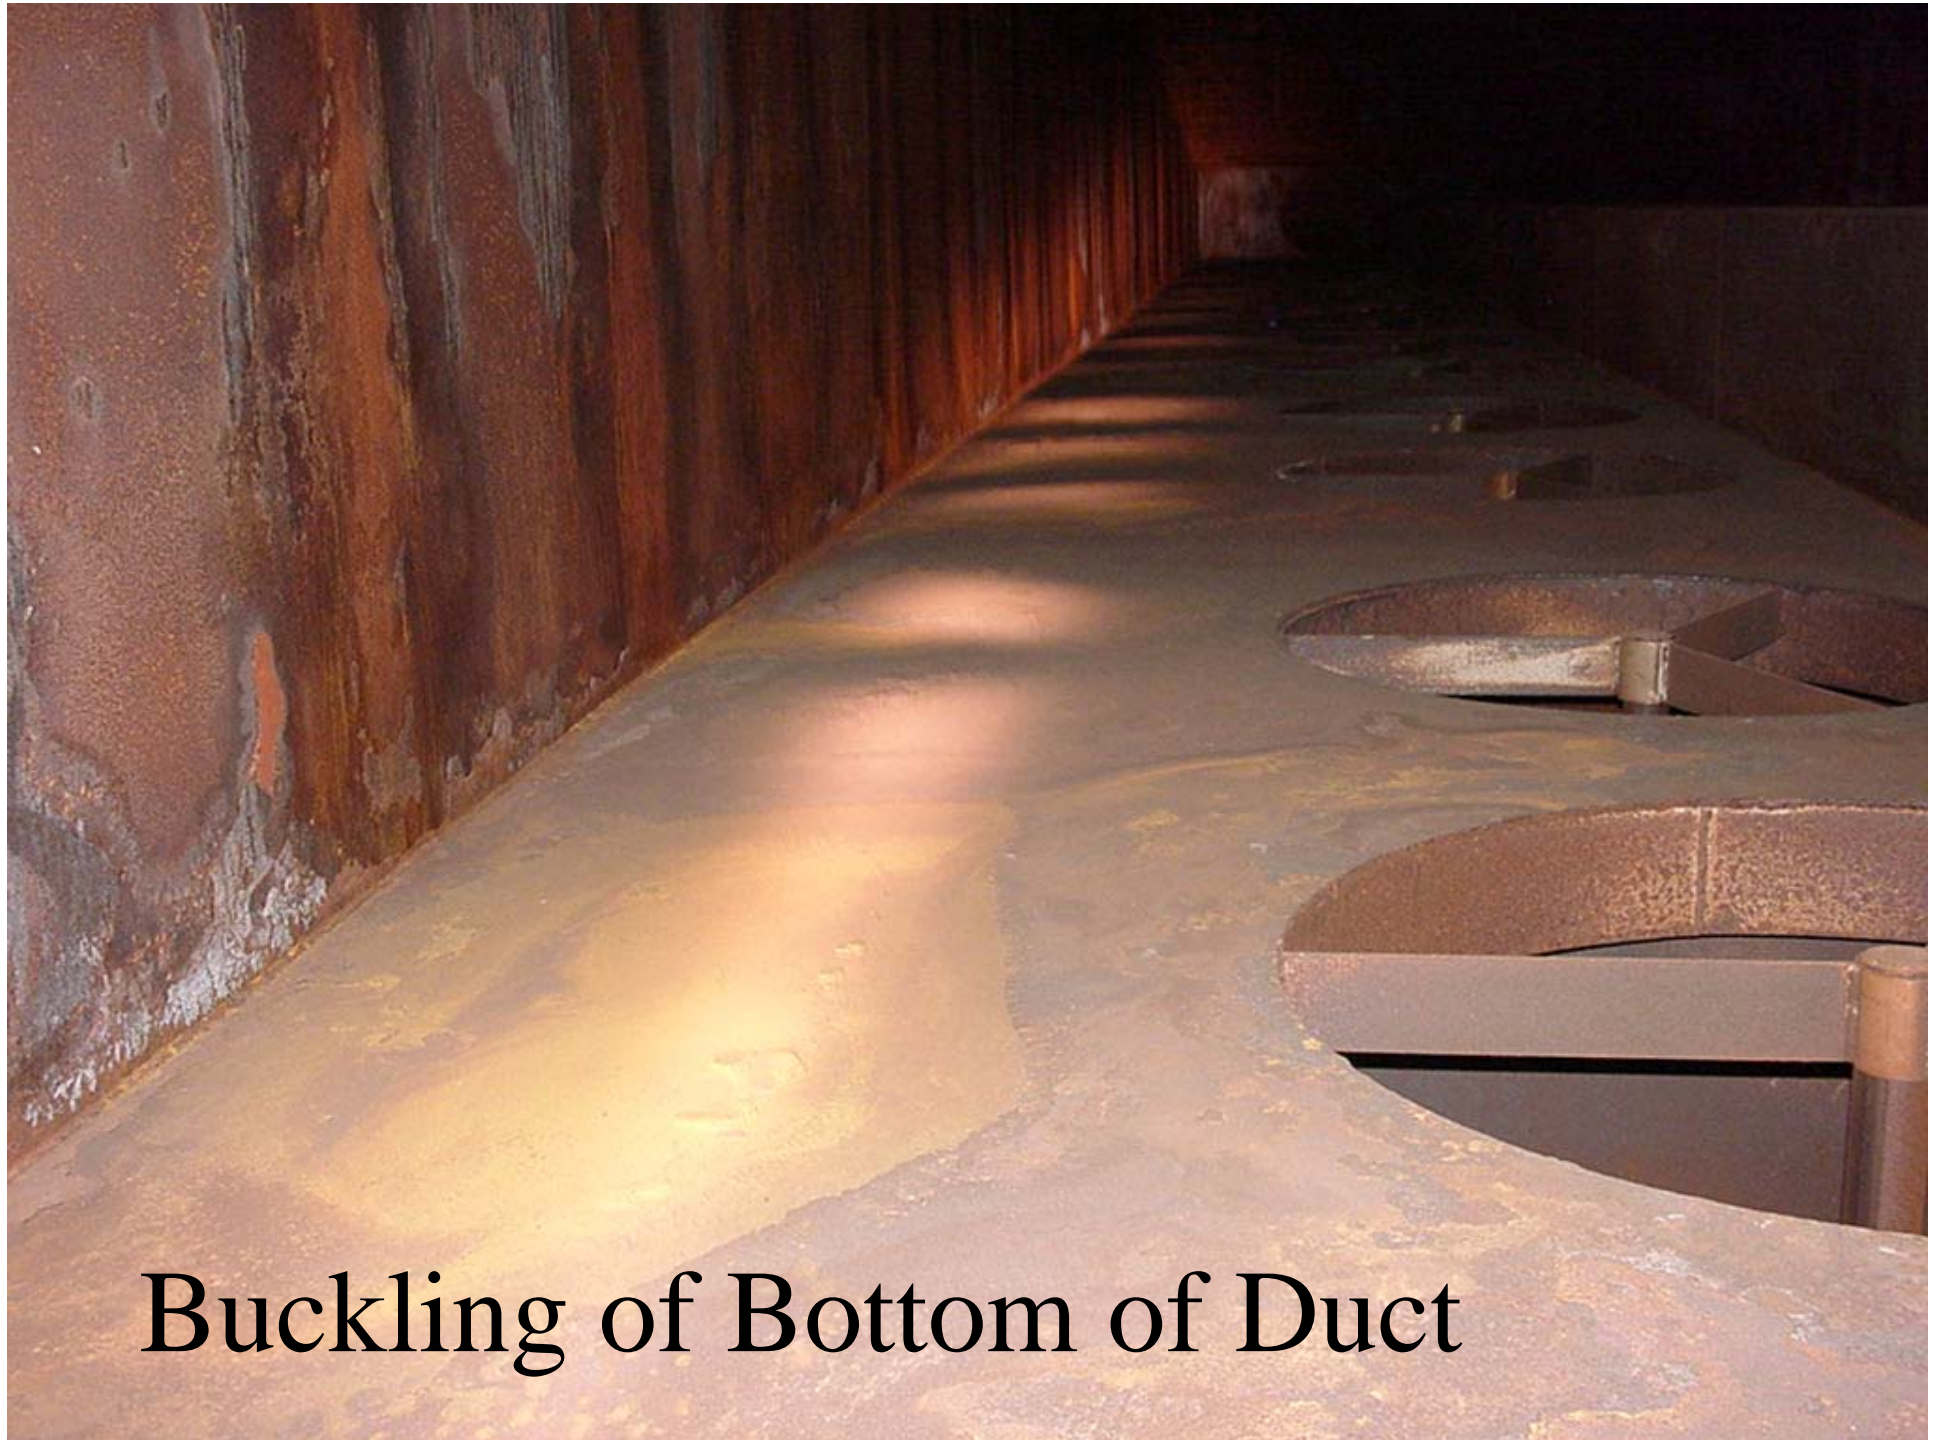
# Inspecting Corrosion of Baghouse

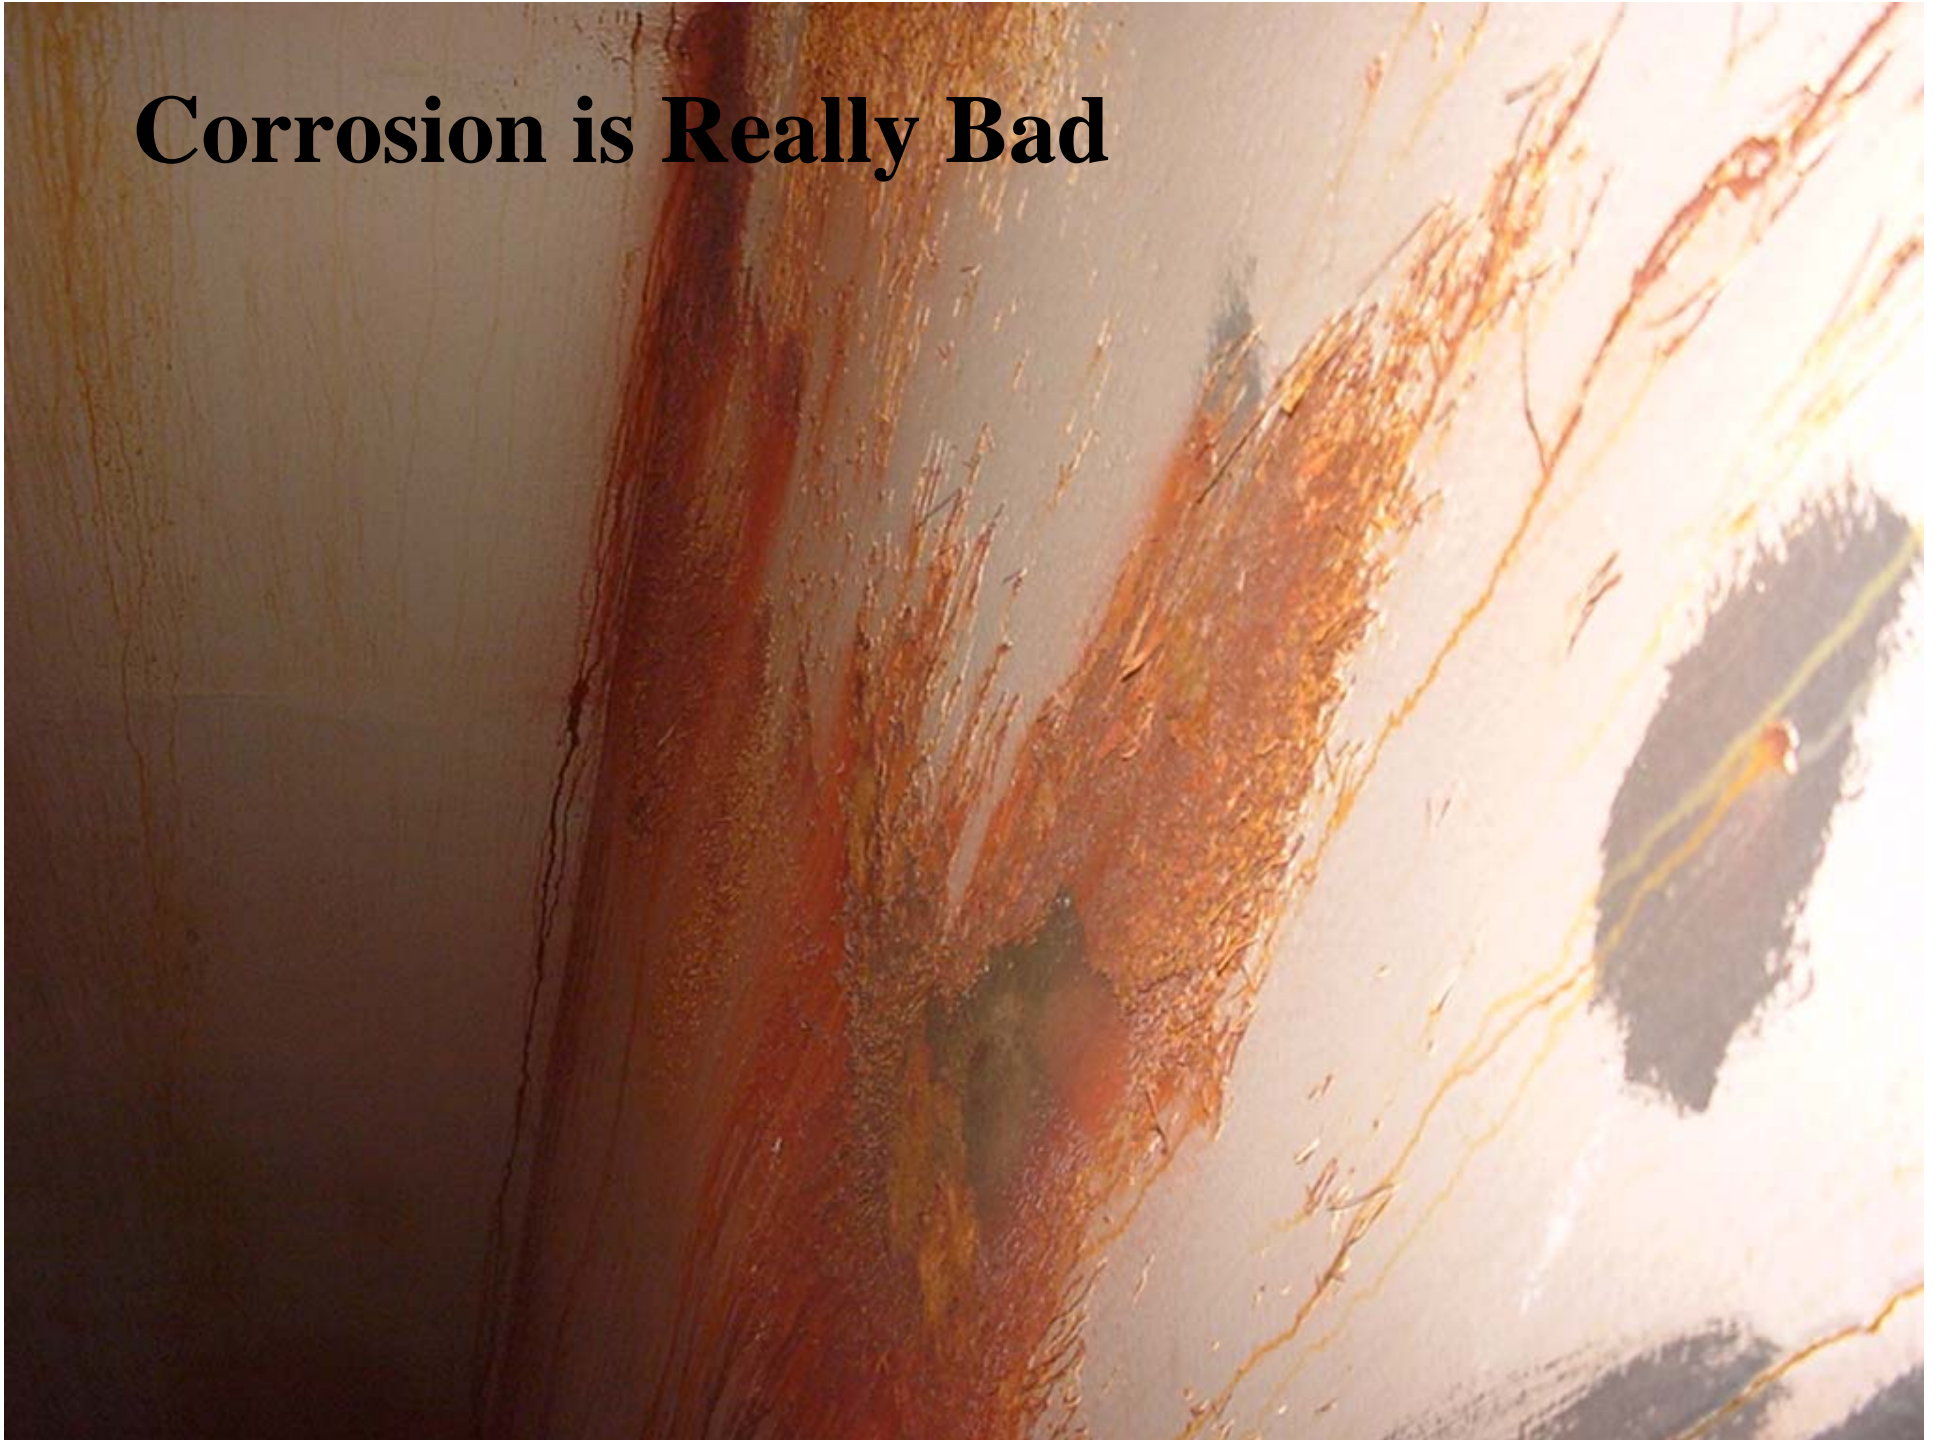
**Close Look at Ceiling Corrosion**

**Corrosion is Really Bad**

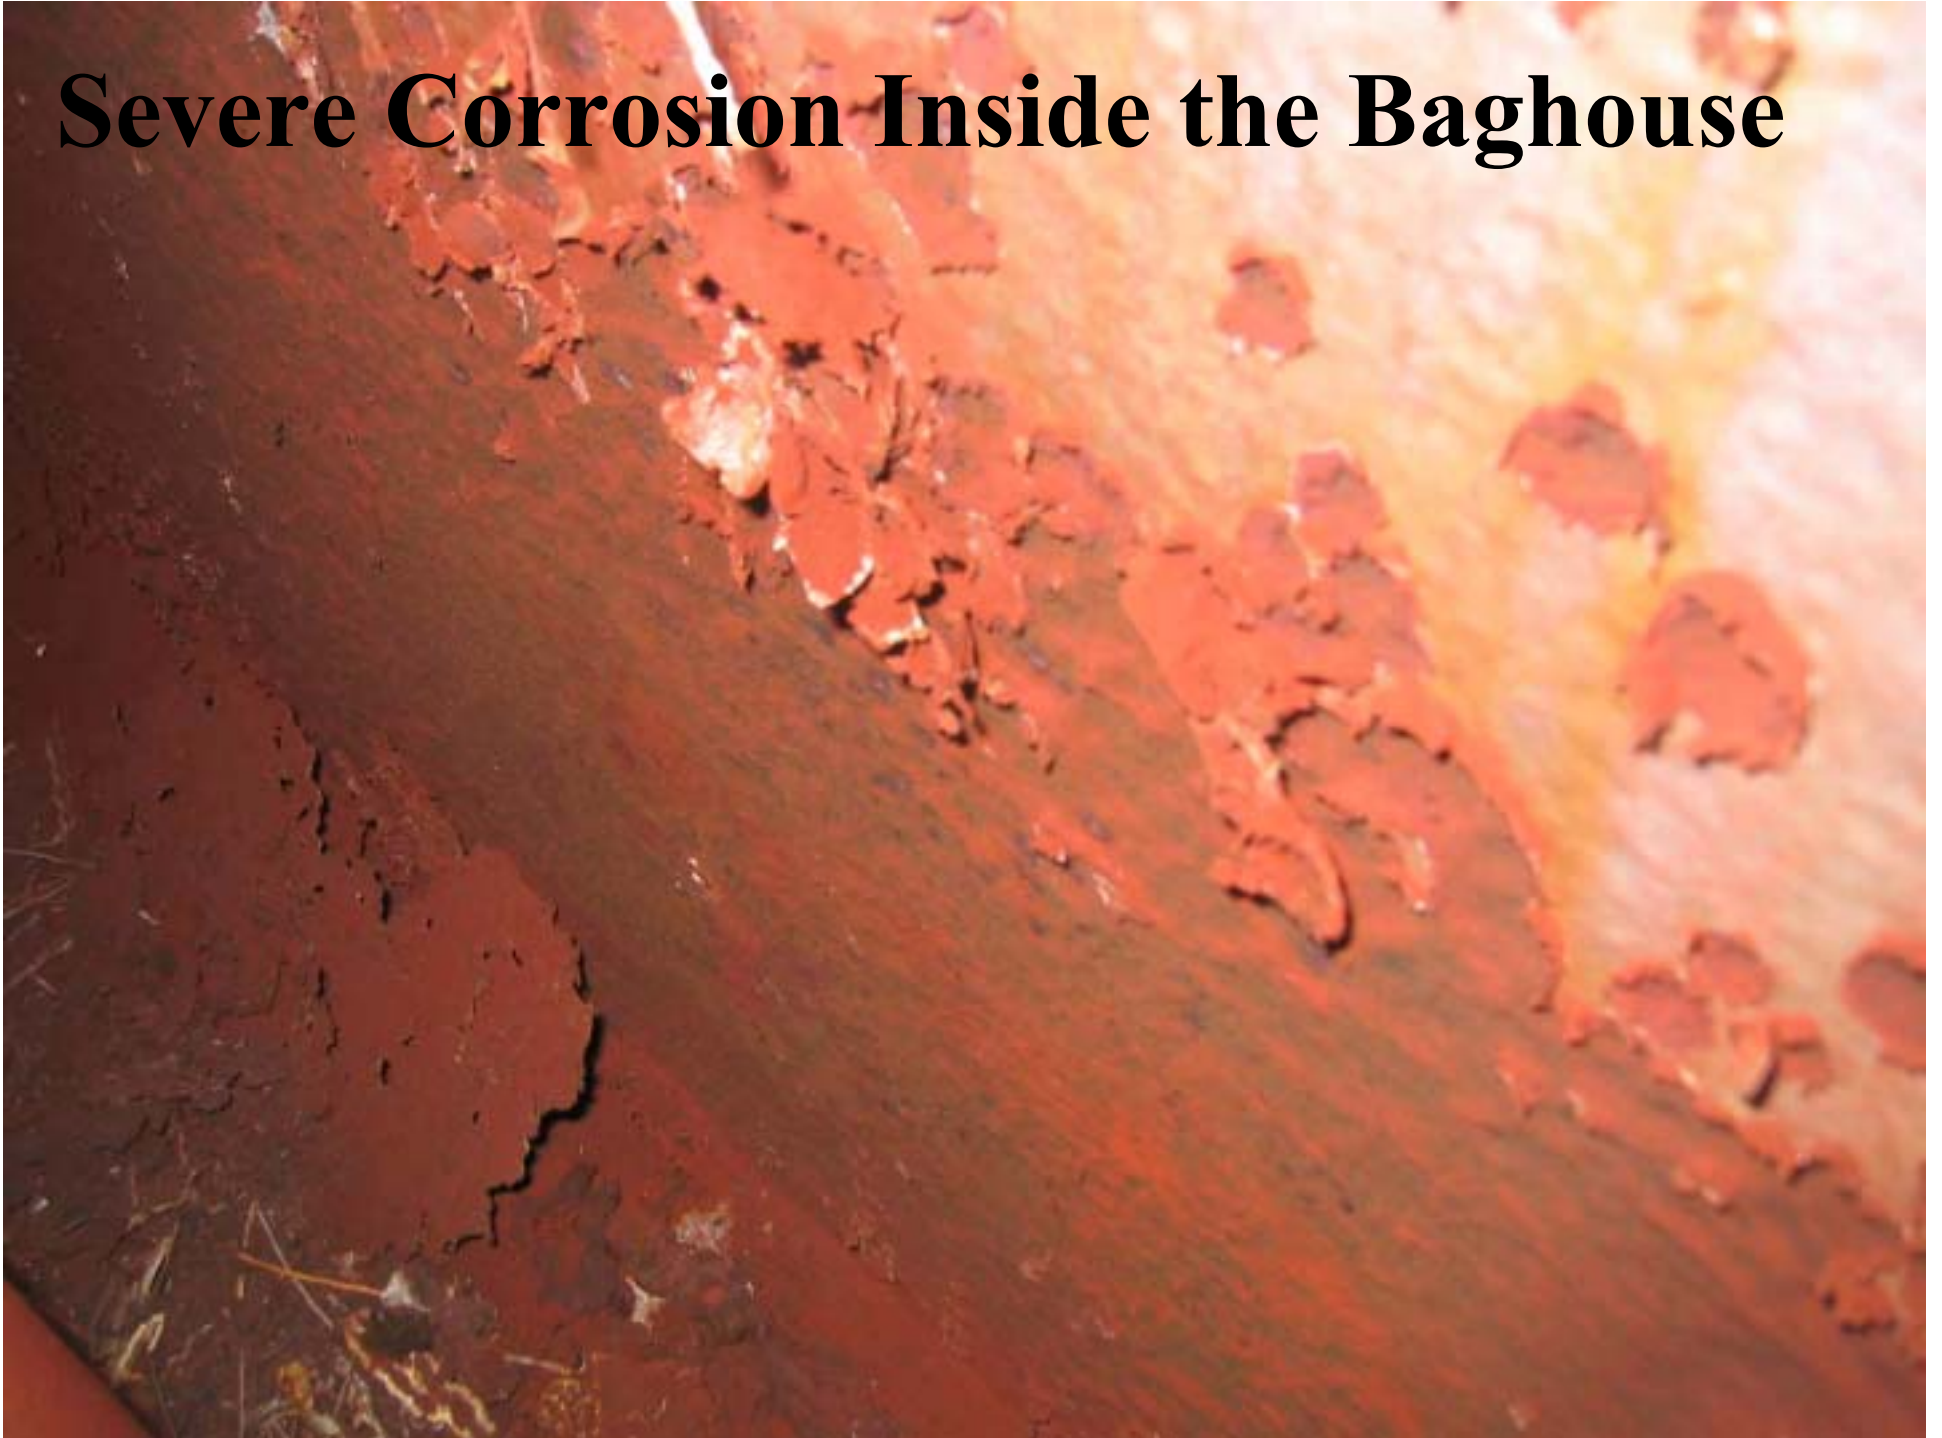
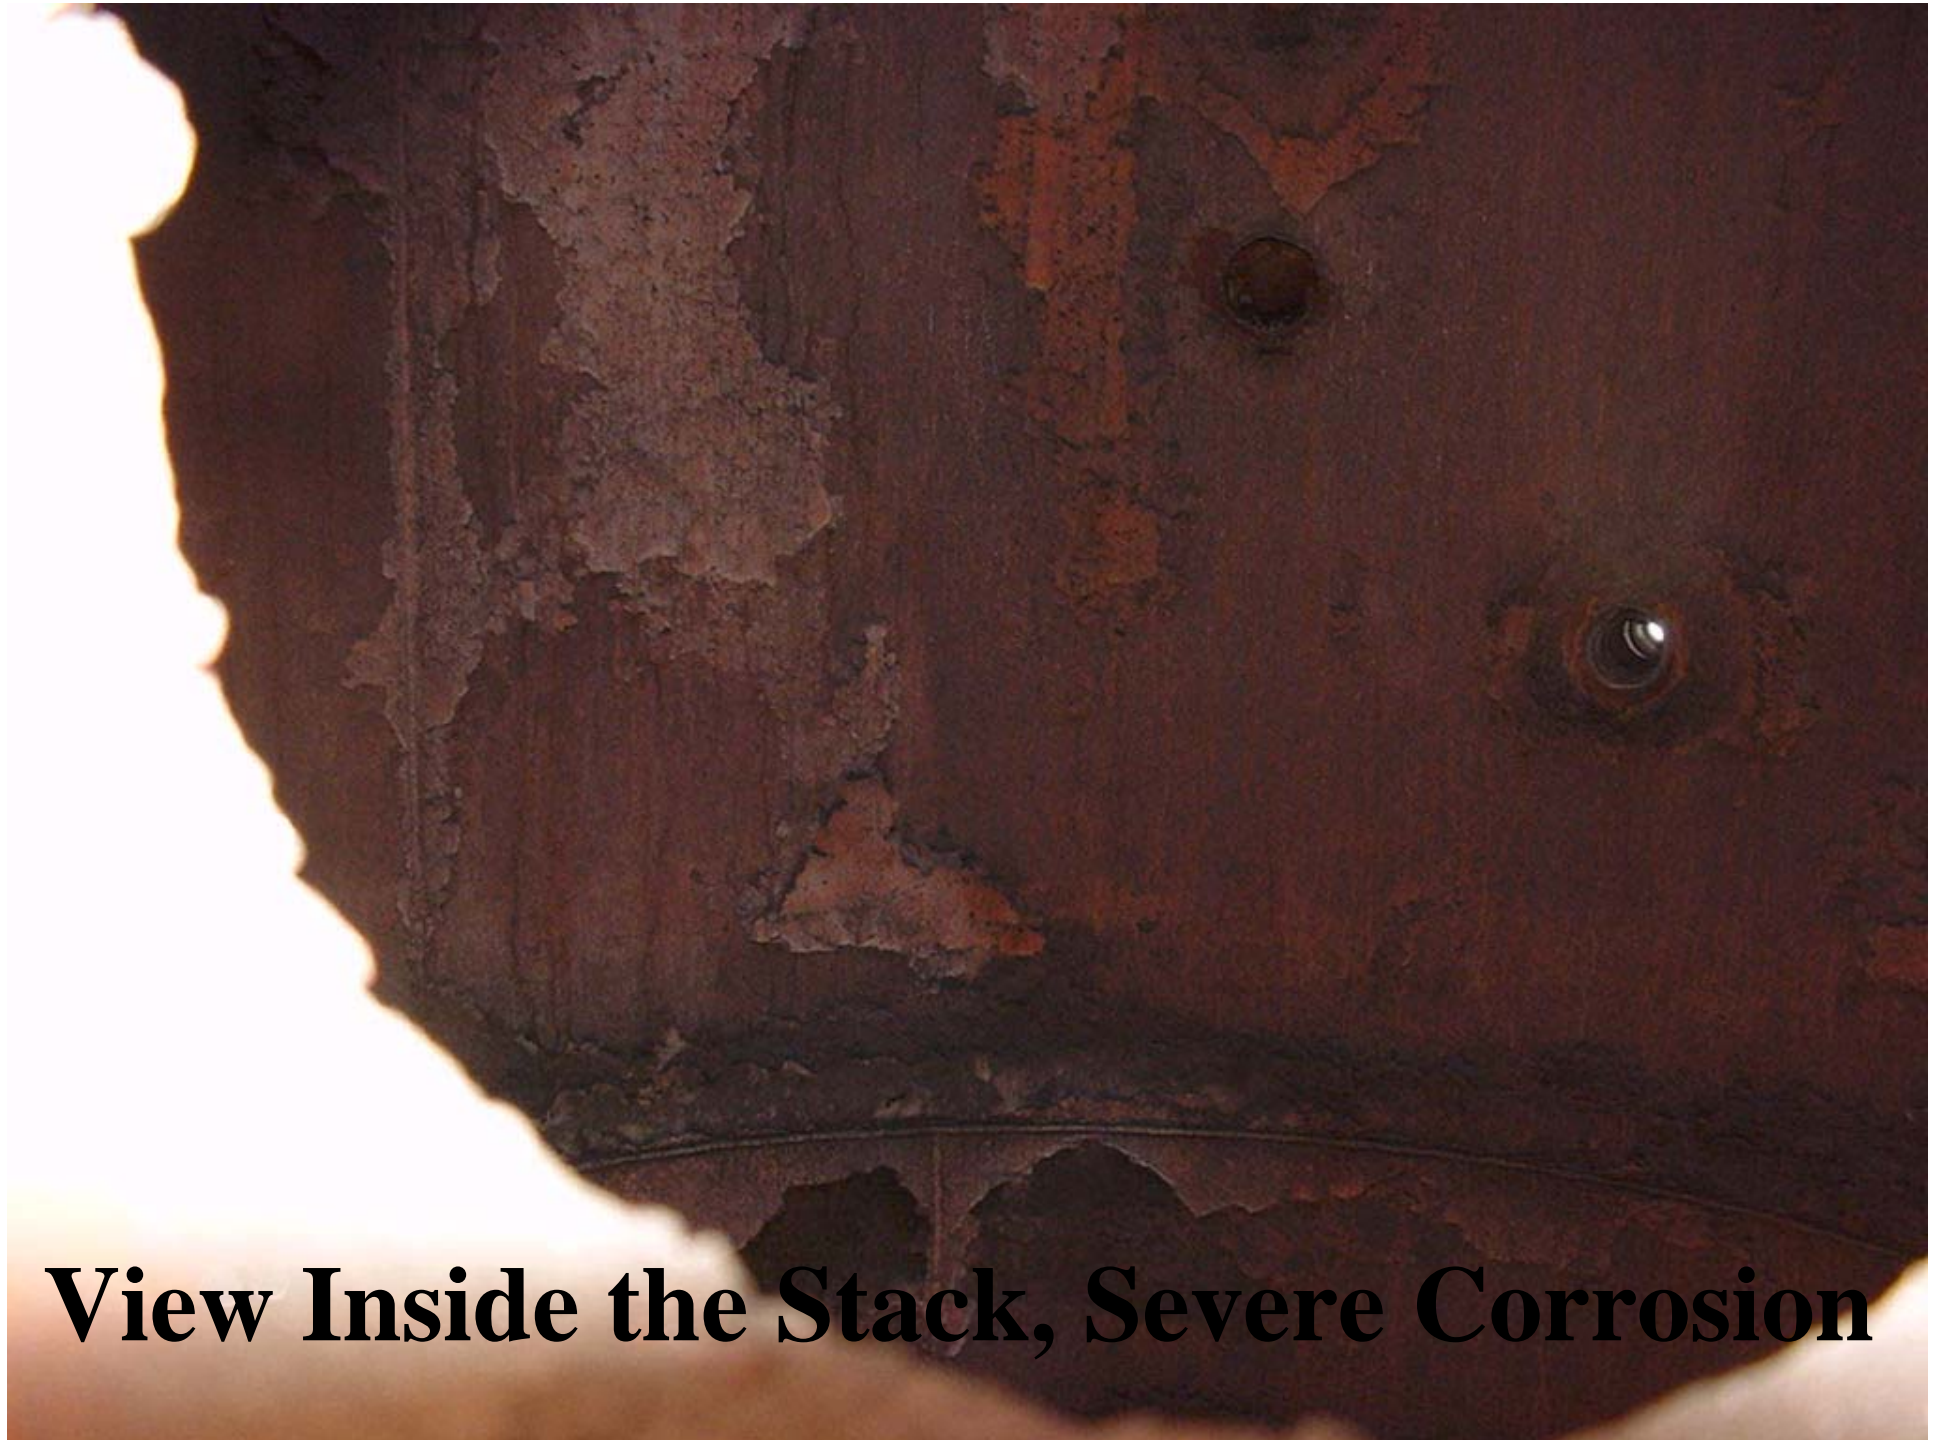
# Severe Corrosion Inside the Baghouse

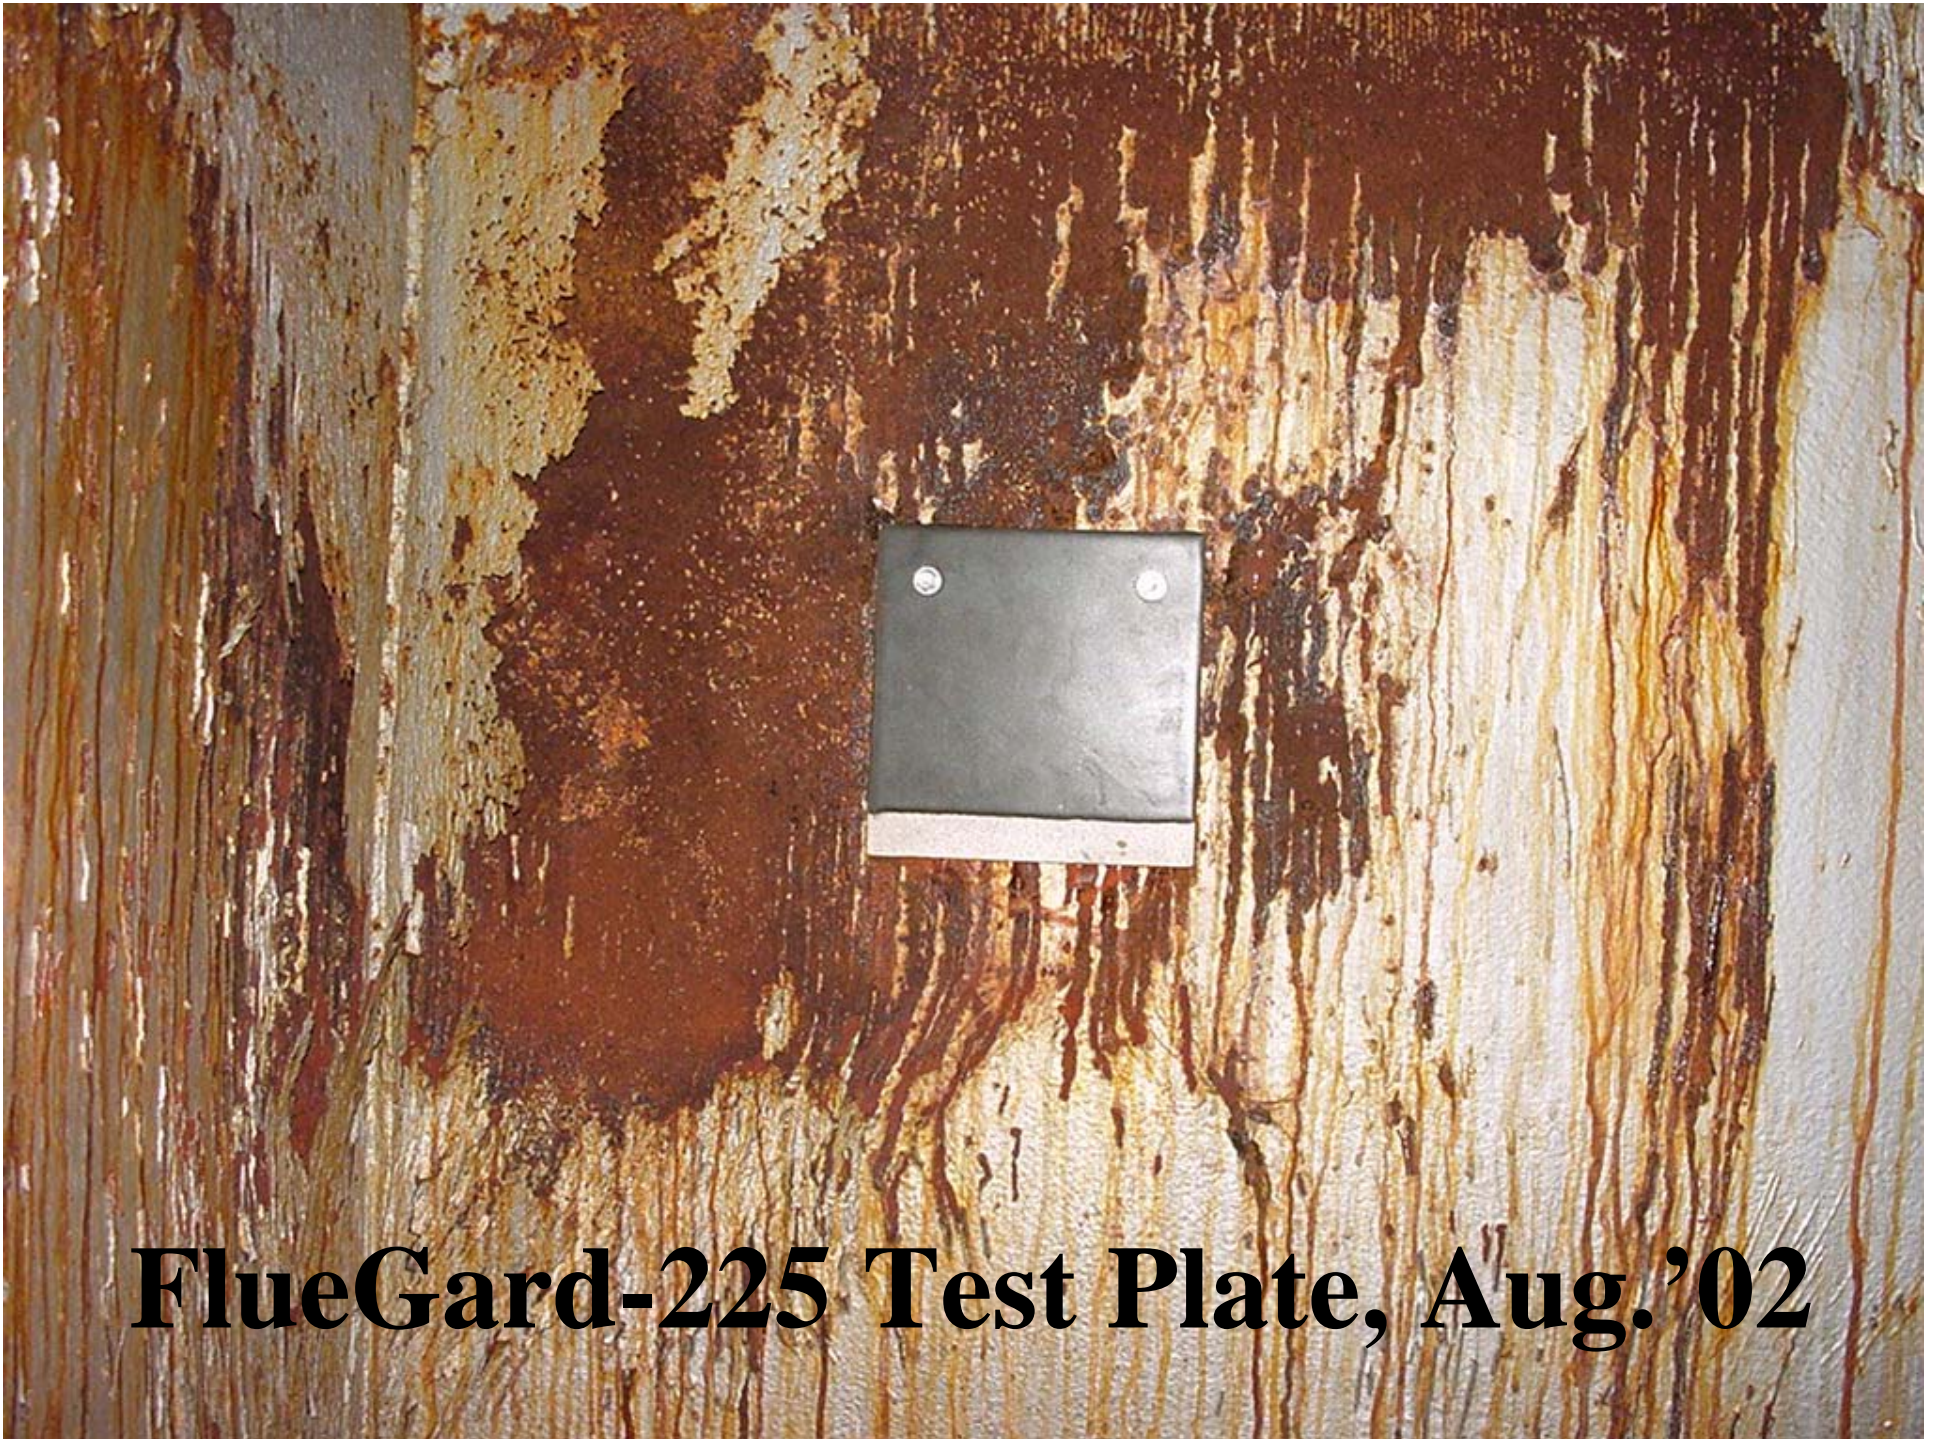
**View Inside the Stack, Severe Corrosion**

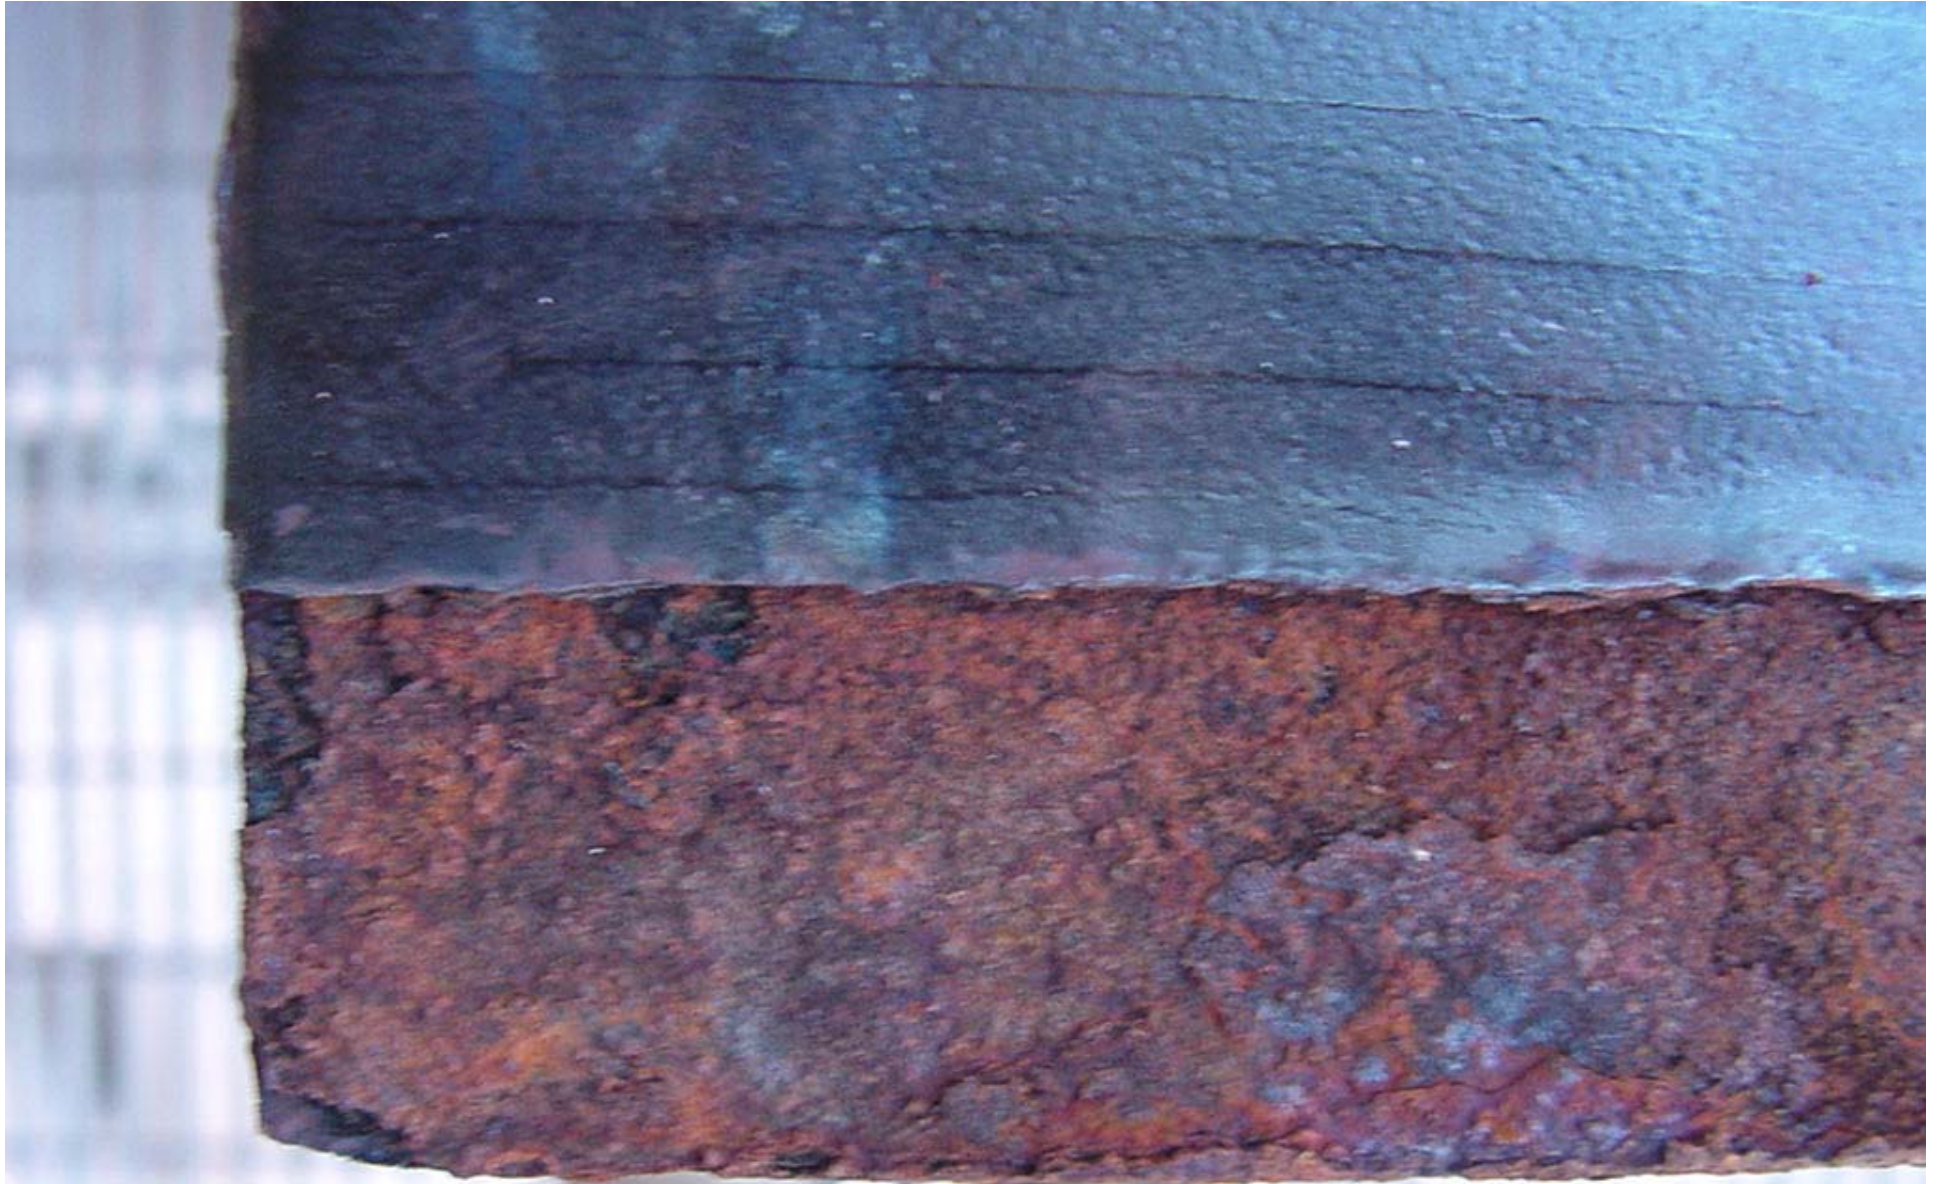
**Test Plate, February 2003**

**Close View of Plate, FlueGard-225 Looks Good**

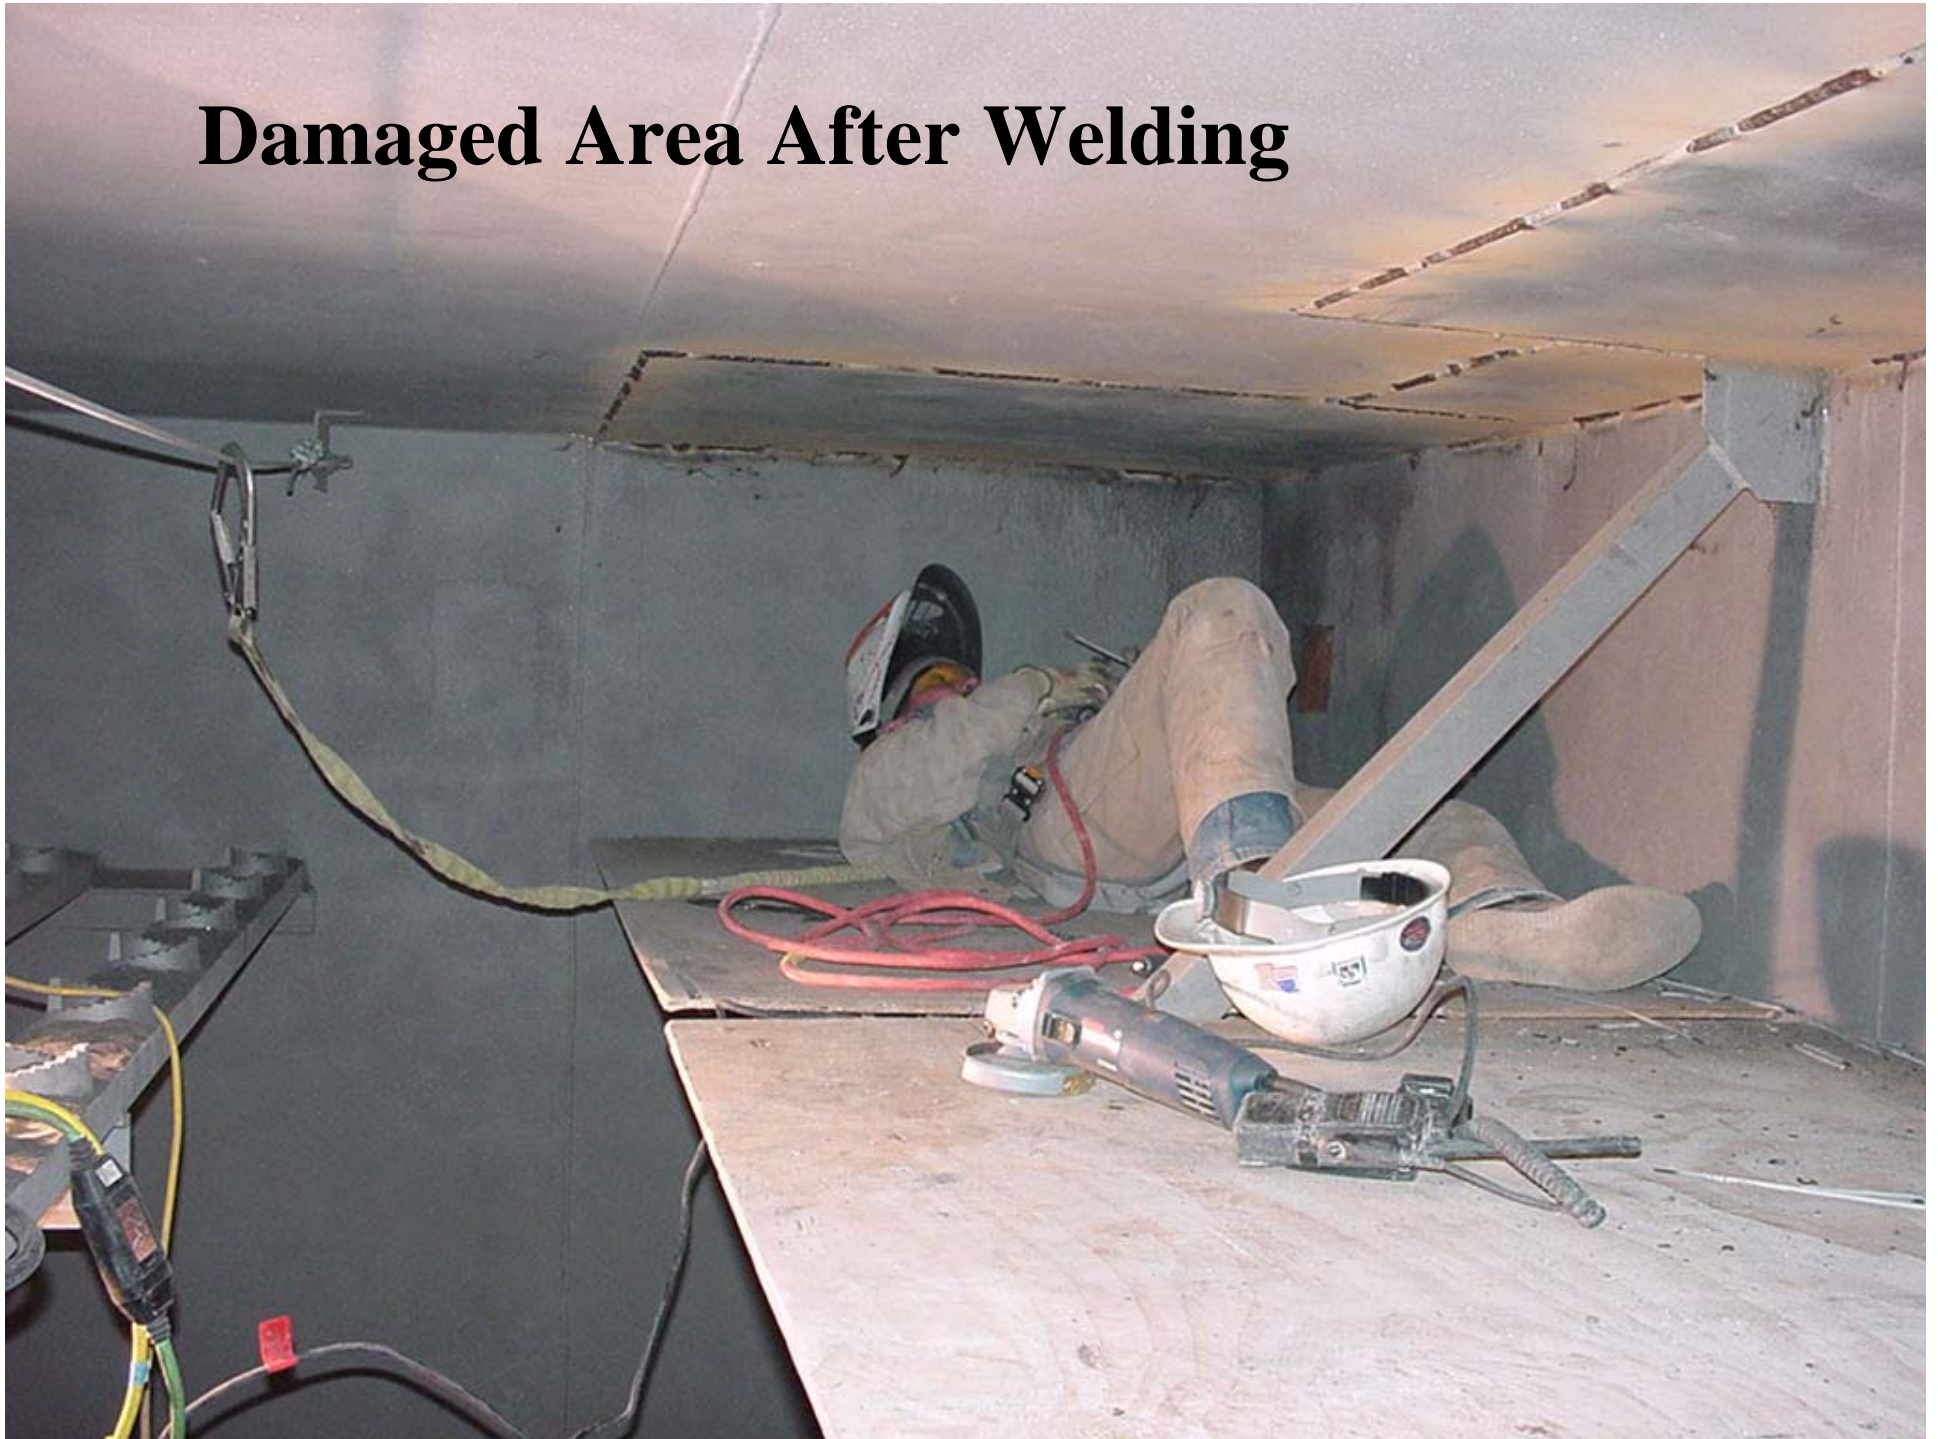
# Damaged Area After Welding
