# Cement Plant at Durkee, OR

- Severe corrosion in the baghouse and fan.
- Original epoxy coating failed shortly after start up.
- Silicone coating applied next failed in less than six months
- FlueGard-225 Test Plate installed August 2002.
- Inspection of plate on Feb. '03 showed good results, made first FlueGard application March '03 to 2 compartments.
- Full inspection on September '03, results are impressive, coated compartments and fan housing in perfect shape. Applied FlueGard-225 to two more compartments and exit duct.
- Final 10 compartments coated with FlueGard-225 during May 2004 with the plant in service.
- Stack to be coated during next shutdown, later in 2004.

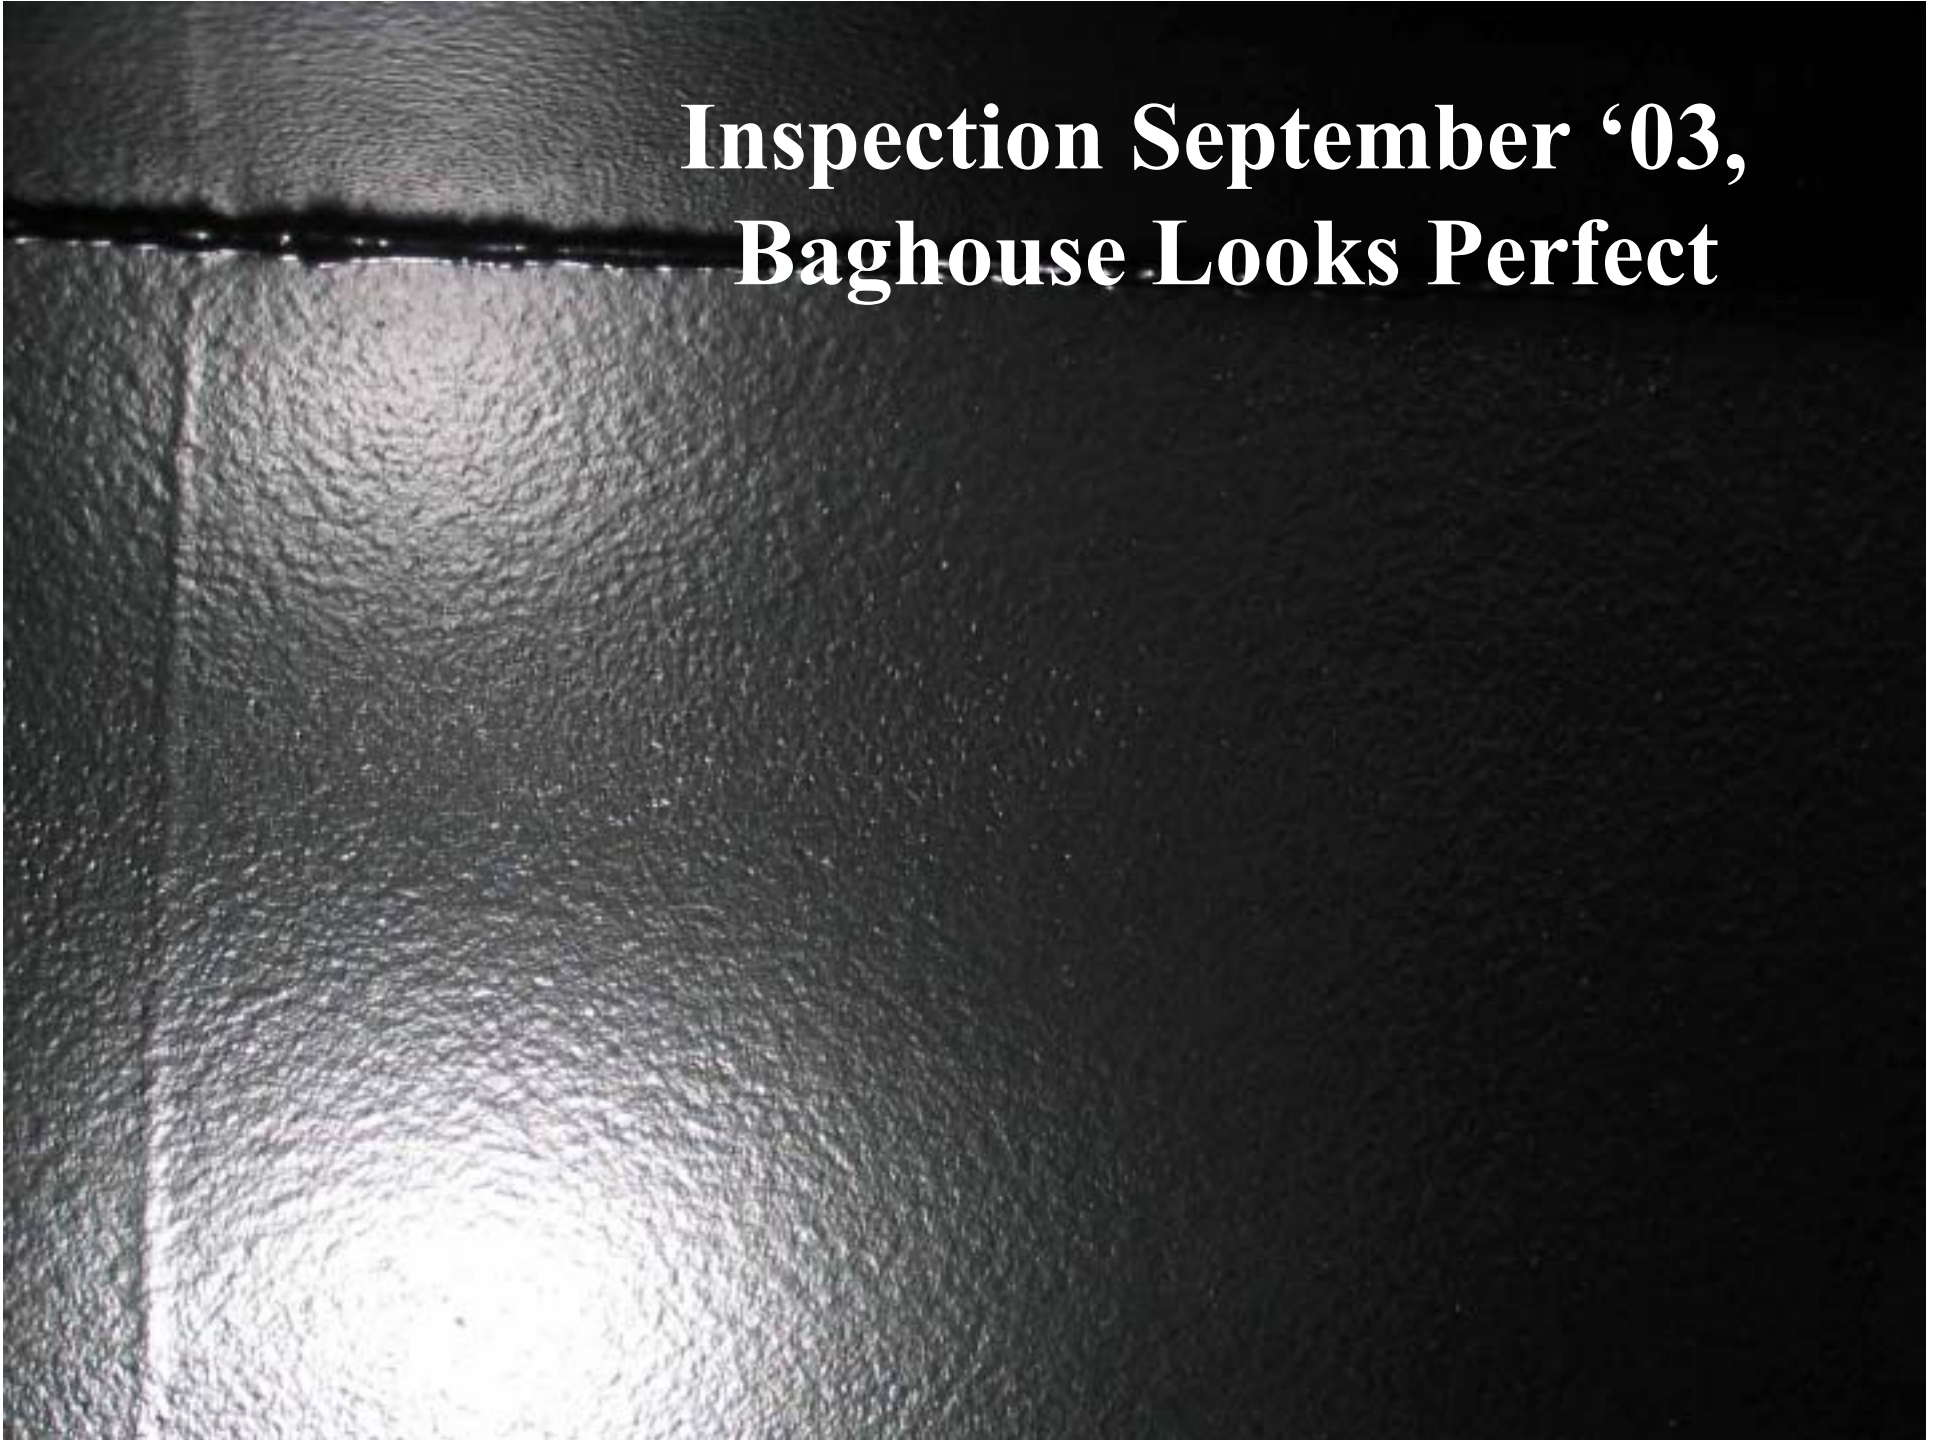
**Inspection September '03,  
Baghouse Looks Perfect**

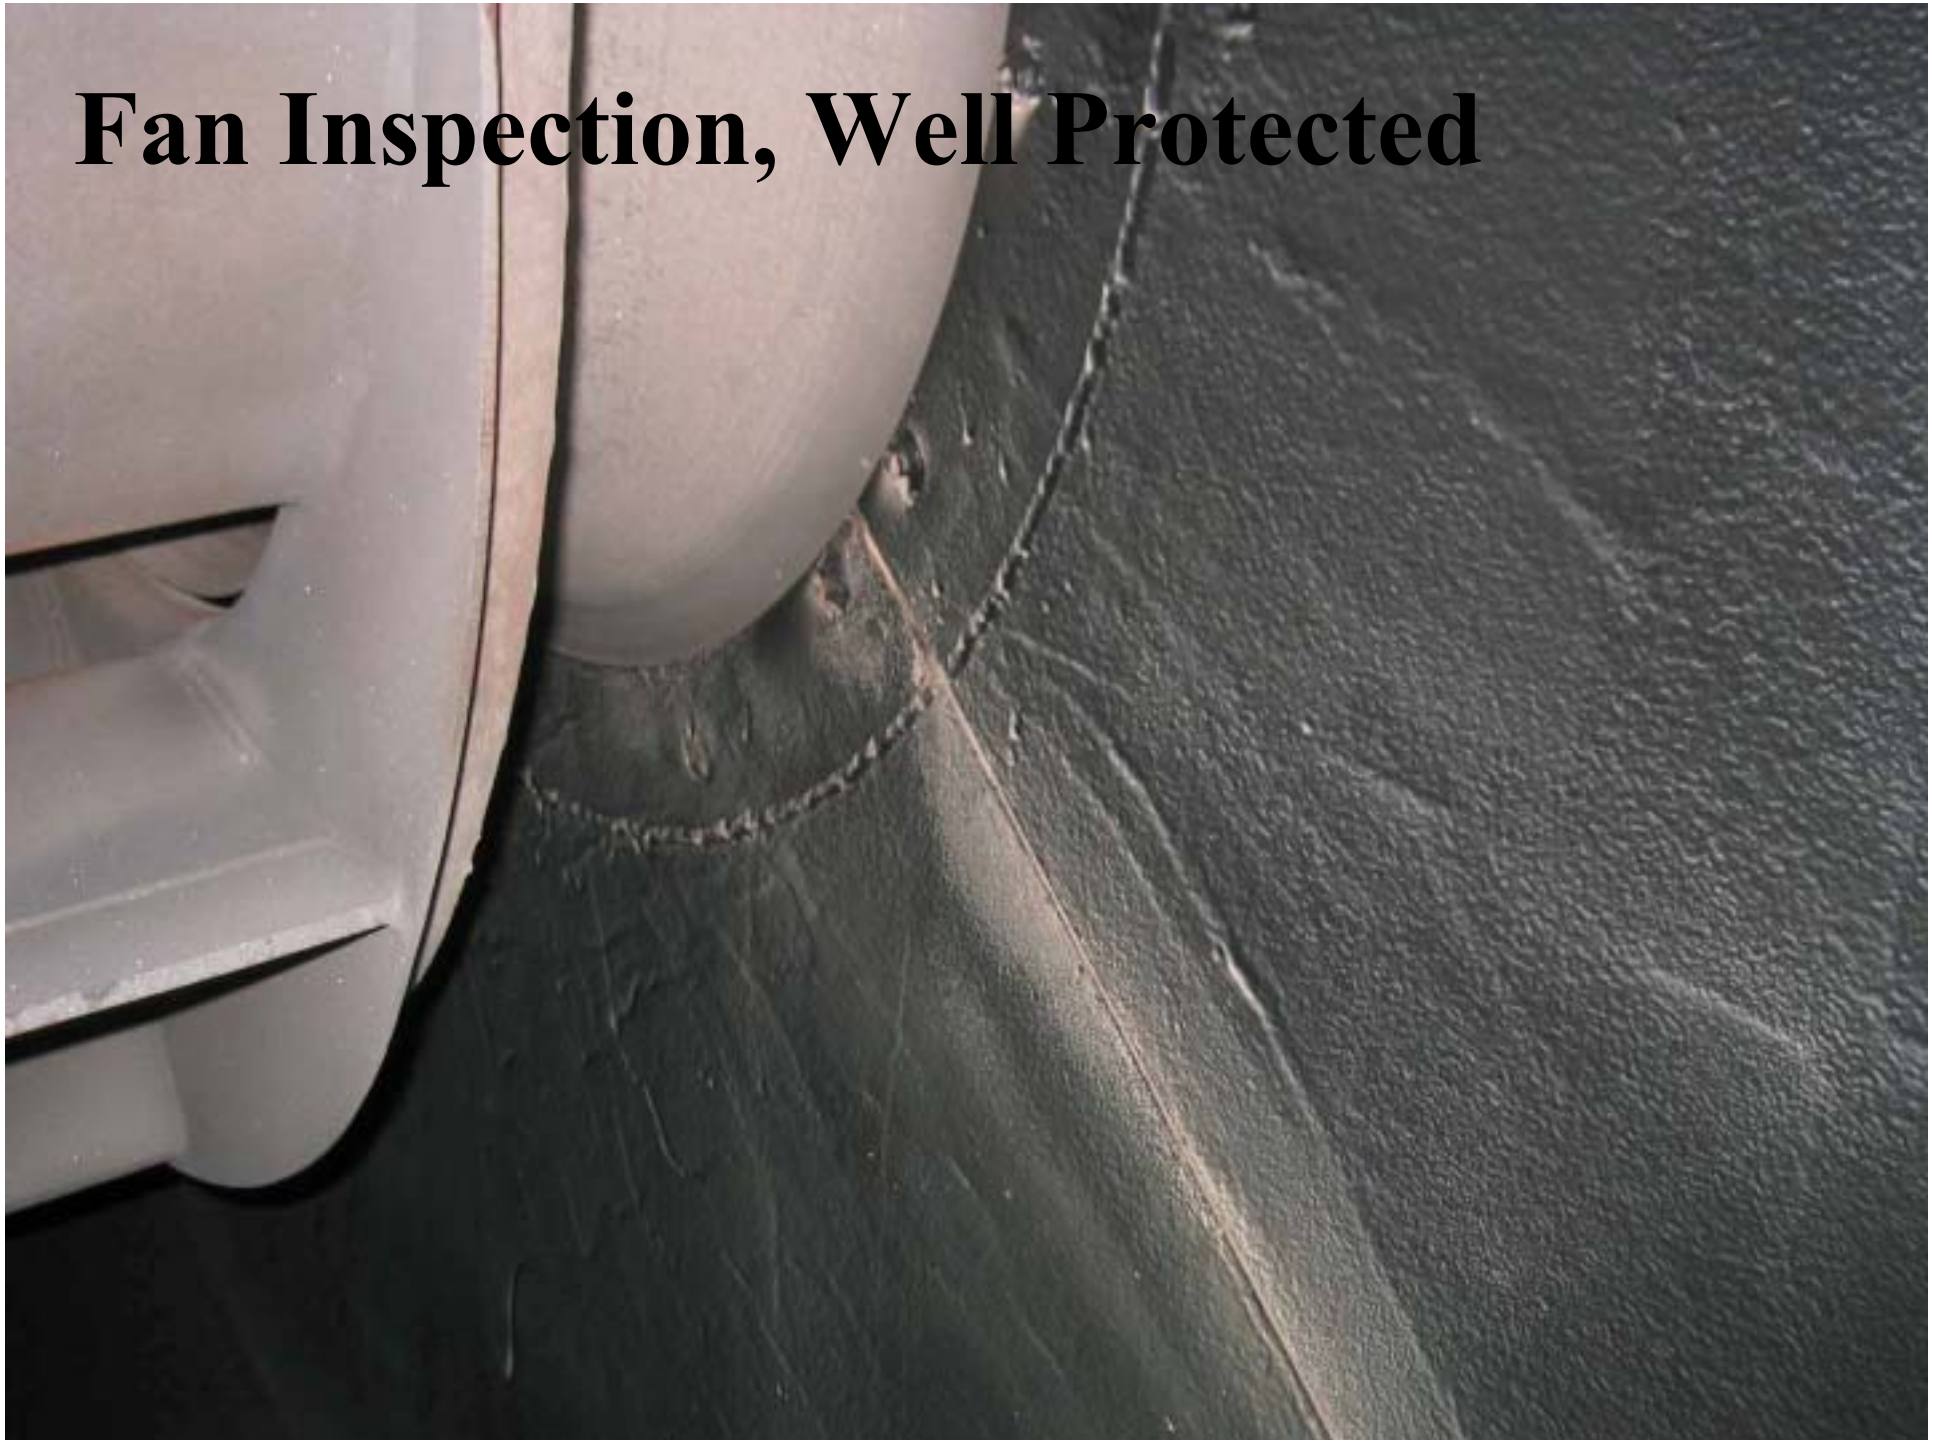
# Fan Inspection, Well Protected

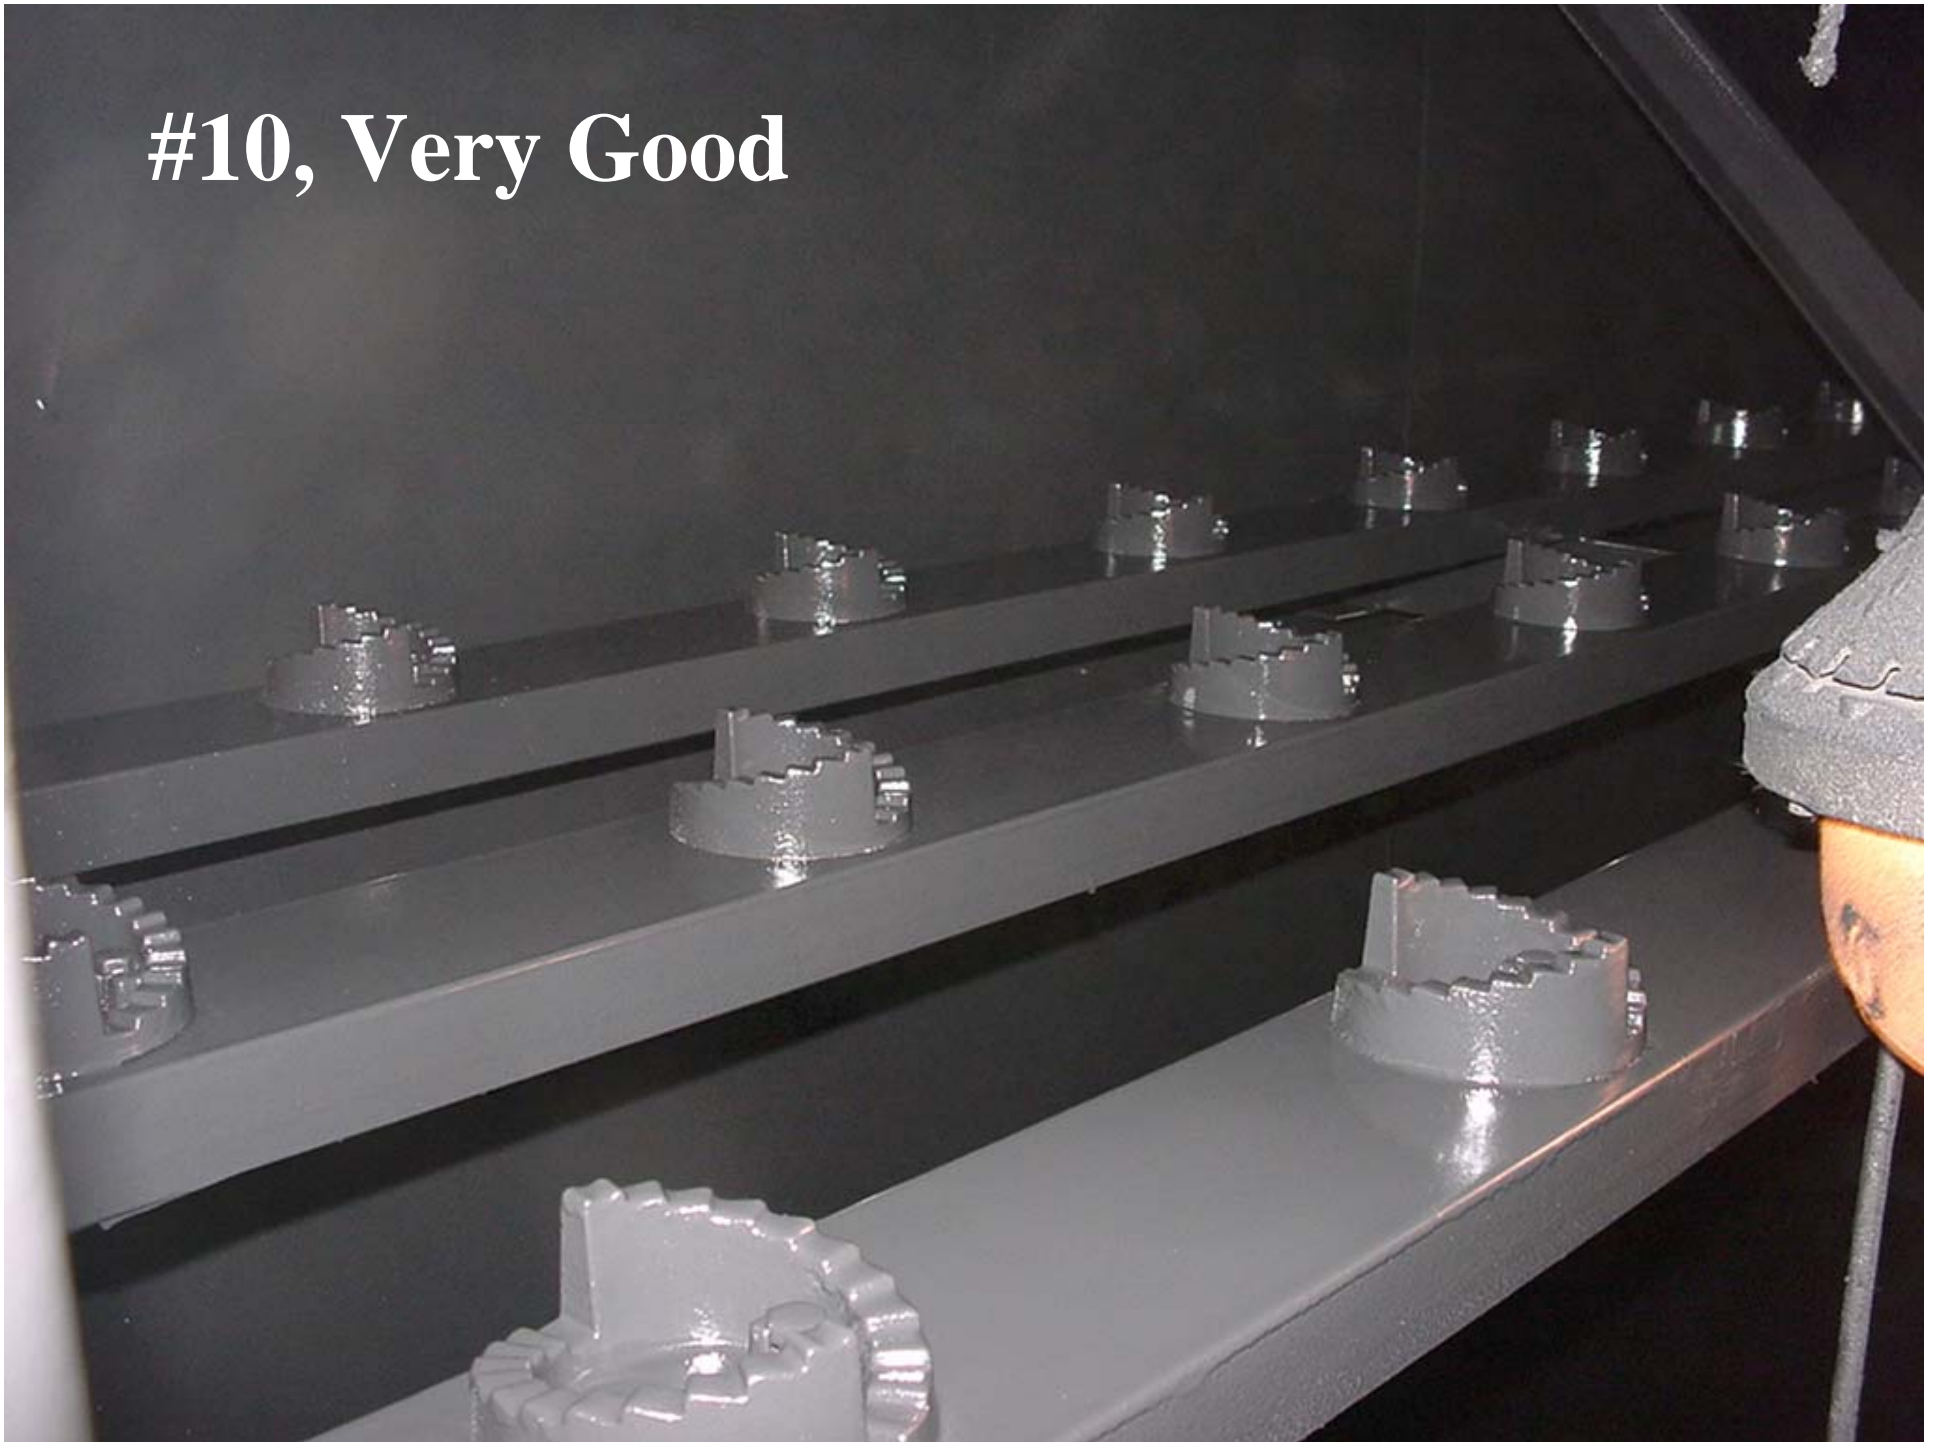
**#10, Very Good**
