CORROSION AND ABRASION: THE FINAL FRONTIER

NEW SOLUTIONS FOR CORROSION AND ABRASION IN CEMENT PLANTS

BY LINAS MAZEIKA, PRESIDENT 3L&T INC.

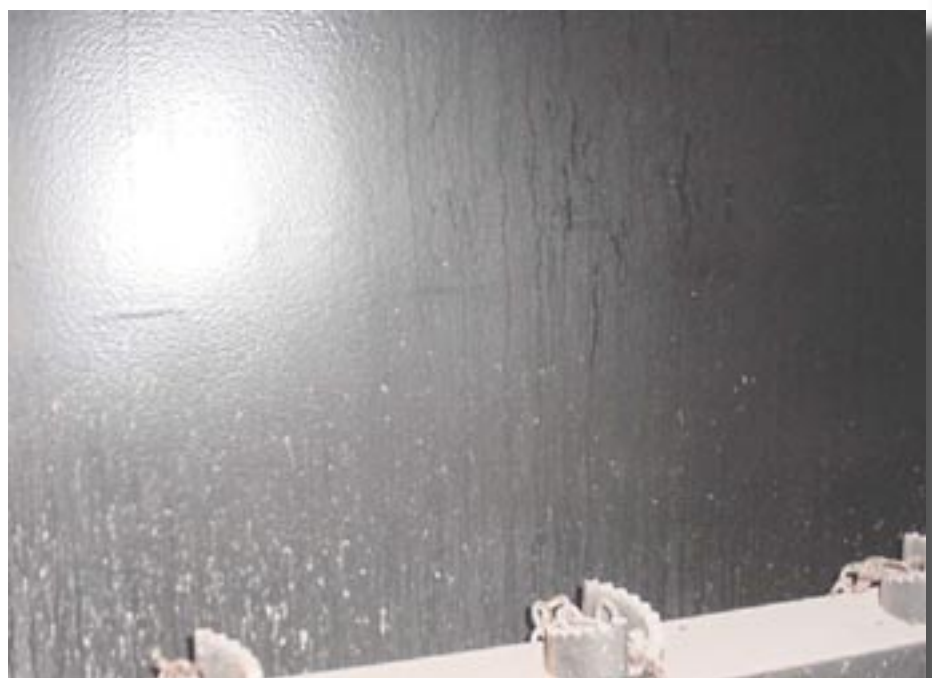
Fig 1. Baghouse wall coated with FlueGard-225SLB, two years previously.

Three years ago, 3L&T Inc. introduced a new corrosion protection technology called FlueGard-225, with a focus on baghouse filter corrosion. Today, after four upgrades, this coating material is being used around the world. Figure 1 shows the condition of a baghouse inspected after the application of FlueGard-225 two years pre-

viously. There has been no corrosion.
