# Stack Corrosion: A Serious Problem

Linus Mazeika, 3L&T, USA, describes the company's method for preventing and stopping corrosion in cement plant chimneys.

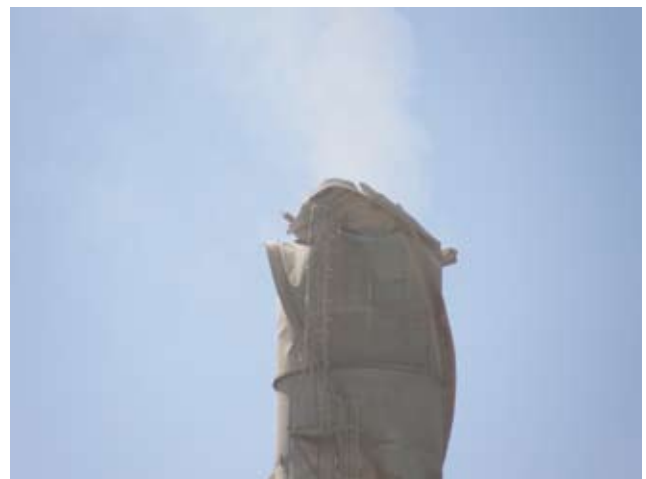
Figure 1. Part of a corroded chimney.

In many cases the corrosion effect is dramatic. After 4 - 5 years, there is significant wall thickness loss and the

chimney becomes structurally unsafe. Figure 1 illustrates a case where the top of the chimney fell down.

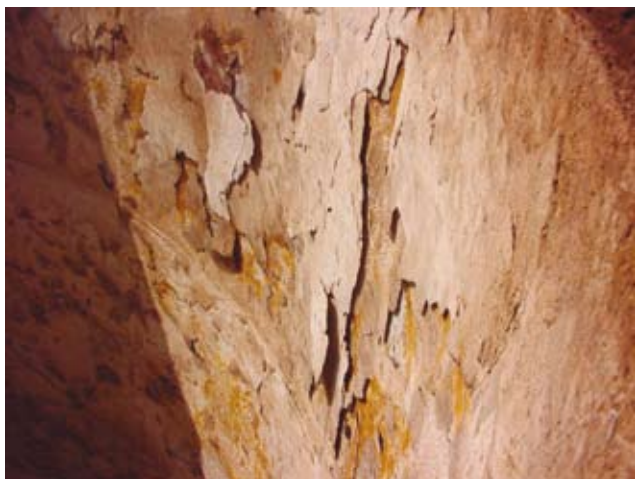
Figure 2. Rust scales inside a chimney.

corrosion is accumulative. As the thickness of the rust layer increases, eventually corrosion flakes disbond from the metal surface and the flue gases push them out. This is often visible in the neighbourhood of a corroding chimney. Figure 2 shows these rust scales inside a chimney.

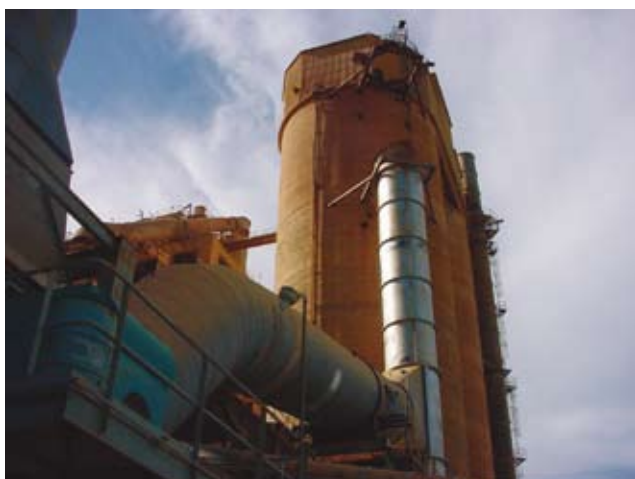
Figure 3. The effect of chlorides in a coastal location.

When there is a higher concentration of acidic compounds in the combustion gases, corrosion is accelerated. Usually there is high sulfur content in the fuel. In many cases, there is often significant chloride content in the alternative fuels as well as CO<sub>2</sub> and NO<sub>x</sub> emissions from the combustion process. Figure 3 shows the effect of chlorides in a coastal location.

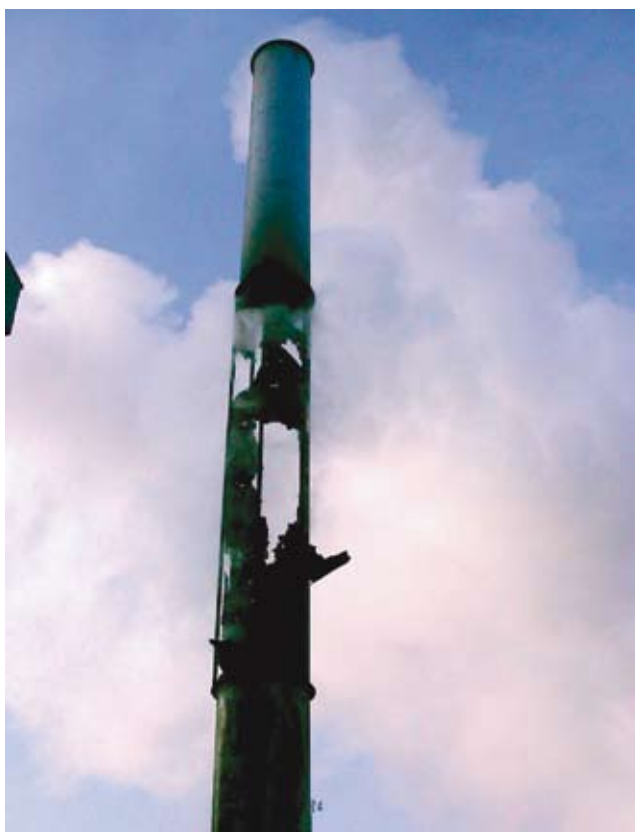
Figure 4. A severely damaged chimney.

Oxidation damage occurs when the metal surface operates above 150 °C (300 °F). Delamination, as a result of undercut corrosion, occurs when there is coating surface damage or imperfection in the surface preparation. It usually starts as a small spot, and from there the propagation is relentless. Figure 4 shows a chimney where the coating applications did not protect it from severe damage.

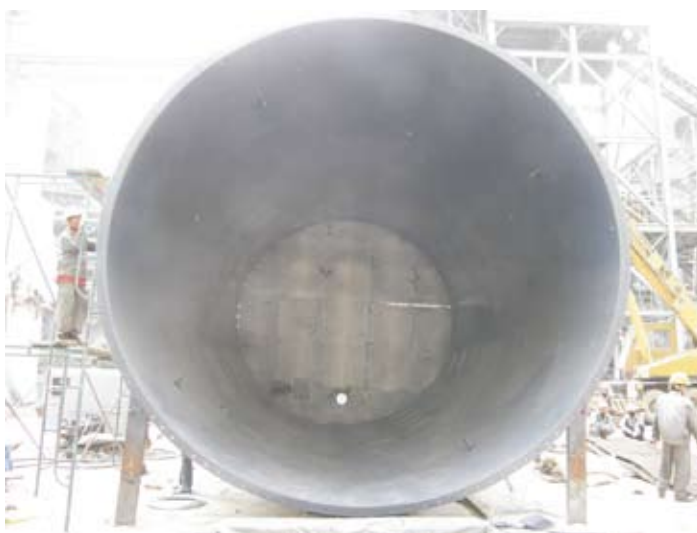
Figure 5. The application of StackGuard-225SQW.

A large cement plant near Jakarta experienced severe corrosion in its kiln chimney. This chimney is 6.5 m dia x 100 m high. The top 70 m were rebuilt during January 2008 in 10 m sections and coated on the ground. Figure 5 shows the application of StackGard-255SQW on one section.

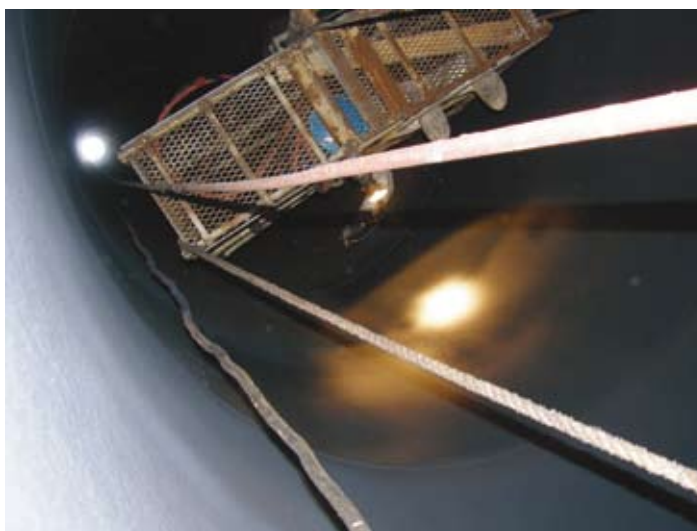
Figure 6. Application in progress.

National Cement's plant, located near Lebec, California decided to coat the whole length of its 100 m chimney using the StackGard-225SQW. This project was completed in April 2008. Figure 6 shows the application in progress.

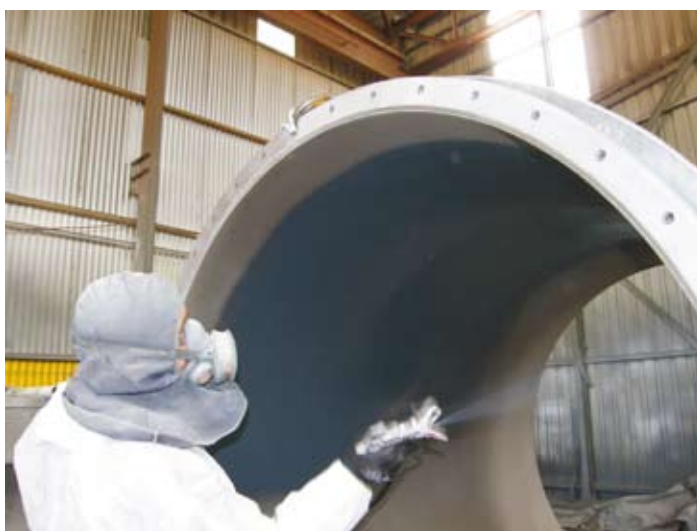
Figure 7. Application on one section of the chimney.

Cemex is building a new cement plant in Teruel, Andorra, and decided to coat the chimney to prevent corrosion damage. The 10 m sections were coated on the ground before assembly. This approach makes the application easier, lowers the total cost and facilitates quality control of the job. Figure 7 shows the application in one section.
