Solutions for **Severe** Corrosion

Linus Mazeika, President, 3L&T Inc., USA, reveals how to prevent equipment corrosion caused by hot combustion gases in a cement plant.

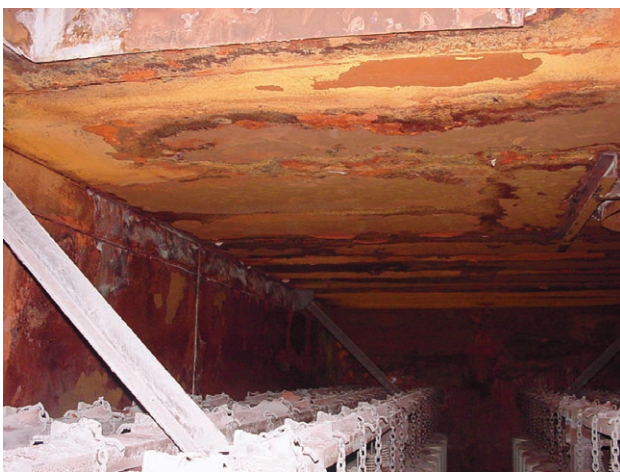
Figure 2. Severe corrosion damage in a reverse air baghouse filter.

Proper insulation and its maintenance can sometimes reduce corrosion problems under the right conditions. However, insulated equipment with operating gas temperatures close to the dew point can still have significant corrosion. Figure 2 shows the inside of an insulated baghouse filter that has experienced severe corrosion. This baghouse operates in a high sulfur environment near the dew point. The walls are corroding and rust scale is falling on the tube sheet along the walls.

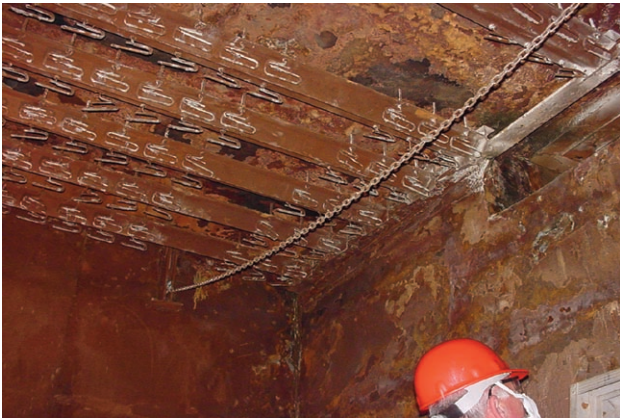
Figure 3. ESP walls made of SS304, corroding severely.

Stainless steels are alloys of iron that generally have a minimum of 12% chromium. More chromium can be added to increase corrosion resistance. Alloys containing Molybdenum have improved resistance to pitting and crevice corrosion. The addition of nickel provides resistance to reducing environments. When nickel comprises more than 25% of the metal, it improves the stress corrosion cracking resistance. Figure 2 shows an ESP made of SS304. The chlorides present in the gases are corroding the walls badly.

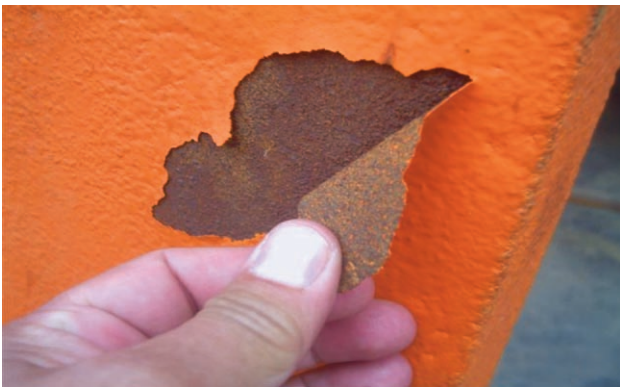
Figure 4. Blistering and delamination of an epoxy coating.

oxygen will be reduced during the transport through the corrosion products. In the case of carbon steel, the initial corrosion product is Fe^{2+} . In the presence of oxygen, it will be oxidised to Fe^{3+} and will consume the oxygen. The corrosion process leads to a film growth at the centre of the blister, which hinders further oxygen transport to that area. The growth of blisters under intact coating is due to cathodic delamination. Figure 4 illustrates this type of failure.

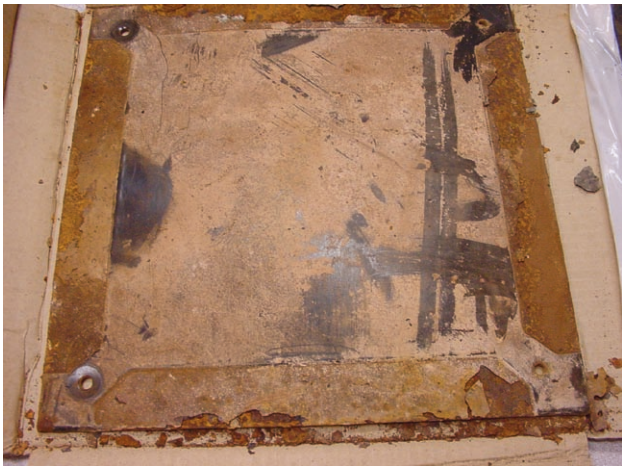
Figure 6. Test plate retrieved after five months of exposure.

To demonstrate the performance of the new material, 3L&T installed test plates inside the baghouse filter, exposing the coating to the actual operating conditions. The test plates were retrieved after several months in service for analysis. Figure 6 shows one sample as received.

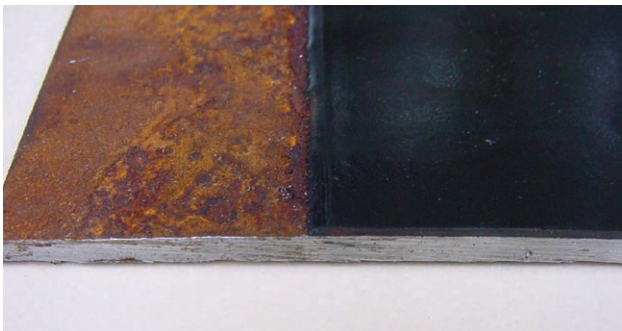
Figure 7. Corrosion stops right at the edge of the protective coating.

After cleaning the test plate, the coating was in very good condition, the corrosion rate in the exposed metal border was measured at >1 mm per year. Most importantly, after cutting through the metal to expose a cross-section of the coating, it is clear that the corrosion stops right at the edge, i.e., there is no undercut corrosion. This can be observed in Figure 7. The reason for this unusual behaviour is the nature of the interface between the coating and the metal. The chemistry of the coating produces a passivation of the metal surface. This passivation prevents the formation of cathodic and anodic regions that are the drivers of the undercut corrosion.

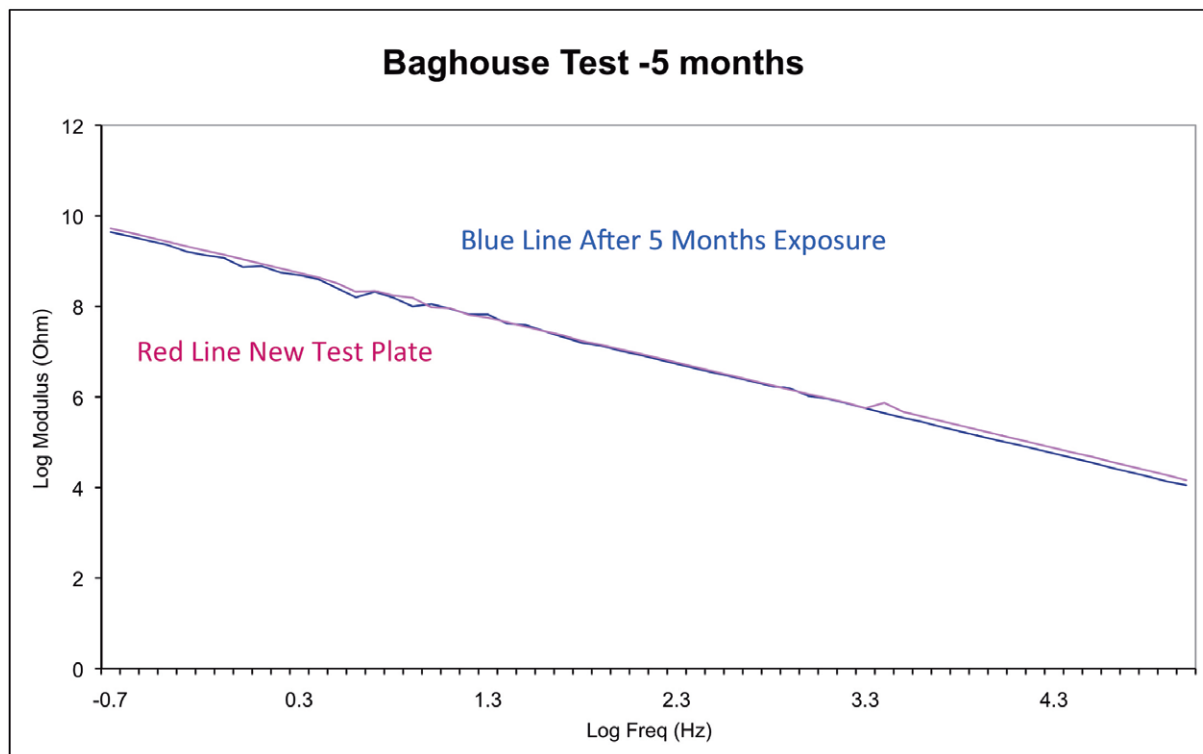
Figure 8. Electrochemical Impedance Spectra, before and after exposure.

The layer was tested in the laboratory using Electrochemical Impedance Spectroscopy (EIS). This is a modern technique available to characterise the electrical properties of organic coatings and their adhesion to metal surfaces. A coated test plate was measured before and after five months of exposure inside a baghouse filter. The two lines of the Bode plot in Figure 8 almost overlap, indicating that there is no measurable damage to the integrity of the coat.

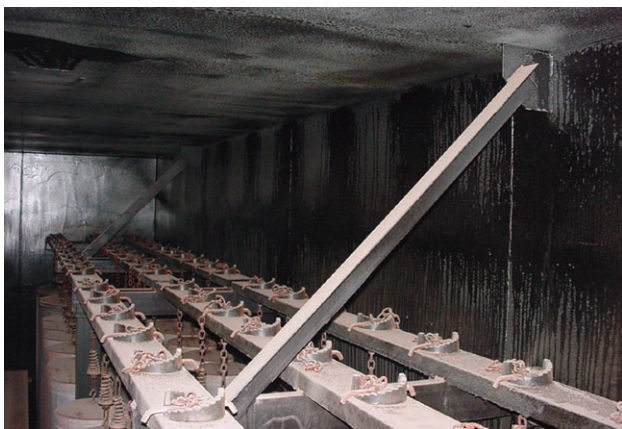
Figure 9. Inspection of FlueGard-225SQC after five years in a baghouse filter, showing no corrosion.

There are currently several ongoing projects in different industries like cement, lime, power generation, metal smelting, waste incineration, glass and battery recycling. Figure 9 shows the effectiveness of this corrosion protection system in a bag hose filter after five years in service.

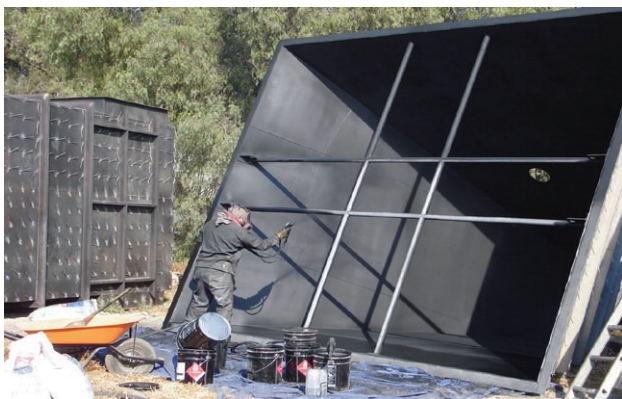
Figure 10. New baghouse filter coated with FlueGard-425S and cured at 200 °C.

This material was developed to address corrosion problems at very high temperatures. This new system is a combination of an inorganic polymer binder and two reactive inorganic fillers that have particle sizes in the nanometer range. The available surface of these fillers is about one million times larger than conventional materials and the end result is a corrosion protection coating that works well up to 425 °C and resists exposures up to 550 °C. Figure 10 shows a new baghouse filter coated with this material called FlueGard-425S. This project was for a cement plant in Mexico.
