Stack corrosion protection

by Linas Mazeika, 3L&T Inc
& Manoj Mohan,
PENTA Industrial Corp, USA

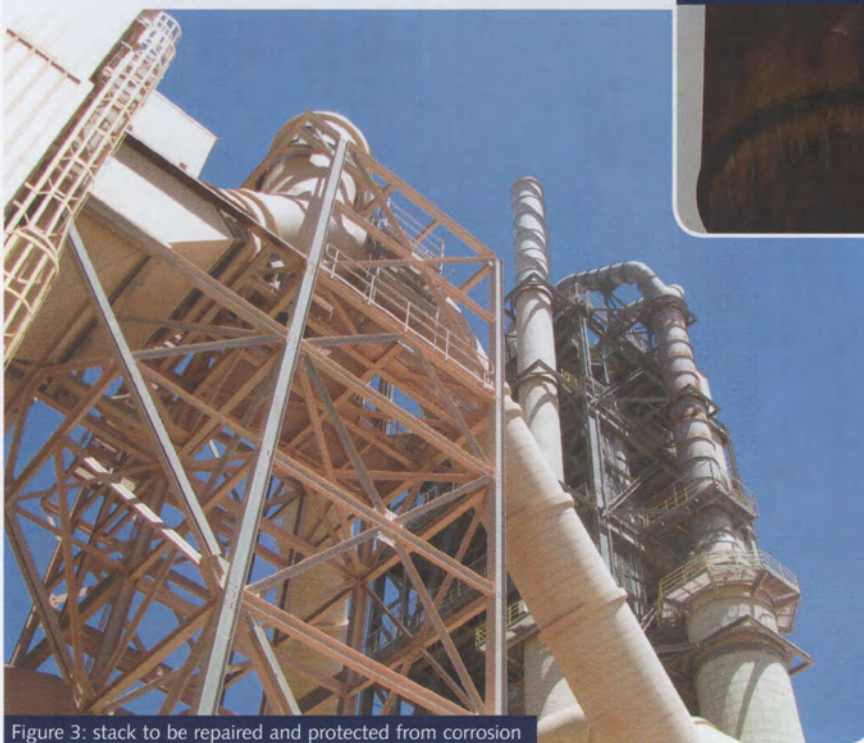
Figure 3: stack to be repaired and protected from corrosion

to install the CorrosionGard™-160S protection on the interior surface of the full height of the stack during the January 2015 shutdown. Figure 3 shows the full chimney.

With the stack out of operation, PENTA Industrial installed a motorised work cage to access the full height of the remaining existing section of the stack. A tarp was installed over the top of the stack to keep out precipitation, and dehumidification

Working two shifts per day to meet the outage schedule, the interior surfaces of the new and existing stack sections were sandblasted to an SSPC SP-10 near-white metal profile and quality control measurements were taken to verify the required profile was achieved.

After blast profile quality measurements were taken and approval to proceed was given, CorrosionGard™-160S was spray applied with a 70-1 airless spray pump to the required wet and dry film thicknesses. Quality control measurements were taken of the dry film thickness to verify required thicknesses were met. Once the spray application was completed and approved, the CorrosionGard™-160S cured at ambient conditions.
