## How to Fix Severe Corrosion in Coal Mill Baghouses

By Andrea Valdes, Project Engineer Cemex, Linas Mazeika, President 3L&T Inc., Carlos Baig, General Manager Solé.

### Cemex Ensenada

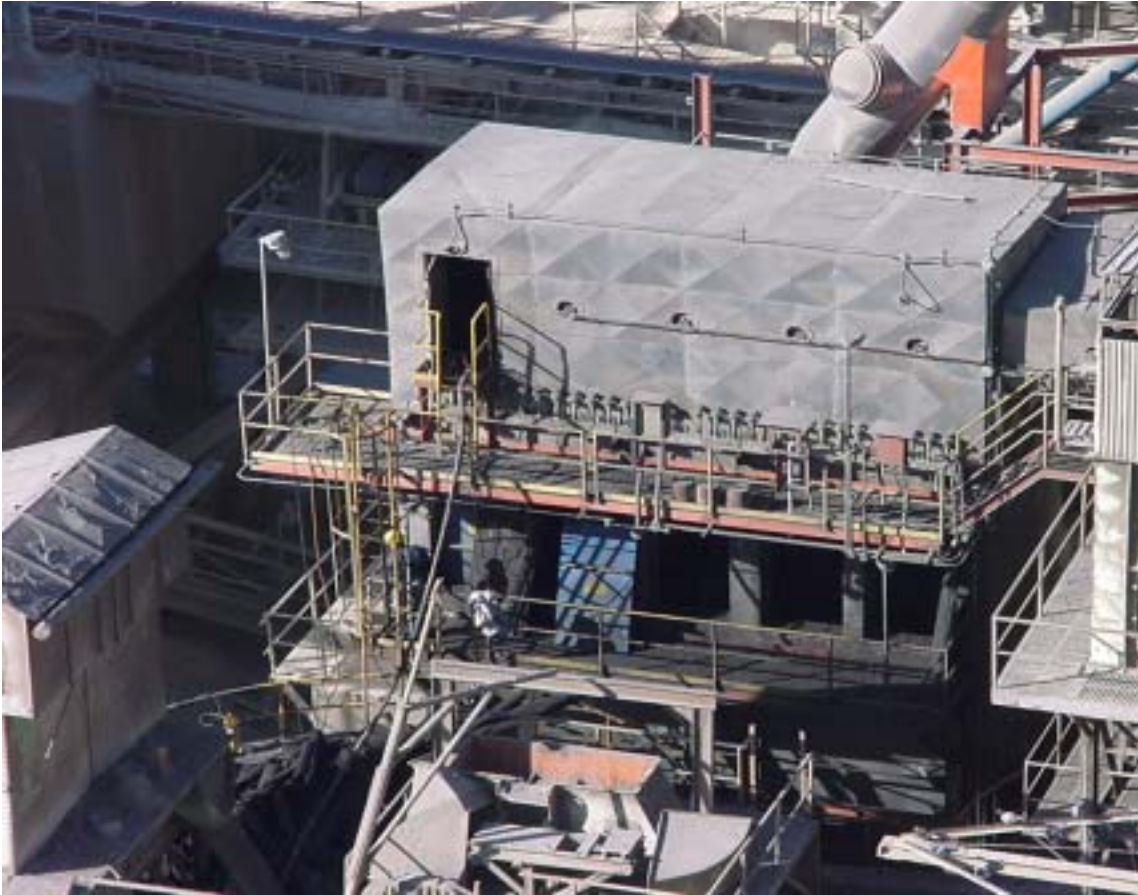
Figure 1 Shows the location of the filter.

Figure 1. View of the Corroding Coke Mill Baghouse

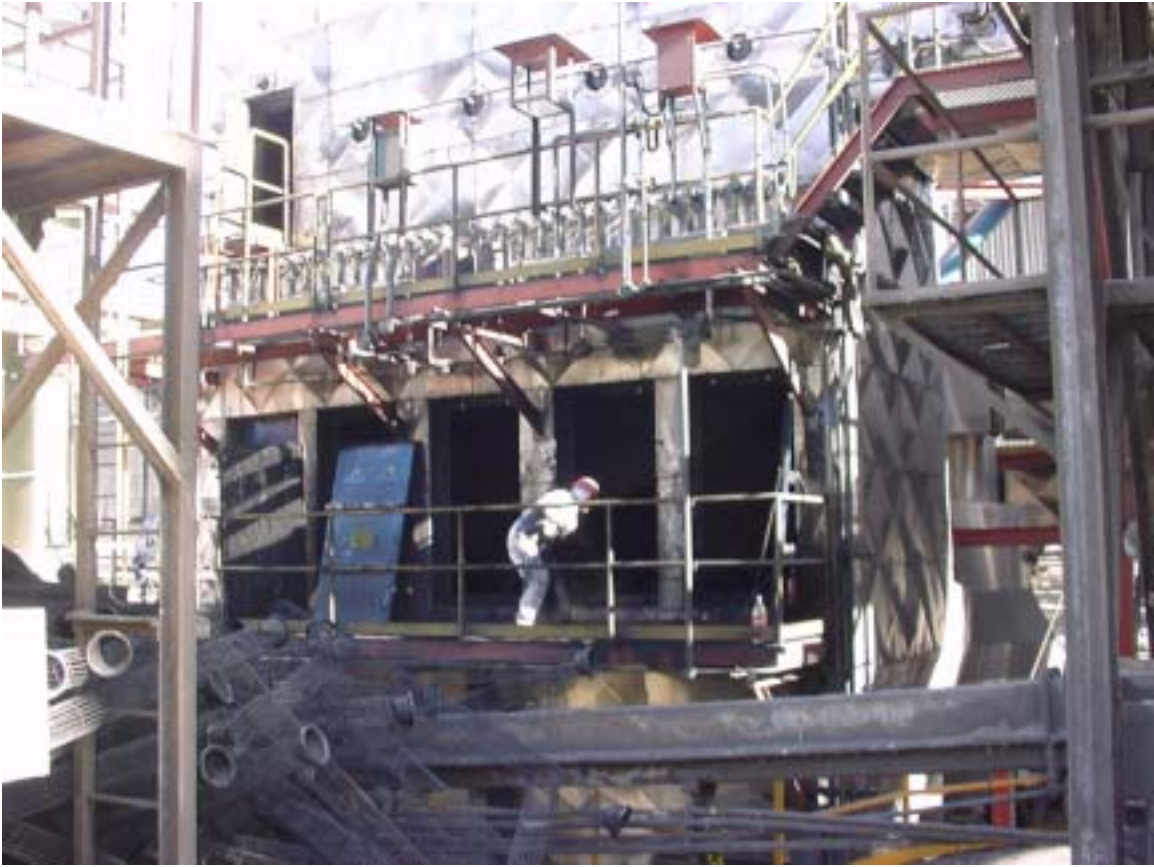
The coating application was done during a plant shutdown late September 2004. Since the job requires complete access to the walls and internal structure, all the bags were removed. Figure 3 shows the bag removal in progress.

Figure 2. Bag removal in progress.

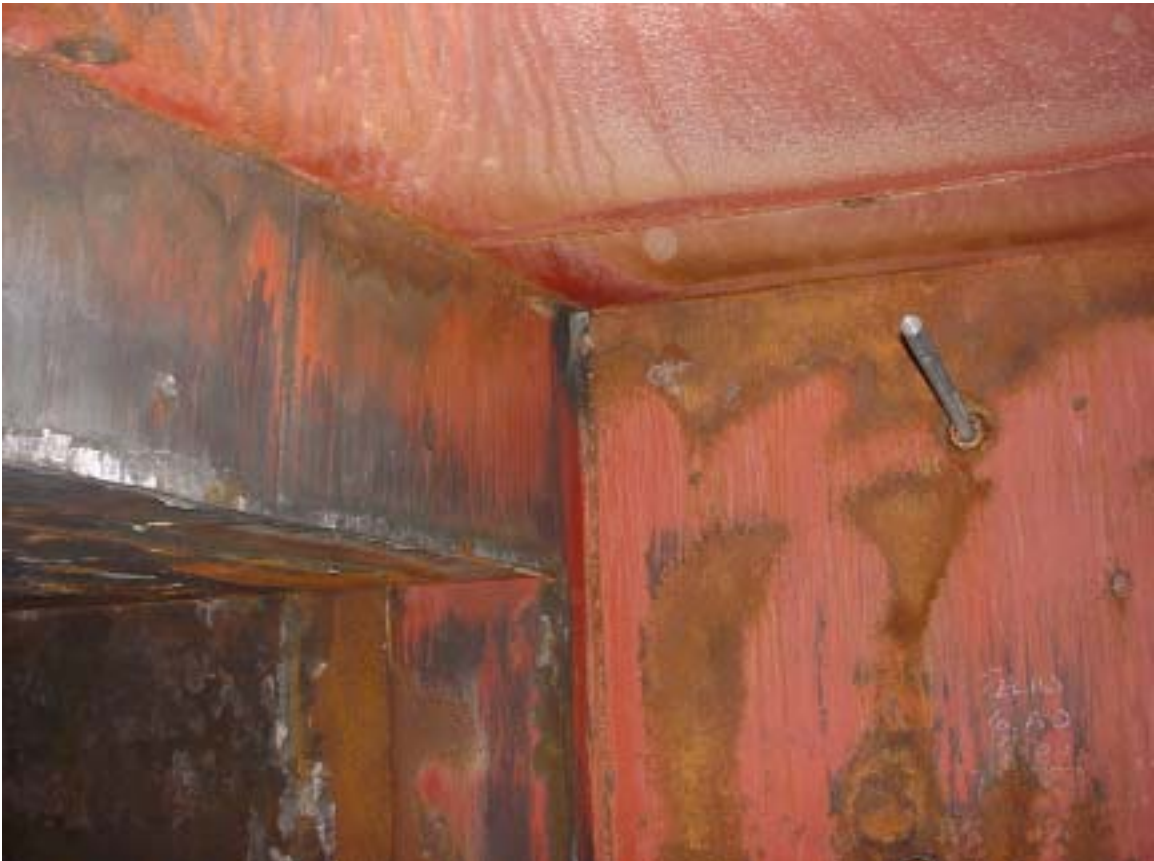
Few months after the start of the equipment, plant personnel noticed signs of corrosion on the walls and ceiling of the clean gas plenum, the epoxy based original coating material was delaminating and failing. After six months the corrosion progress was alarming, at that point the project engineering team decided to install a better solution. Figure 2 Illustrates the corrosion damage.

Figure 3. Corrosion damage after only six months of service.

The plant contacted AAF and they recommended to install the FlueGard™-225 coating, they asked Solé S.A., the local partner for 3L&T, to review the filter and prepare a proposal to solve the corrosion issues.

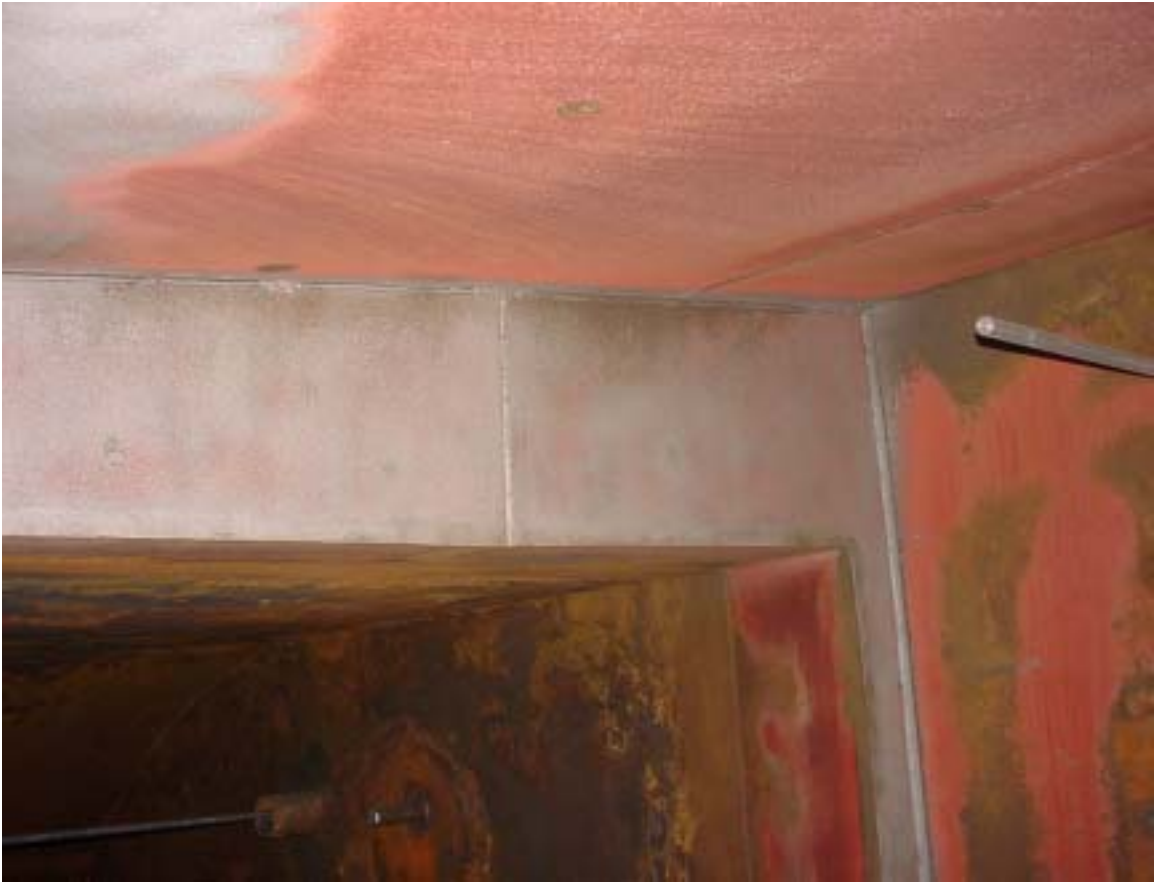
The walls, ceiling, tube sheet and hopper were sandblasted, using a coarse copper slag to a > 75µ profile ( 3 mils ), the Figure 4 shows the condition of the clean surface.

figure 4. Beginning of surface preparation.

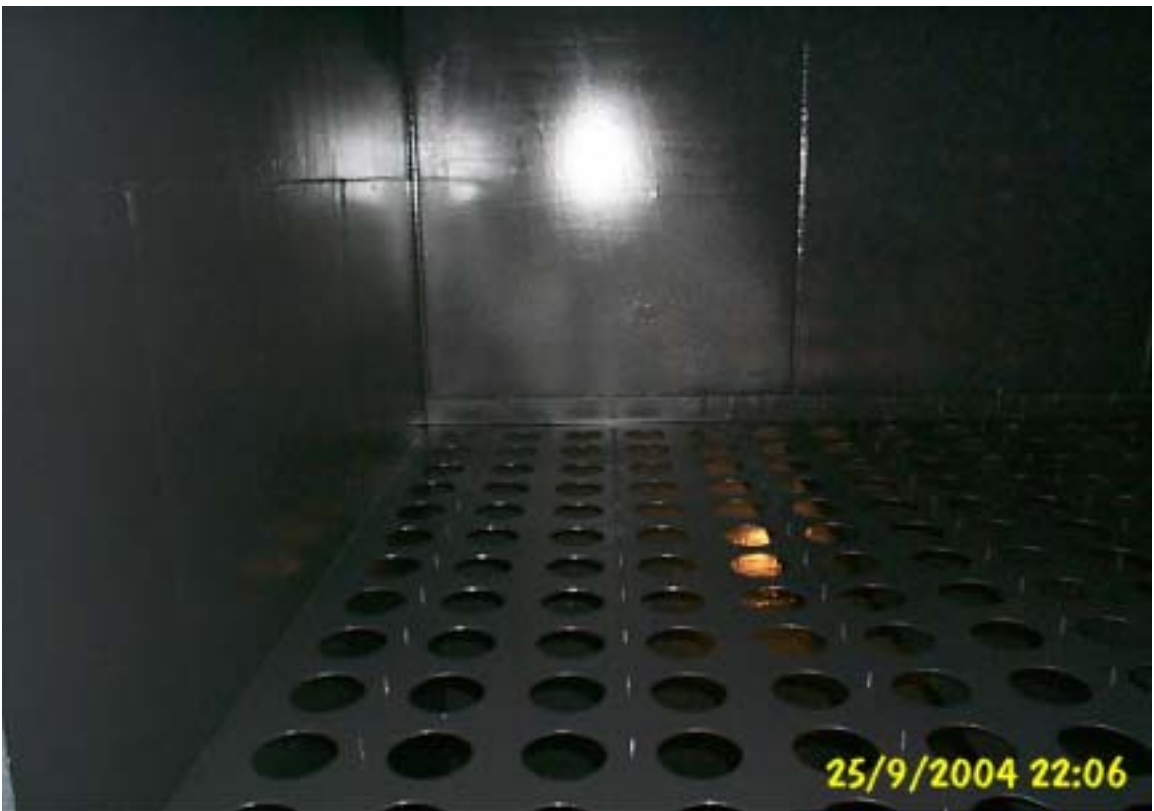
Figure 5. Baghouse protected from corrosion with FlueGard-225

The FlueGard™-225 was applied in two layers, using a conventional spray equipment, to a total dry film of 0.5 mm ( 20 mils ), Figure 5 shows the application in progress. The coating dries after 24 hours to an elastomeric, dry to touch film. At this time the new coating was inspected and approved.

The final stage for the full operating performance of the FlueGard™-225 protection, is a high temperature cure. This part of the process was done using the hot gases from four external burners. The inlet temperature to the filter was ramped up at a rate of 30°C /hr. to a final cure temperature of 134°C, which was maintained for 11 hours. At this point the coating is fully functional and provides an outstanding corrosion protection in this very harsh environment.
