CORROSION

BY ACID GASES IN CEMENT PLANTS

**LINAS MAZEIKA, 3L&T INC., USA,
DISCUSSES CORROSION BY ACID
GASES IN CEMENT PLANTS.**

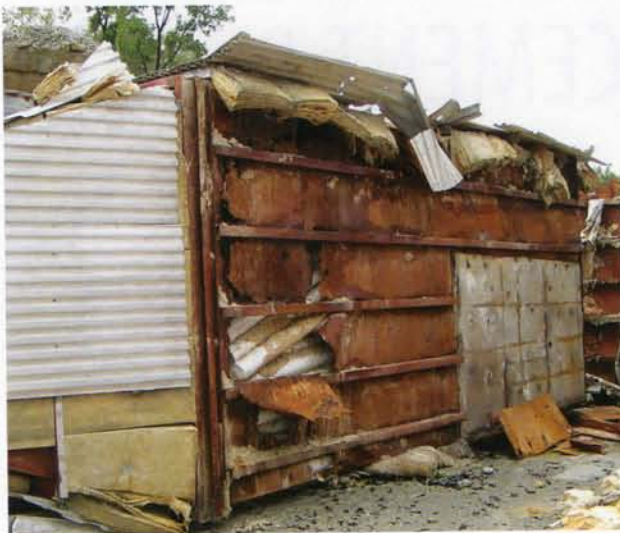
Figure 3. Severely corroded baghouse filter after three years.

Corrosion damage due to condensation of high acidity gases can be devastating. Figure 3 shows what is left of an alkali bypass baghouse filter after only three years in service. The filter had to be replaced with a new one.

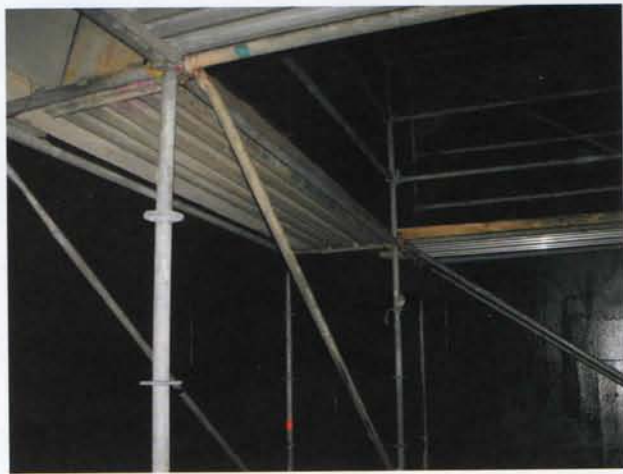
Figure 4. Coating of lower section of a chimney in Missouri.

Figure 4 shows the application in the base of a chimney that operates at less the 200 °F (93 °C). At this temperature there was heavy and continuous acid condensation with severe corrosion consequences.

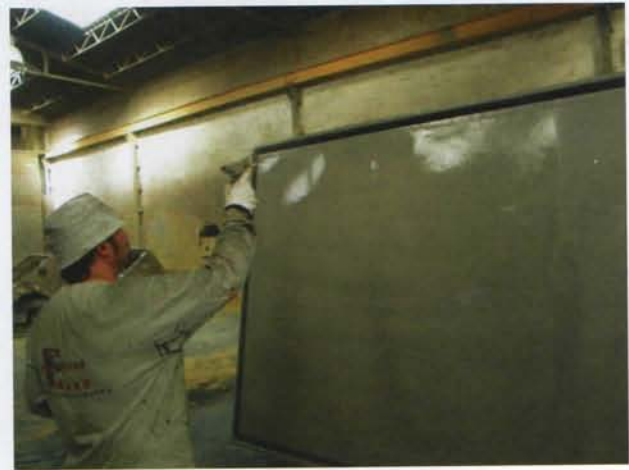
Figure 6. Spray application of CorrosionGard-160S in Spain.

A cement plant in Spain, based on previous experience, decided to protect a new baghouse filter before putting the equipment in service. Figure 6 shows the spray application at a contractor's shop on one of the lid covers. A recent inspection after

six months in operation shows the coating in excellent condition.

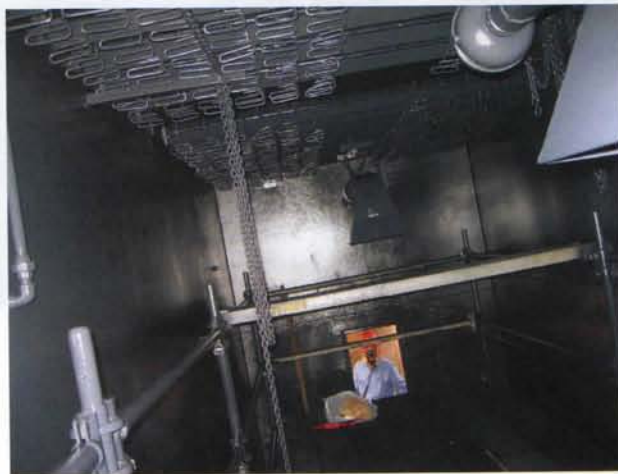
Figure 5. Coating of a baghouse in California.

The baghouse filter shown in Figure 5 was experiencing accelerated corrosion after only one year in service. During a shutdown, the walls were sandblasted and coated with CorrosionGard-160S, using an airless spray equipment. An interim inspection eight months later shows good protection.

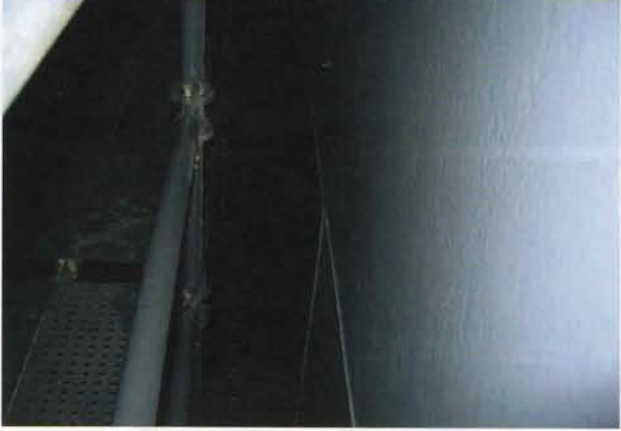
Figure 7. CorrosionGard-160S coating on a waste incineration baghouse in France.

Internal corrosion of baghouses in waste incineration plants can be extremely severe. They do not have the benefit of alkaline dust, which in cement plants tends to neutralise the condensing acids and slow down the corrosive damage. Figure 7 shows a job in progress of the internal coating application in a baghouse that was experiencing substantial corrosion.

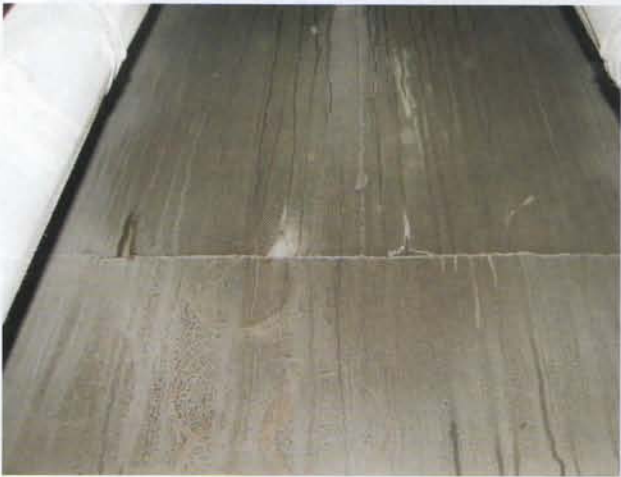
Figure 8. Wall inspection after one year in service, no corrosion.

Figure 8 shows the condition of a baghouse wall in Brazil, coated more than a year ago with CorrosionGard-160S. The surface shows some dust and some condensation streaks but no corrosion.
