CORROSION

BY ACID GASES IN CEMENT PLANTS

**LINAS MAZEIKA, 3L&T INC., USA,
DISCUSSES CORROSION BY ACID
GASES IN CEMENT PLANTS.**

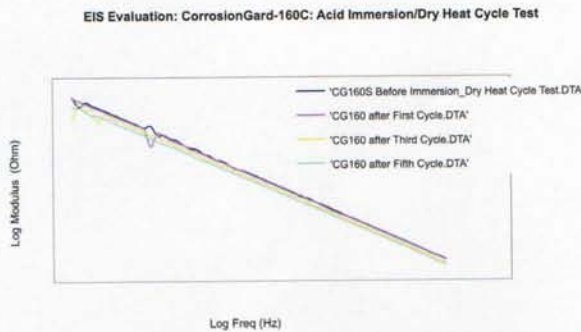
Figure 1. EIS spectra of the CorrosionGard -160S sample after immersion/dry heat cycles.

This test was performed to examine CorrosionGard-160S performance characteristics in an environment that is similar to the walls of a baghouse filter or a chimney. The steps for each cycle were as follows:

- 20 hours immersion in 35% sulfuric acid at 200 °F (93 °C).
- 3 hours dry heat exposure at 450 °F (233 °C).
- 2 hours cool down at room temperature.
- 3 hours dry heat at 200 °F (93 °C).

The coated panels were exposed to five full cycles. After the end of each cycle, the samples were subjected to an Electrochemical Impedance Spectroscopy (EIS) to measure the barrier properties. An EIS spectrum after several cycles is shown in Figure 1. The barrier properties show no signs of deterioration.

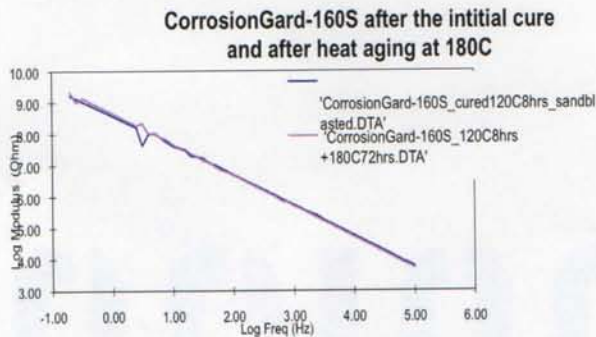
Figure 2. Thermal fatigue testing of CorrosionGard-160S.

CorrosionGard-160S samples were tested for thermal fatigue exposing coated steel plates to continuous heat at 180 °C during a period of three days. Samples were also cycled between ambient temperature and 180 °C with up to 1 hour excursions to 250 °C as described in ASTM D2485 standard test methods for evaluating coatings for high temperature service.

The company's new coating material passed the test without disbondment or deterioration. Electrochemical impedance also remained unchanged, as shown in Figure 2.

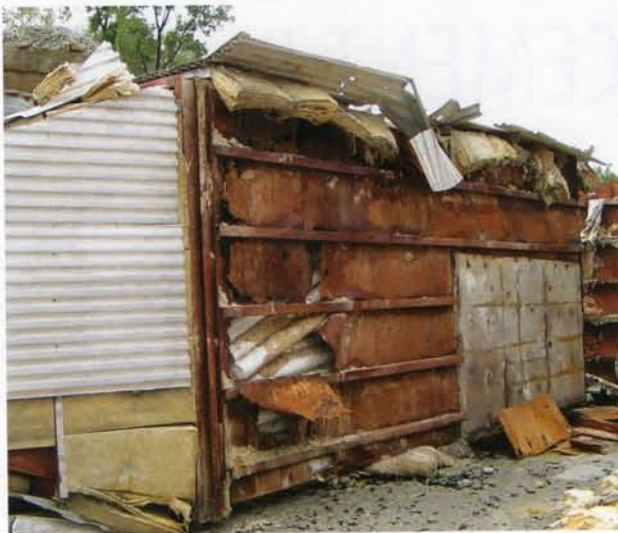
Figure 3. Severely corroded baghouse filter after three years.

Corrosion damage due to condensation of high acidity gases can be devastating. Figure 3 shows what is left of an alkali bypass baghouse filter after only three years in service. The filter had to be replaced with a new one.
