Corrosion in Pollution Control Equipment

Linas Mazeika, President of 3L&T Inc., USA, discusses the effect of corrosion and the most effective ways to prevent it.

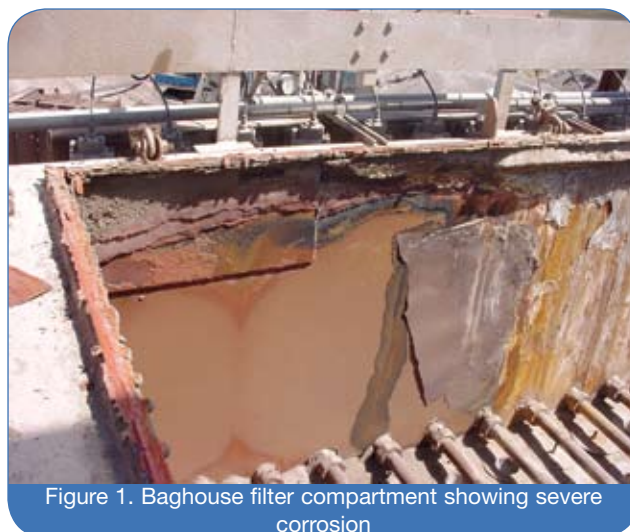
Figure 1. Baghouse filter compartment showing severe corrosion

chlorides. Pollution control equipment like baghouse filters and ESPs, frequently fail due to corrosion. Associated components such as conditioning towers, ducts, fans and stacks also suffer corrosion damage. Typically, equipment operating with cleaner gases in the cooler end of the process will show accelerated corrosion damage. These areas are exposed to frequent condensation, especially when there are cold air leaks, low external temperatures, and frequent shutdowns.

Corrosion is more severe when there is a higher concentration of acidic compounds in the combustion gases. The sources are usually sulfur content in the feed or the fuel, chloride content in the feed or in air near the coast, and CO_2 and NO_x from the combustion process. The acidic condensate typically has a pH value below 1.0 and contains sulfuric and sulfurous acid mostly from the sulfur in the fuel. Additional acids may also be present. This high temperature acid condensate corrodes the metal very rapidly. It is common to have thickness loss of 1 mm per year or even higher. This leads to perforated walls in four years, or less in some cases.

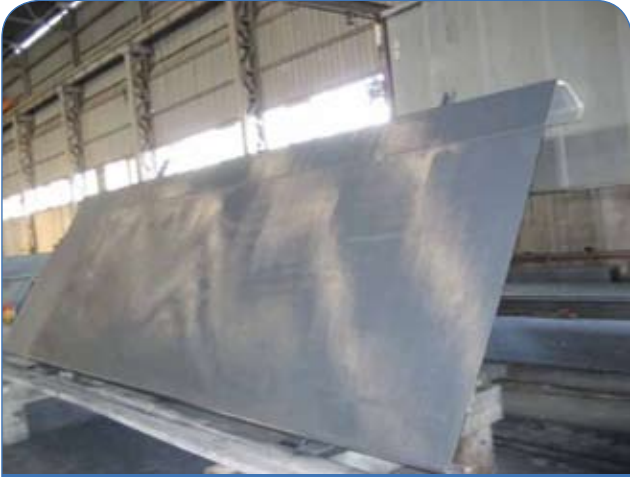
Figure 2. New filter plate coated with FlueGard-225SQC.

A new kiln baghouse designed by Lurgi was built and coated in sections in Turkey, and then the components were shipped to Switzerland for assembly. The Figure 2 shows one of the plates after the application of the protective coating.

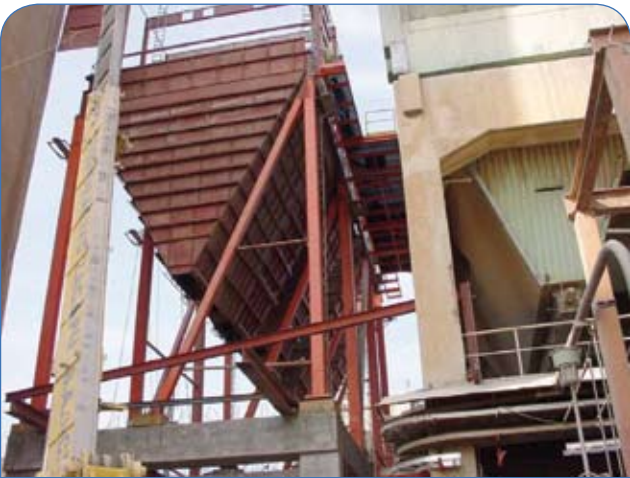
Figure 3. New ESP filter in Mérida, México, coated with FlueGard-225.

Another new filter, this one is an ESP for the raw mill drying, was supplied by FLSmidth, Mexico, to a cement plant in Merida. Again, the sections were coated with FlueGard-225SQC on the ground and then assembled in place. Figure 3 shows the hoppers already in place. The final cure in this case, was carried out with the hot gases from the drying burner, bypassing the dryer.

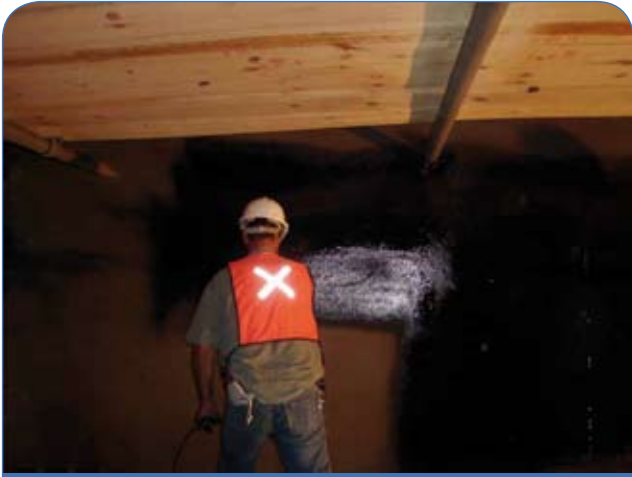
Figure 4. Airless Spray of FlueGard-225SQC in South Africa.

This cement plant decided to install a new kiln baghouse to improve the environmental performance. Based on their previous experience, they expected severe corrosion in the new equipment. They specified the application of FlueGard-225SQC on the clean gas side of a jet pulse filter manufactured by Mikropul (Pty) Limited. This project was completed towards the end of 2006. Figure 4 shows the application of the coating material using airless spray equipment.

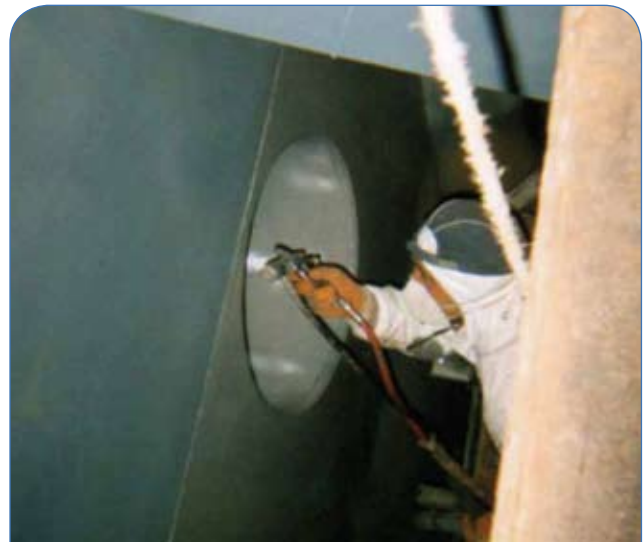
Figure 5. Air spray application of FlueGard-425S in Ireland.

This plant has a new coal mill baghouse designed and built by Redecam. The plant owner was concerned about the coating resistance to high temperatures in case of an internal fire in the filter. In this case the selected corrosion protection coating was the FlueGard-425S. This material will survive temperature peaks of 600 °C (1112 °F), and additionally it will not burn. The project was completed during October 2006. Figure 5 shows the spray application of the protective coating.
