NEW LEVELS OF PROTECTION

Linas Mazeika, 3L&T Inc., USA, asks how we can protect equipment from corrosion and abrasion at very high temperatures.

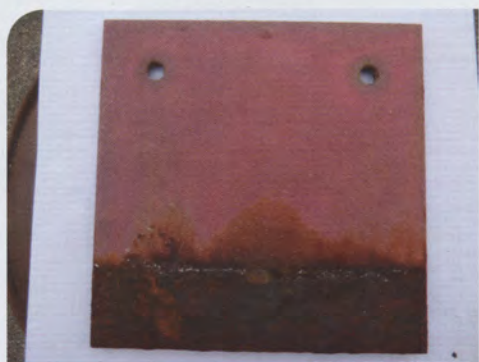
Figure 1. Exposed border corroded, no undercut damage.

A unique characteristic of 3L&T's coating materials is their resistance to undercut corrosion. This is a destructive failure mode where an exposed edge starts corroding under the coating and propagates until most of it disbonds and delaminates. Figure 1 shows the test plate a year later: coating is in perfect condition; exposed

metal is badly corroded but corrosion stops right at the edge of the coating.

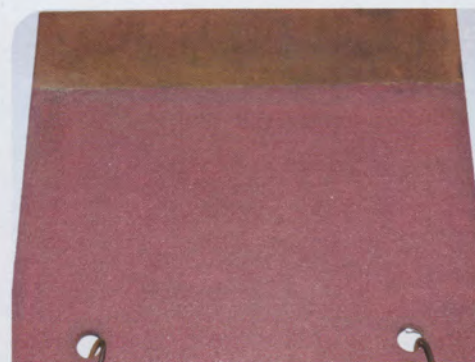
Figure 2. Test plate coated with ceramic FlueGard™-455CHT.

The test was performed on a 6 x 6 x 1/8 in. sandblasted hot rolled steel panel. The test panel was prepared by applying FlueGard™-455CHT ceramic coating and cured according to 3L&T specifications for the product.

The sample was then hung inside the kiln baghouse compartment by the wires and exposed to the service environment for more than 8 months. The exposure temperatures were in the range 240 – 440°F (116 – 226°C) with peaks up to 560°F (293°C).

Inspection of the test plate coated with FlueGard™-455CHT ceramic material, which is rated

for higher temperatures, showed no signs of coating deterioration. No defects in the coating film were detected. The coating retained its strong bonding to the steel surface. The coating thickness and hardness also remained the same. Based on these results, FlueGard™-455CHT is deemed to be well suited to the corrosion protection of the equipment in which it was tested.

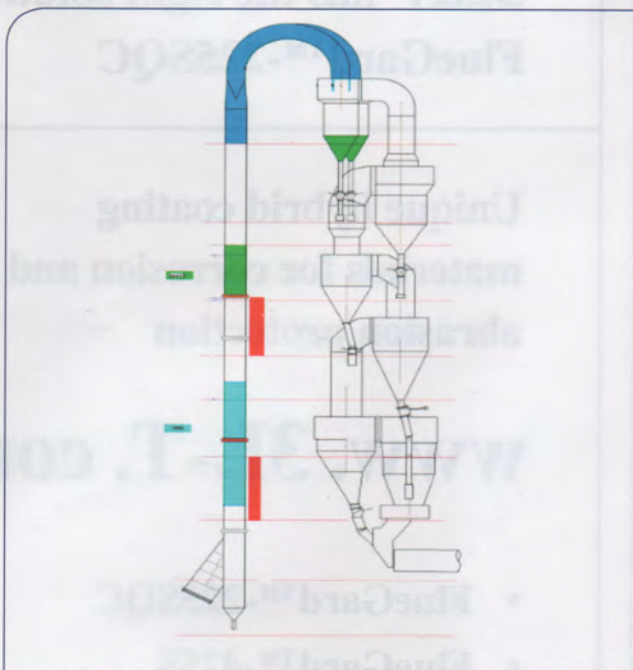
Figure 3. Coloured sections of the duct replaced in the last 2 years.

Figure 3 shows in different colours the sections of the preheater tower outlet duct that have been replaced recently due to internal corrosion and abrasion. The proposal is to coat with FlueGard™-455CHT the section that is replaced next and follow up the protection performance.

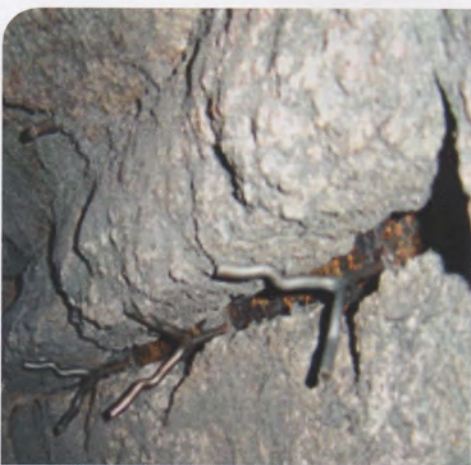
Figure 4. Replacement of damaged anchors.

The other serious problem that is being evaluated with 3L&T's partner in Mexico is the protection of the refractory anchors, as shown in Figure 4.

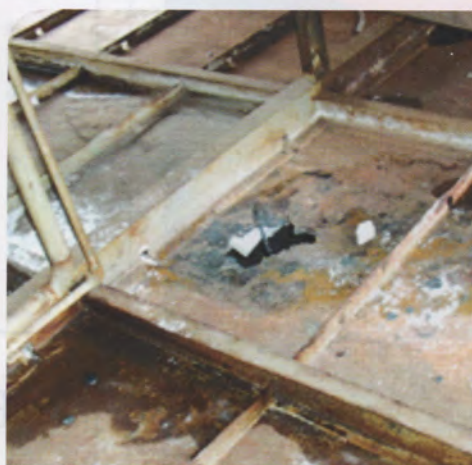
Figure 5. Roofing corroded due to refractory failure.

Anchor failure can lead to severe refractory damage and corrosion of the equipment walls, as shown in Figure 5. The company recommended the application of the FlueGard™-455CHT coat on the anchors and on the inside of the shell. The ceramic material will bond to the metal and protect it from any damage whenever the refractory cracks during the plant operation.
