# FlueGard-225SLB at Obourg ESP

- The 2 kiln electro filters at Holcim Obourg plant are totally built in stainless steel to slow down corrosion.
- The presence of chlorides in the gases is severely corroding away the stainless steel walls.
- The welds are more affected by corrosion due to the heat treatment, in some areas they are punctured.
- The plant installed a 15 mt<sup>2</sup> new section of SS during November 2004 to repair a damaged wall.
- The section was coated by P.A Technologies using FlueGard-225SLB, a polymeric alloy material from 3L&T to control the corrosion of the metal.
- The following pictures illustrate the application.

November 2004

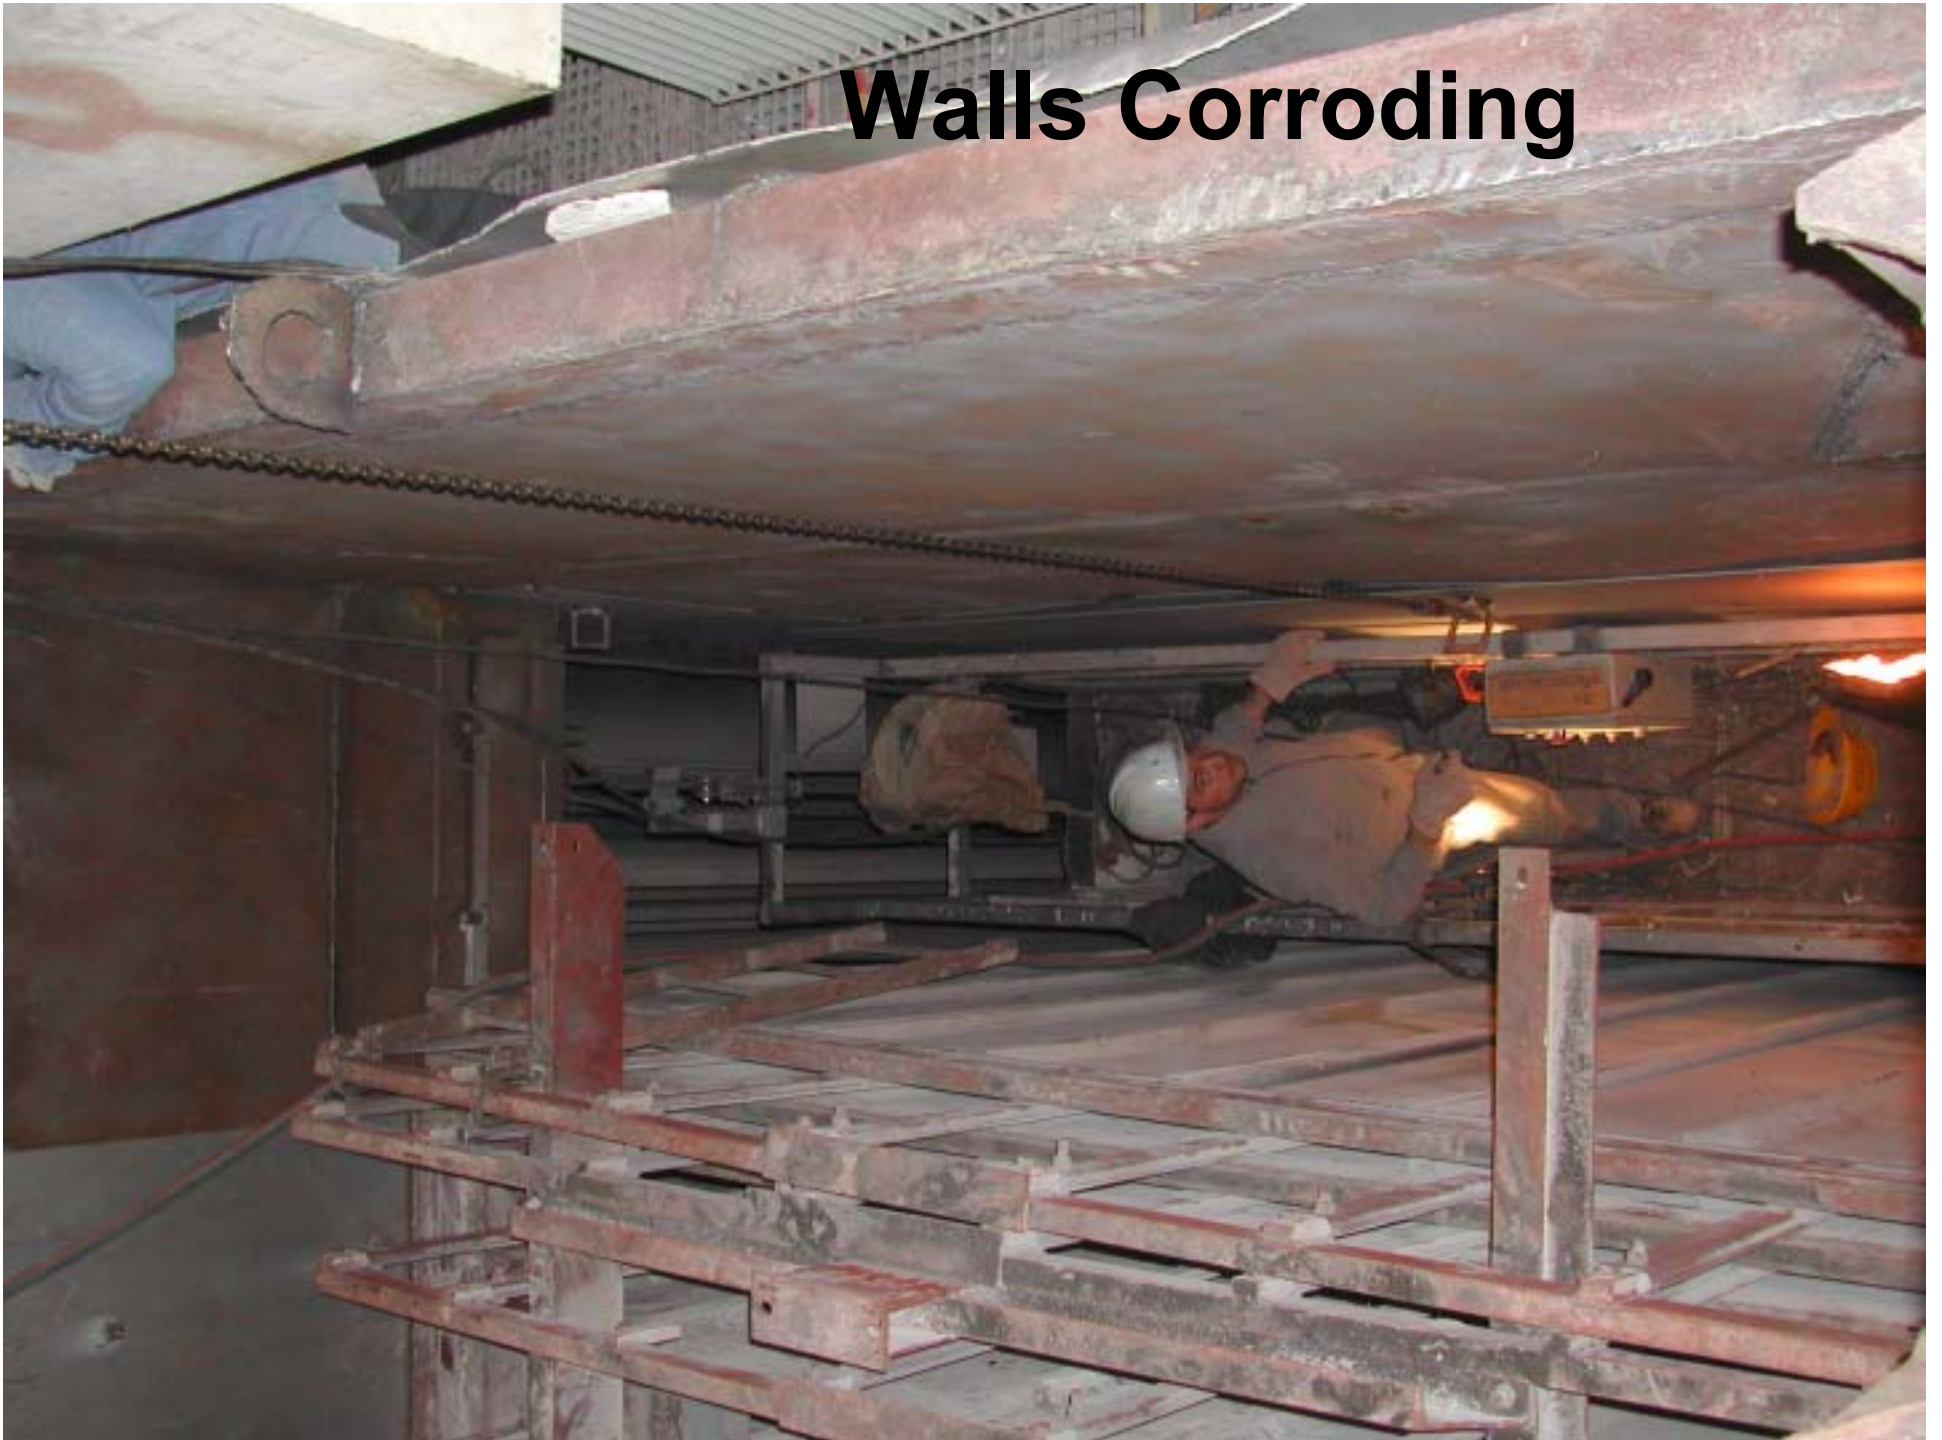
# Walls Corroding

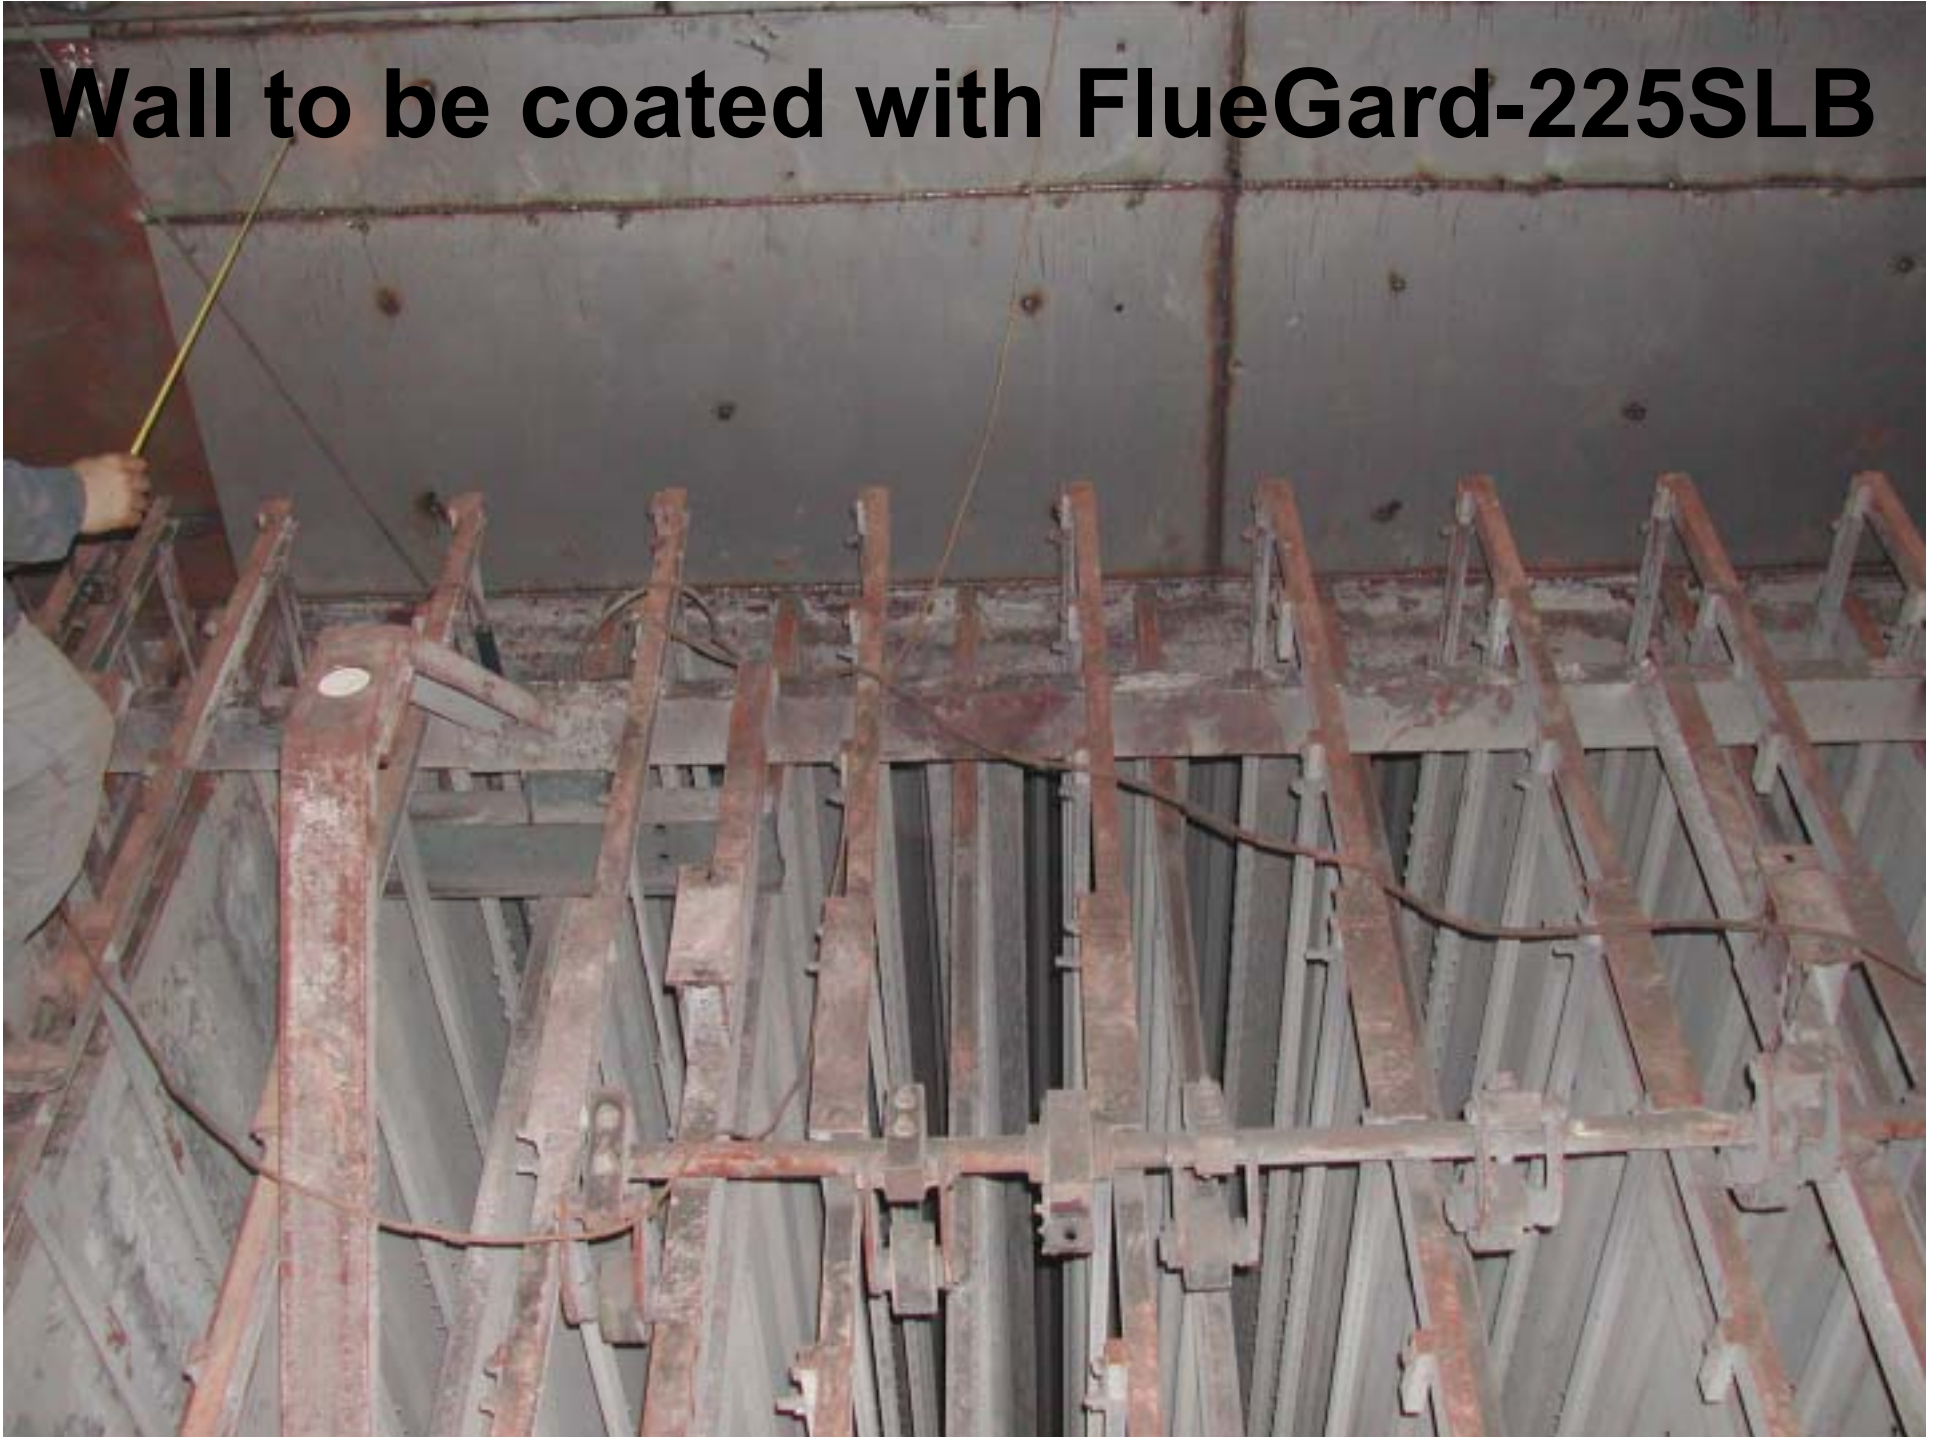
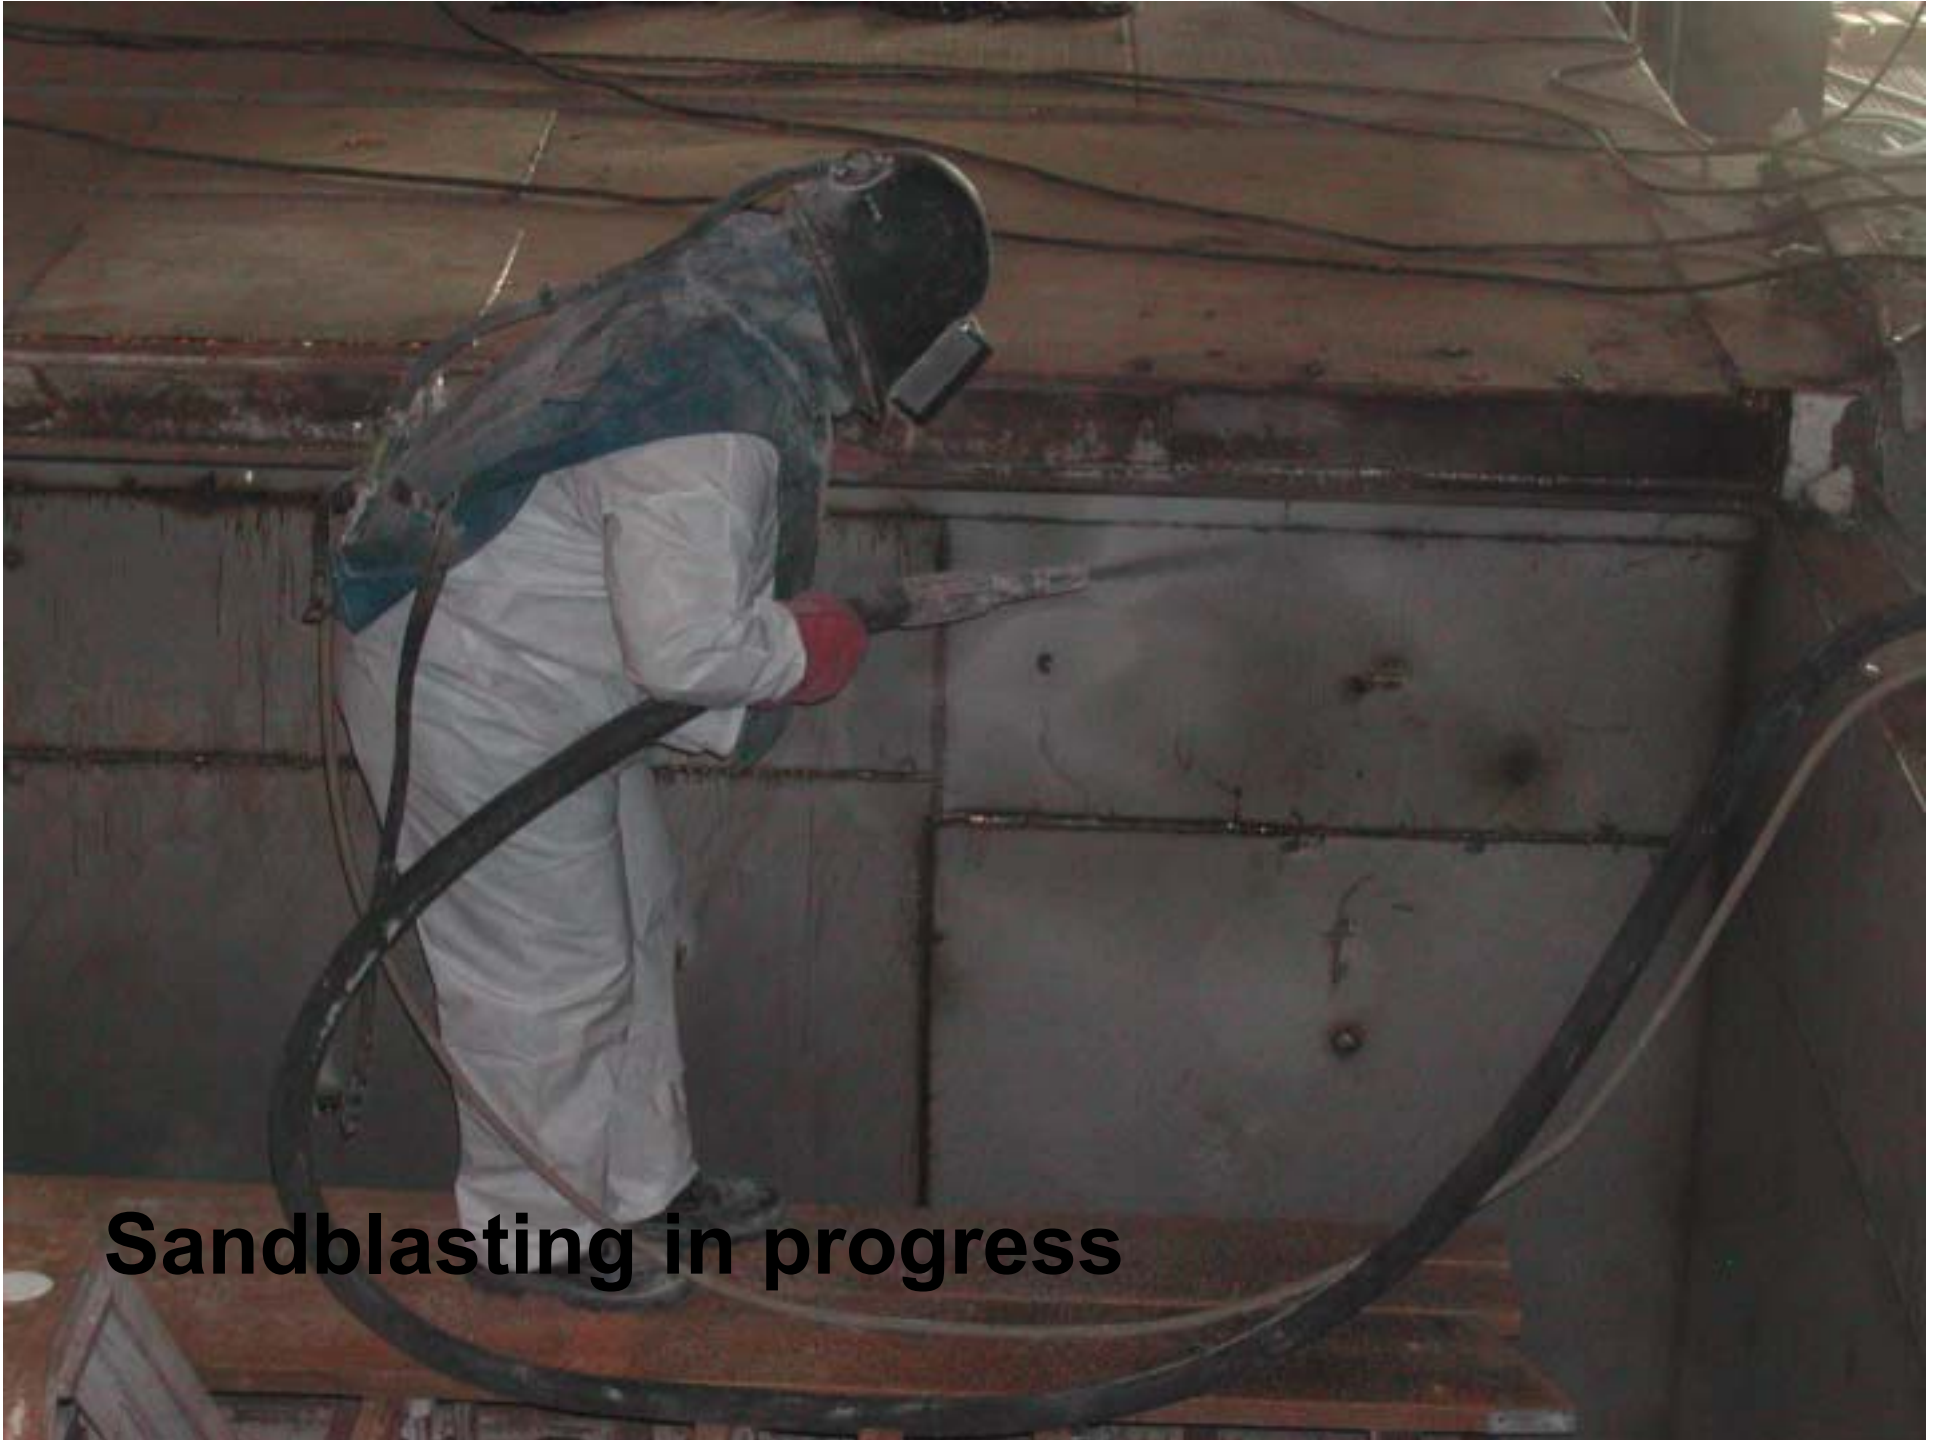
**Wall to be coated with FlueGard-225SLB**
