Kiln corrosion protection

by Linas Mazeika, 3L&T Inc, USA

With internal corrosion of kiln shells becoming a more frequent and serious problem at cement plants, 3L&T explore the causes behind this issue and detail one particular protection measure that has been applied at a number of cement plants across the world, with specific reference to case studies in Mexico and the Philippines.

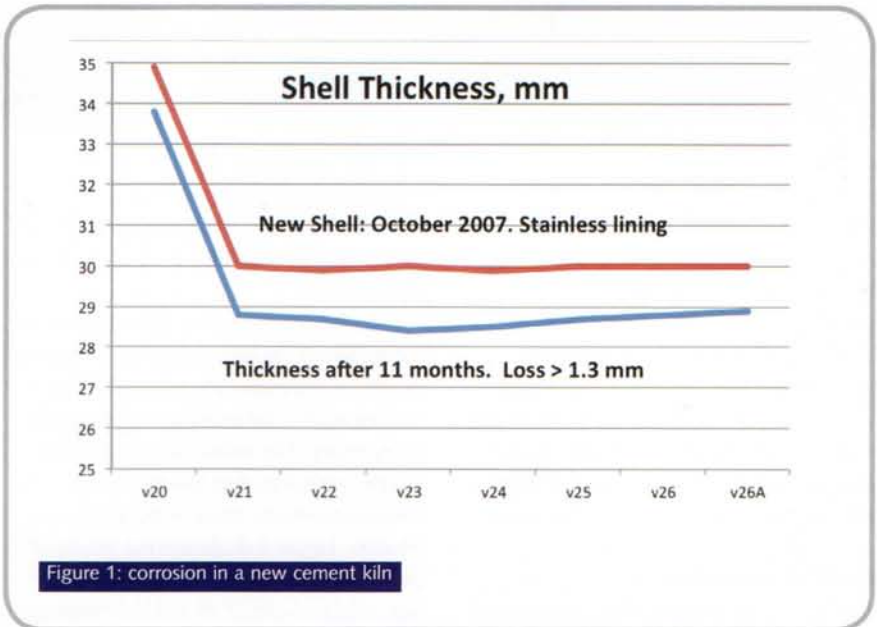
Figure 1 shows the corrosion rate of a kiln that was protected with a sacrificial stainless steel sheet. Shell thickness loss was more than 1.3mm in just 11 months in service. Obviously this is not a good corrosion protection system.

Figure 1: corrosion in a new cement kiln

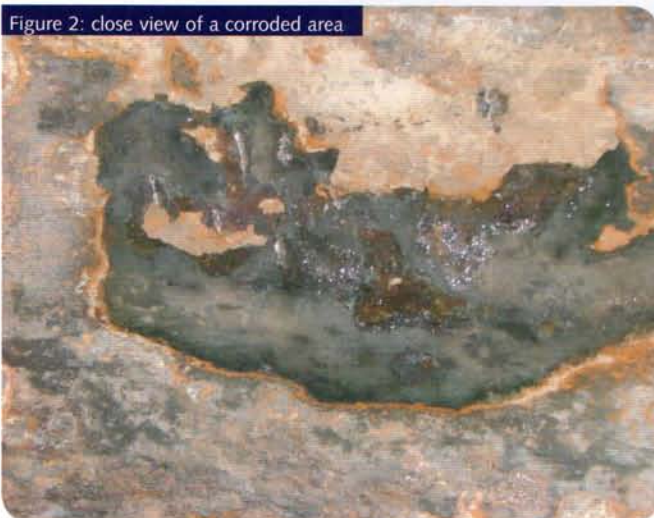
Figure 2 shows the inside of a cement kiln after removing the refractory. After six years of operation, the shell thickness went from 30mm to 19mm in some areas.

Figure 2: close view of a corroded area

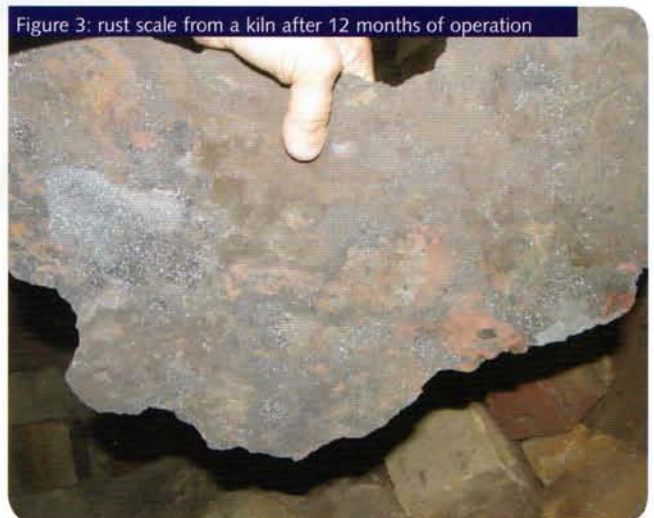
Figure 3: rust scale from a kiln after 12 months of operation

The vapours of sulphur oxides and chlorides can leak through cracks in the refractory, reach the inside of the shell and produce acid condensates which can be very aggressive. Figure 3, shows a large piece of shell rust with 3-4mm thickness.

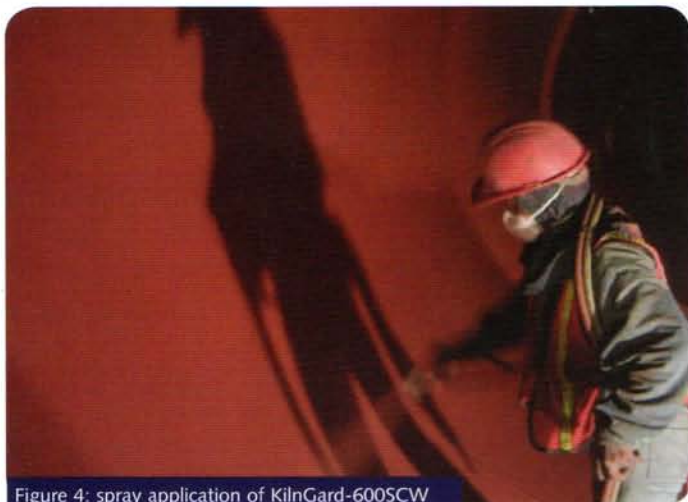
Figure 4: spray application of KilnGard-600SCW

This was a good opportunity to install the new nano-ceramic material developed by 3L&T to extend the useful life of the kiln shell. This material is applied by air spray on a sandblasted steel surface, the recommended thickness is 0.5mm. After drying at room temperature for about 12 hours, the bricks can be installed as usual. The ceramic coating attains its maximum physical and chemical properties after heating the kiln during the start-up process. Figure 4 illustrates the spray application process.

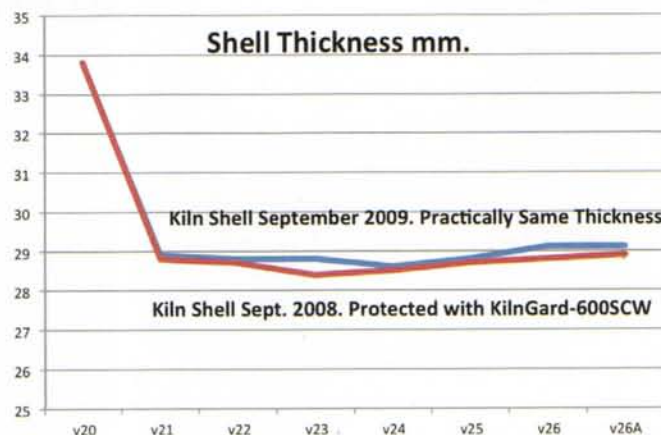
A good way to confirm the corrosion protection of the kiln shell is by measuring the metal thickness along the kiln. The recommended distance for monitoring is every metre. The initial measured spots will be marked so that the follow-up measurements are done in the same location. Figure 6 illustrates the results of these measurements for a kiln protected with KilnGard-600SCW, the shell thickness is practically the same after 12 months in service.

Figure 6: thickness measurements in a protected kiln shell
