Kiln corrosion protection

by Linas Mazeika, 3L&T Inc, USA

With internal corrosion of kiln shells becoming a more frequent and serious problem at cement plants, 3L&T explore the causes behind this issue and detail one particular protection measure that has been applied at a number of cement plants across the world, with specific reference to case studies in Mexico and the Philippines.

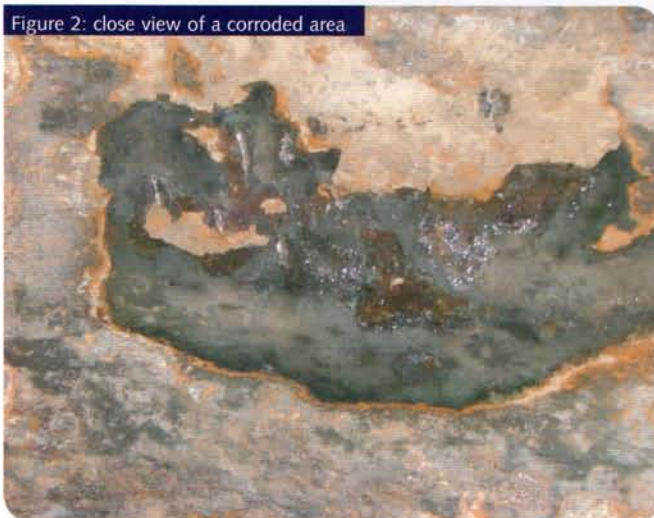
Figure 2 shows the inside of a cement kiln after removing the refractory. After six years of operation, the shell thickness went from 30mm to 19mm in some areas.

Figure 2: close view of a corroded area

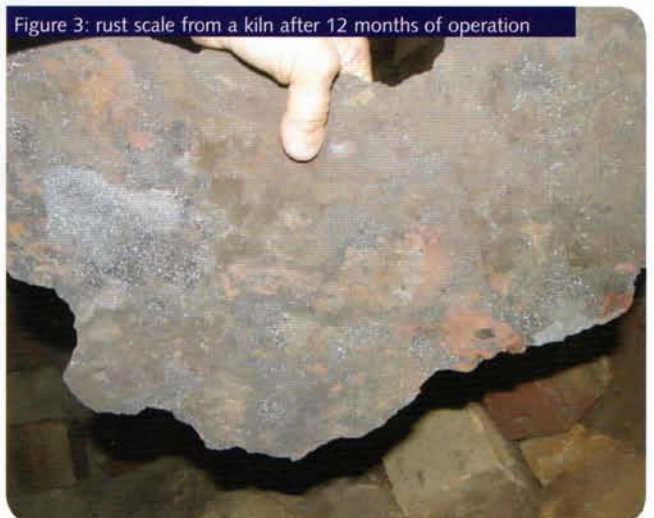
Figure 3: rust scale from a kiln after 12 months of operation

The vapours of sulphur oxides and chlorides can leak through cracks in the refractory, reach the inside of the shell and produce acid condensates which can be very aggressive. Figure 3, shows a large piece of shell rust with 3-4mm thickness.

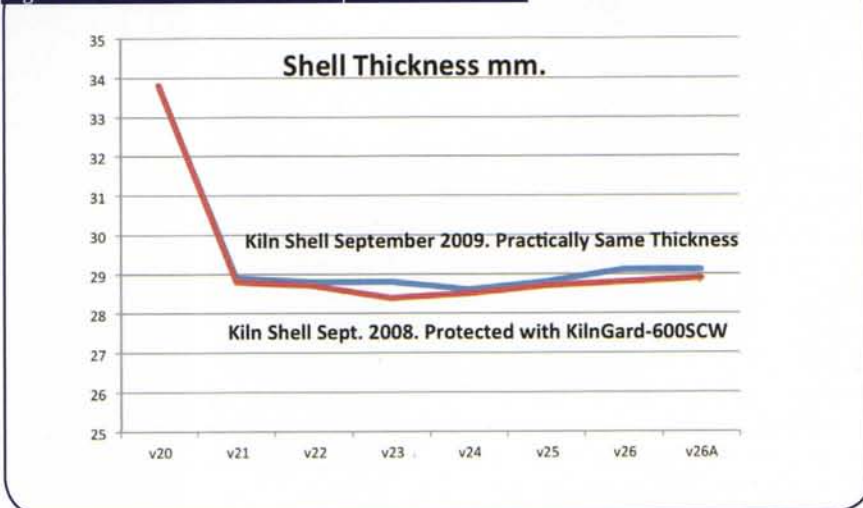
A good way to confirm the corrosion protection of the kiln shell is by measuring the metal thickness along the kiln. The recommended distance for monitoring is every metre. The initial measured spots will be marked so that the follow-up measurements are done in the same location. Figure 6 illustrates the results of these measurements for a kiln protected with KilnGard-600SCW, the shell thickness is practically the same after 12 months in service.

Figure 6: thickness measurements in a protected kiln shell
