# Midlothian, Texas October 2005

- The reversed air baghouse is badly corroded after several years in service.
- During early October 2005, compartments #1 and #4 needed bags replacement, the opportunity was also used to apply FlueGard-225SLB on the walls.
- The following pictures illustrate the condition of the equipment and the application of the corrosion protection coating.

# Kiln Baghouse, Compartment #1 Open

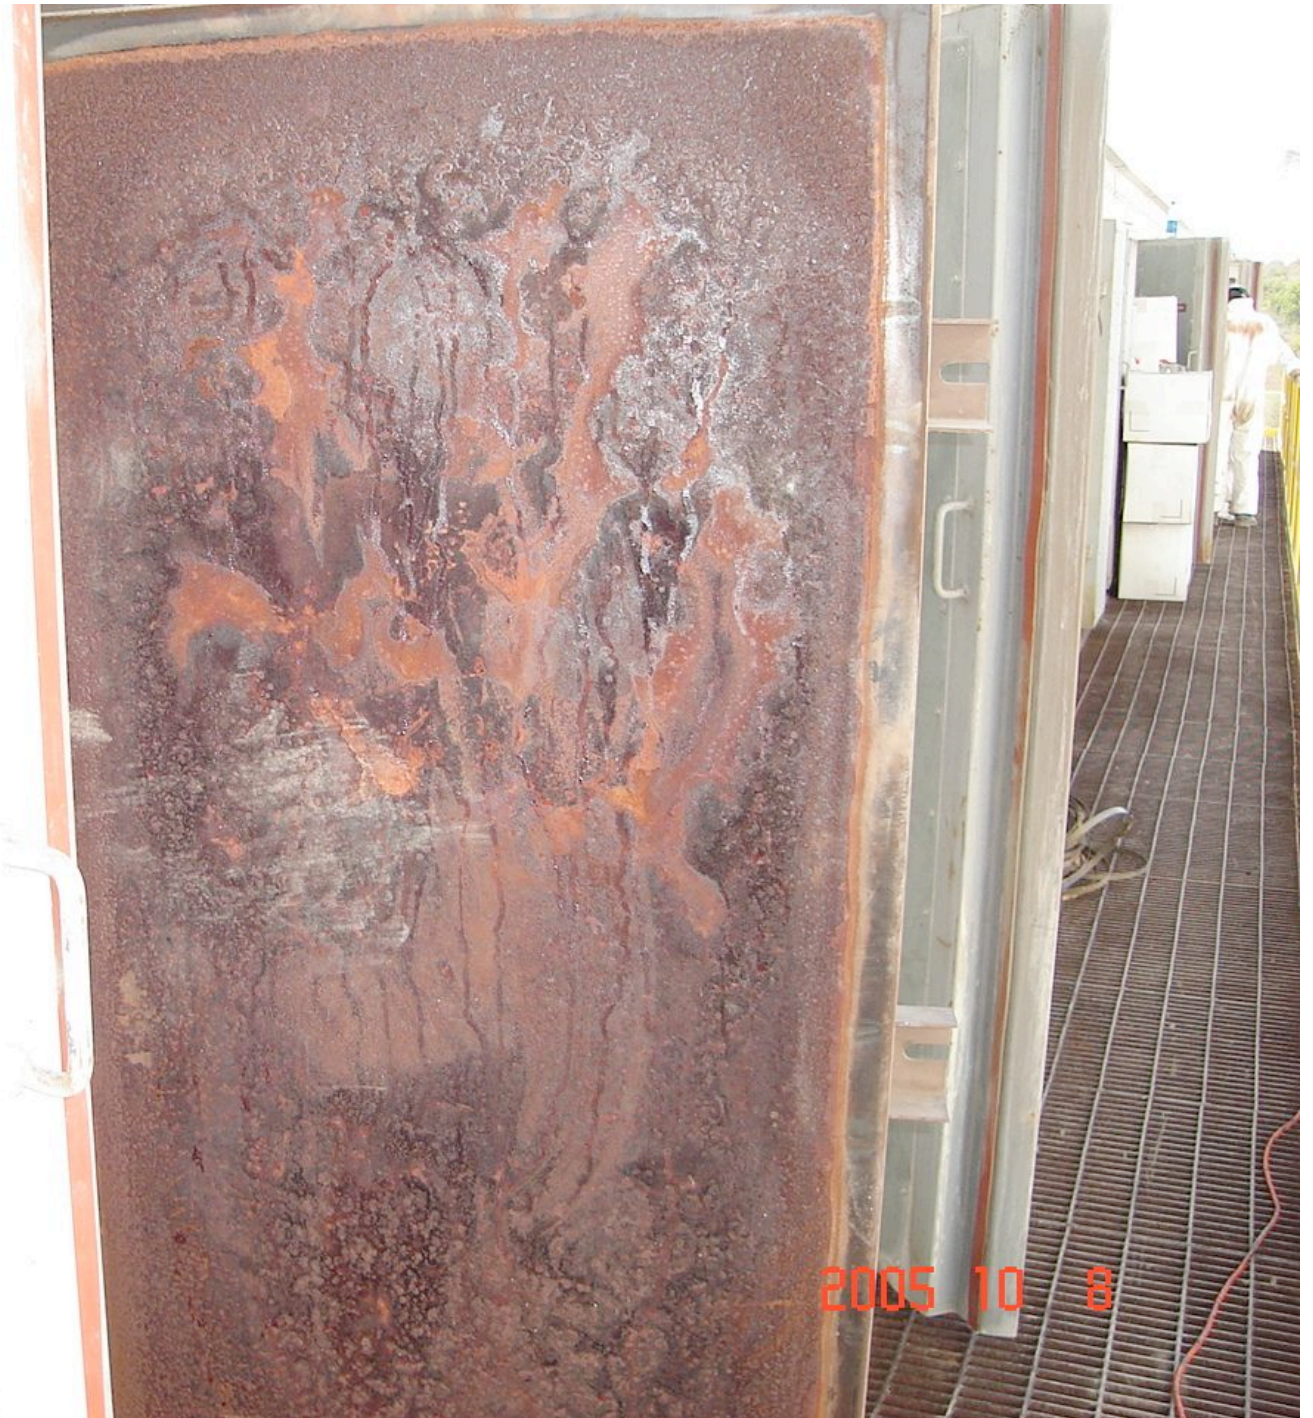
**Doors Badly  
Corroded**

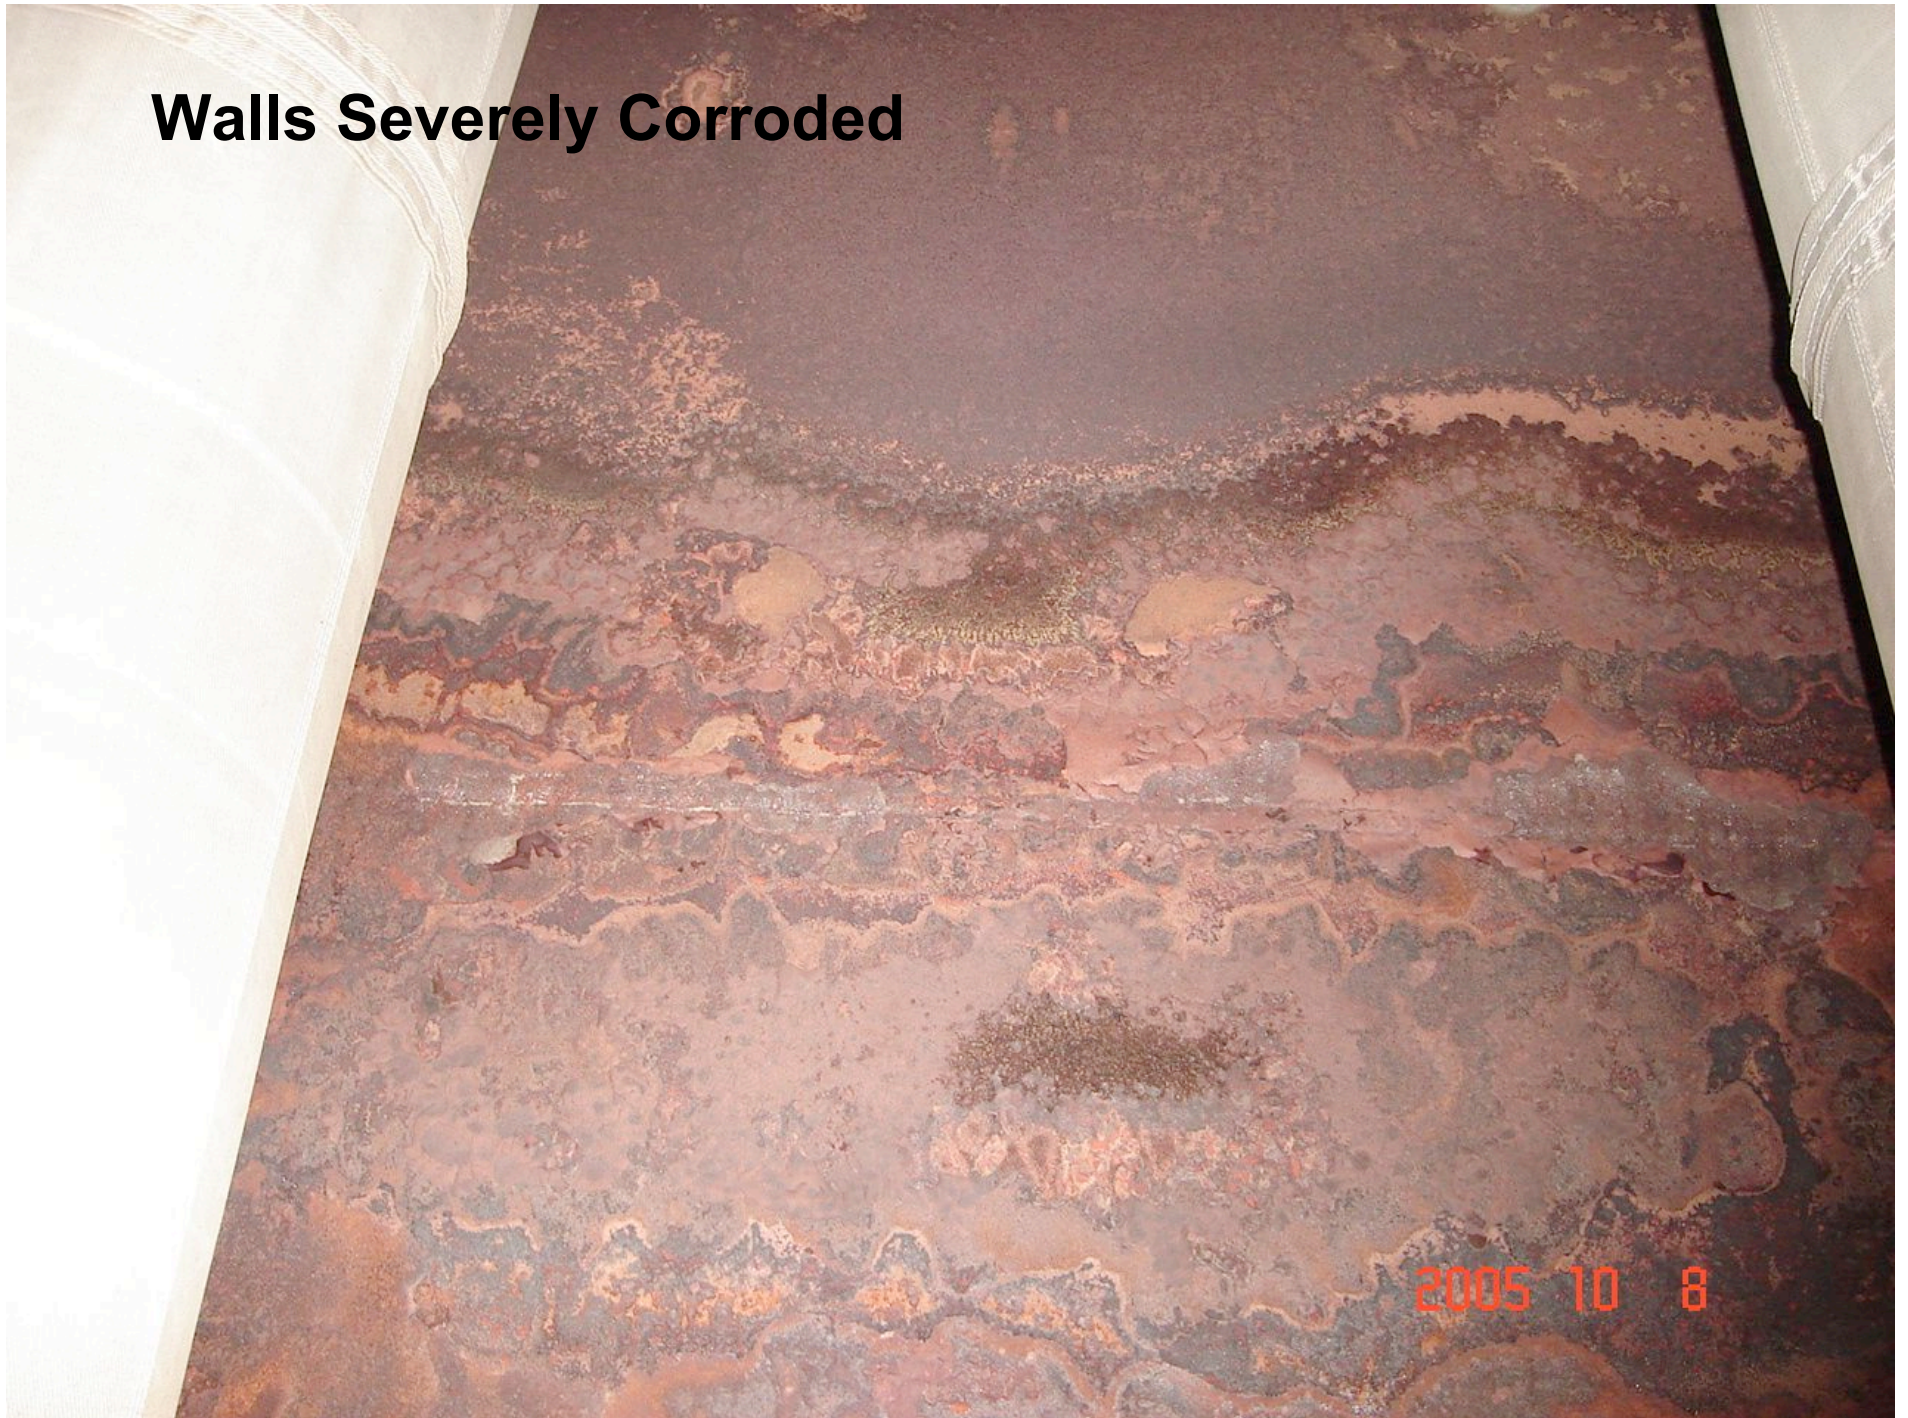
**Walls Severely Corroded**

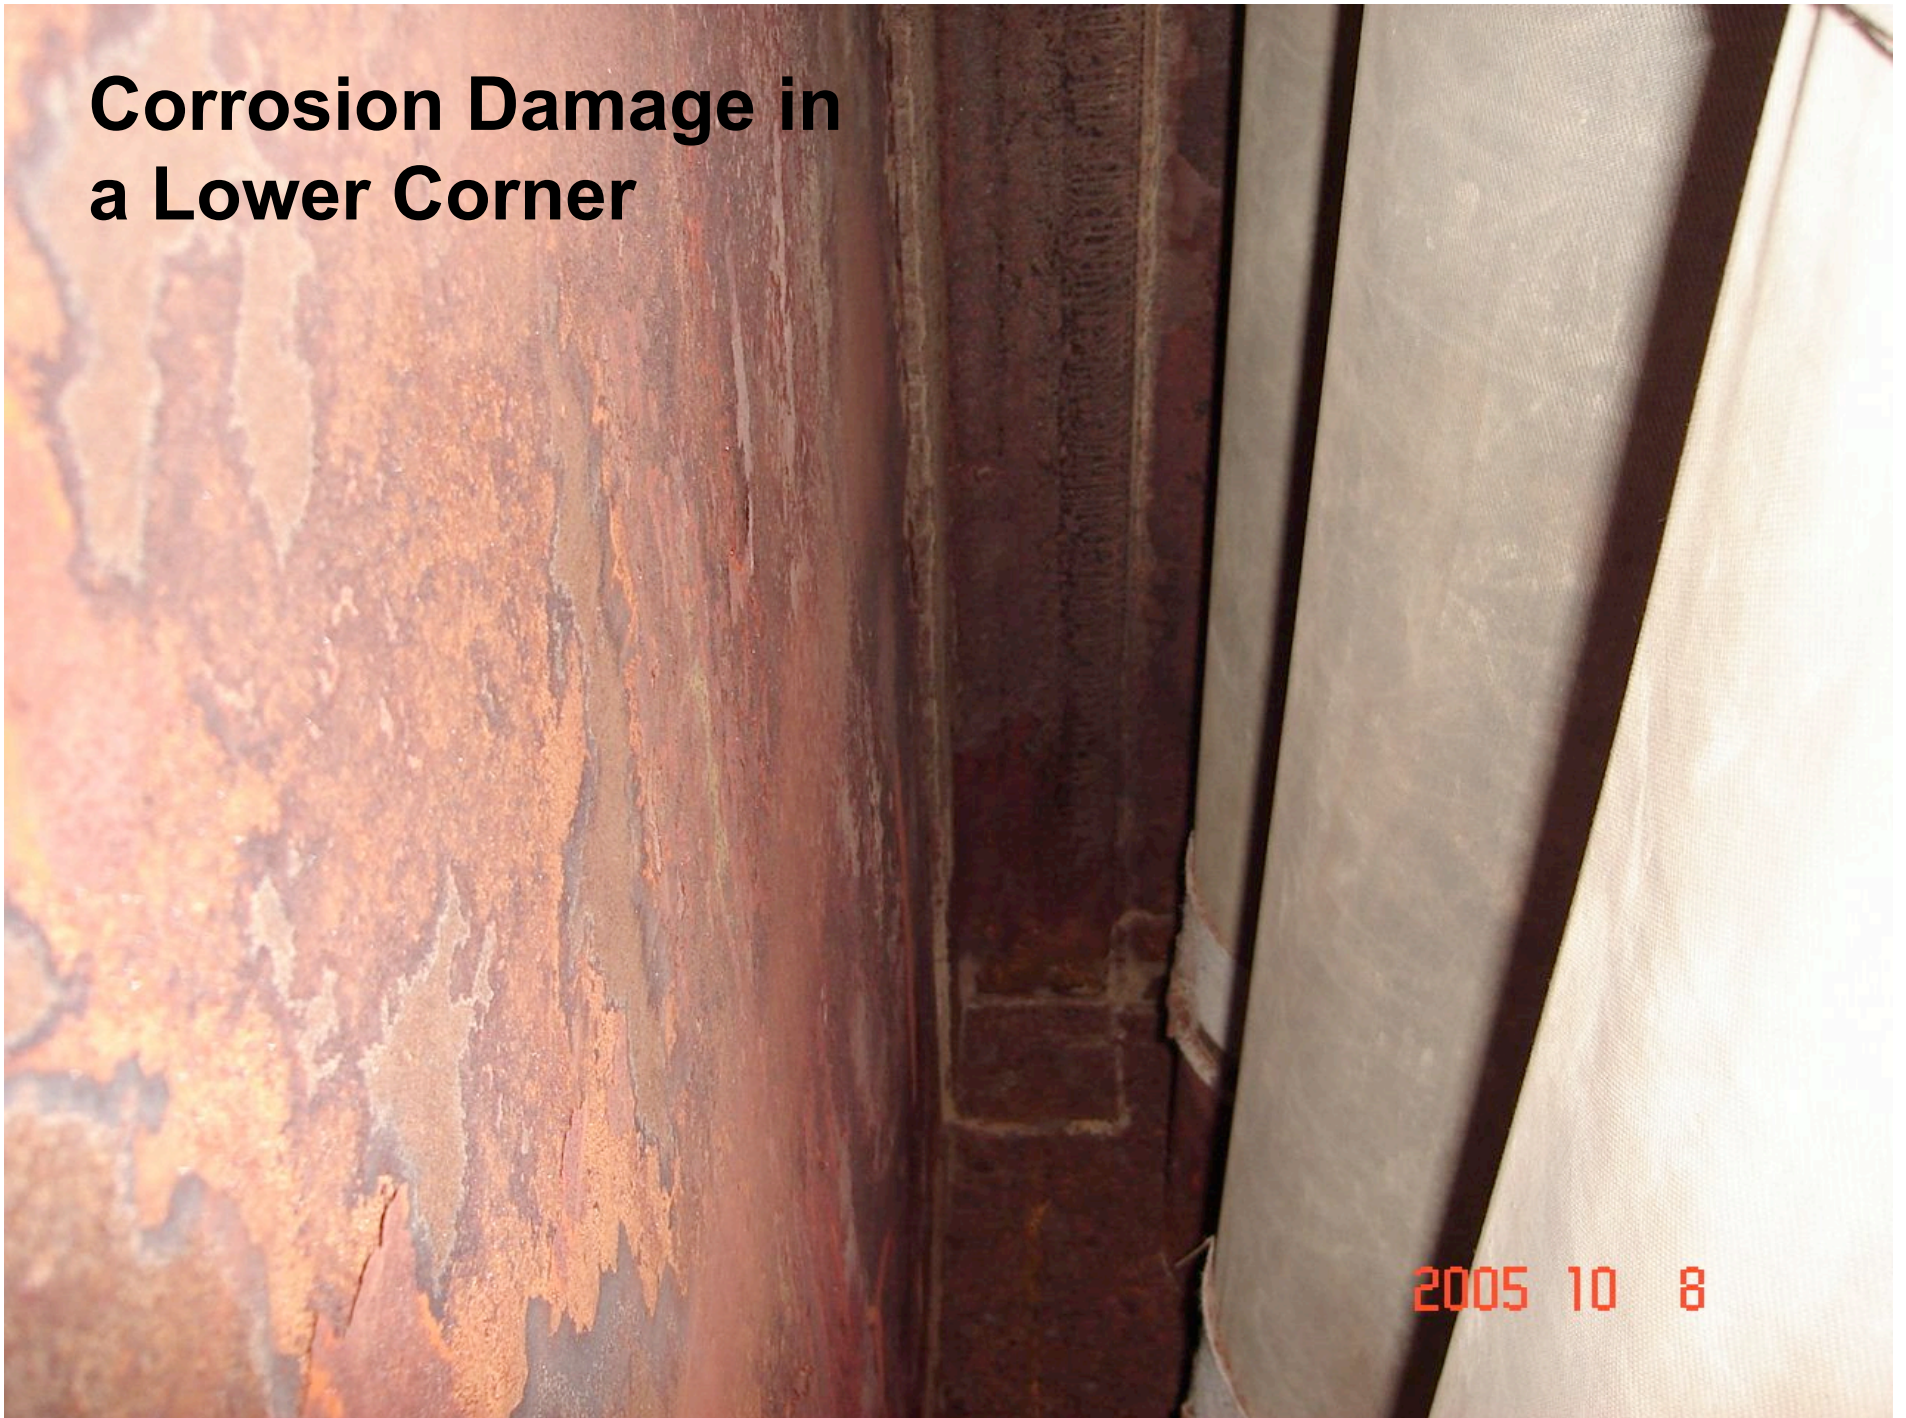
# Corrosion Damage in a Lower Corner

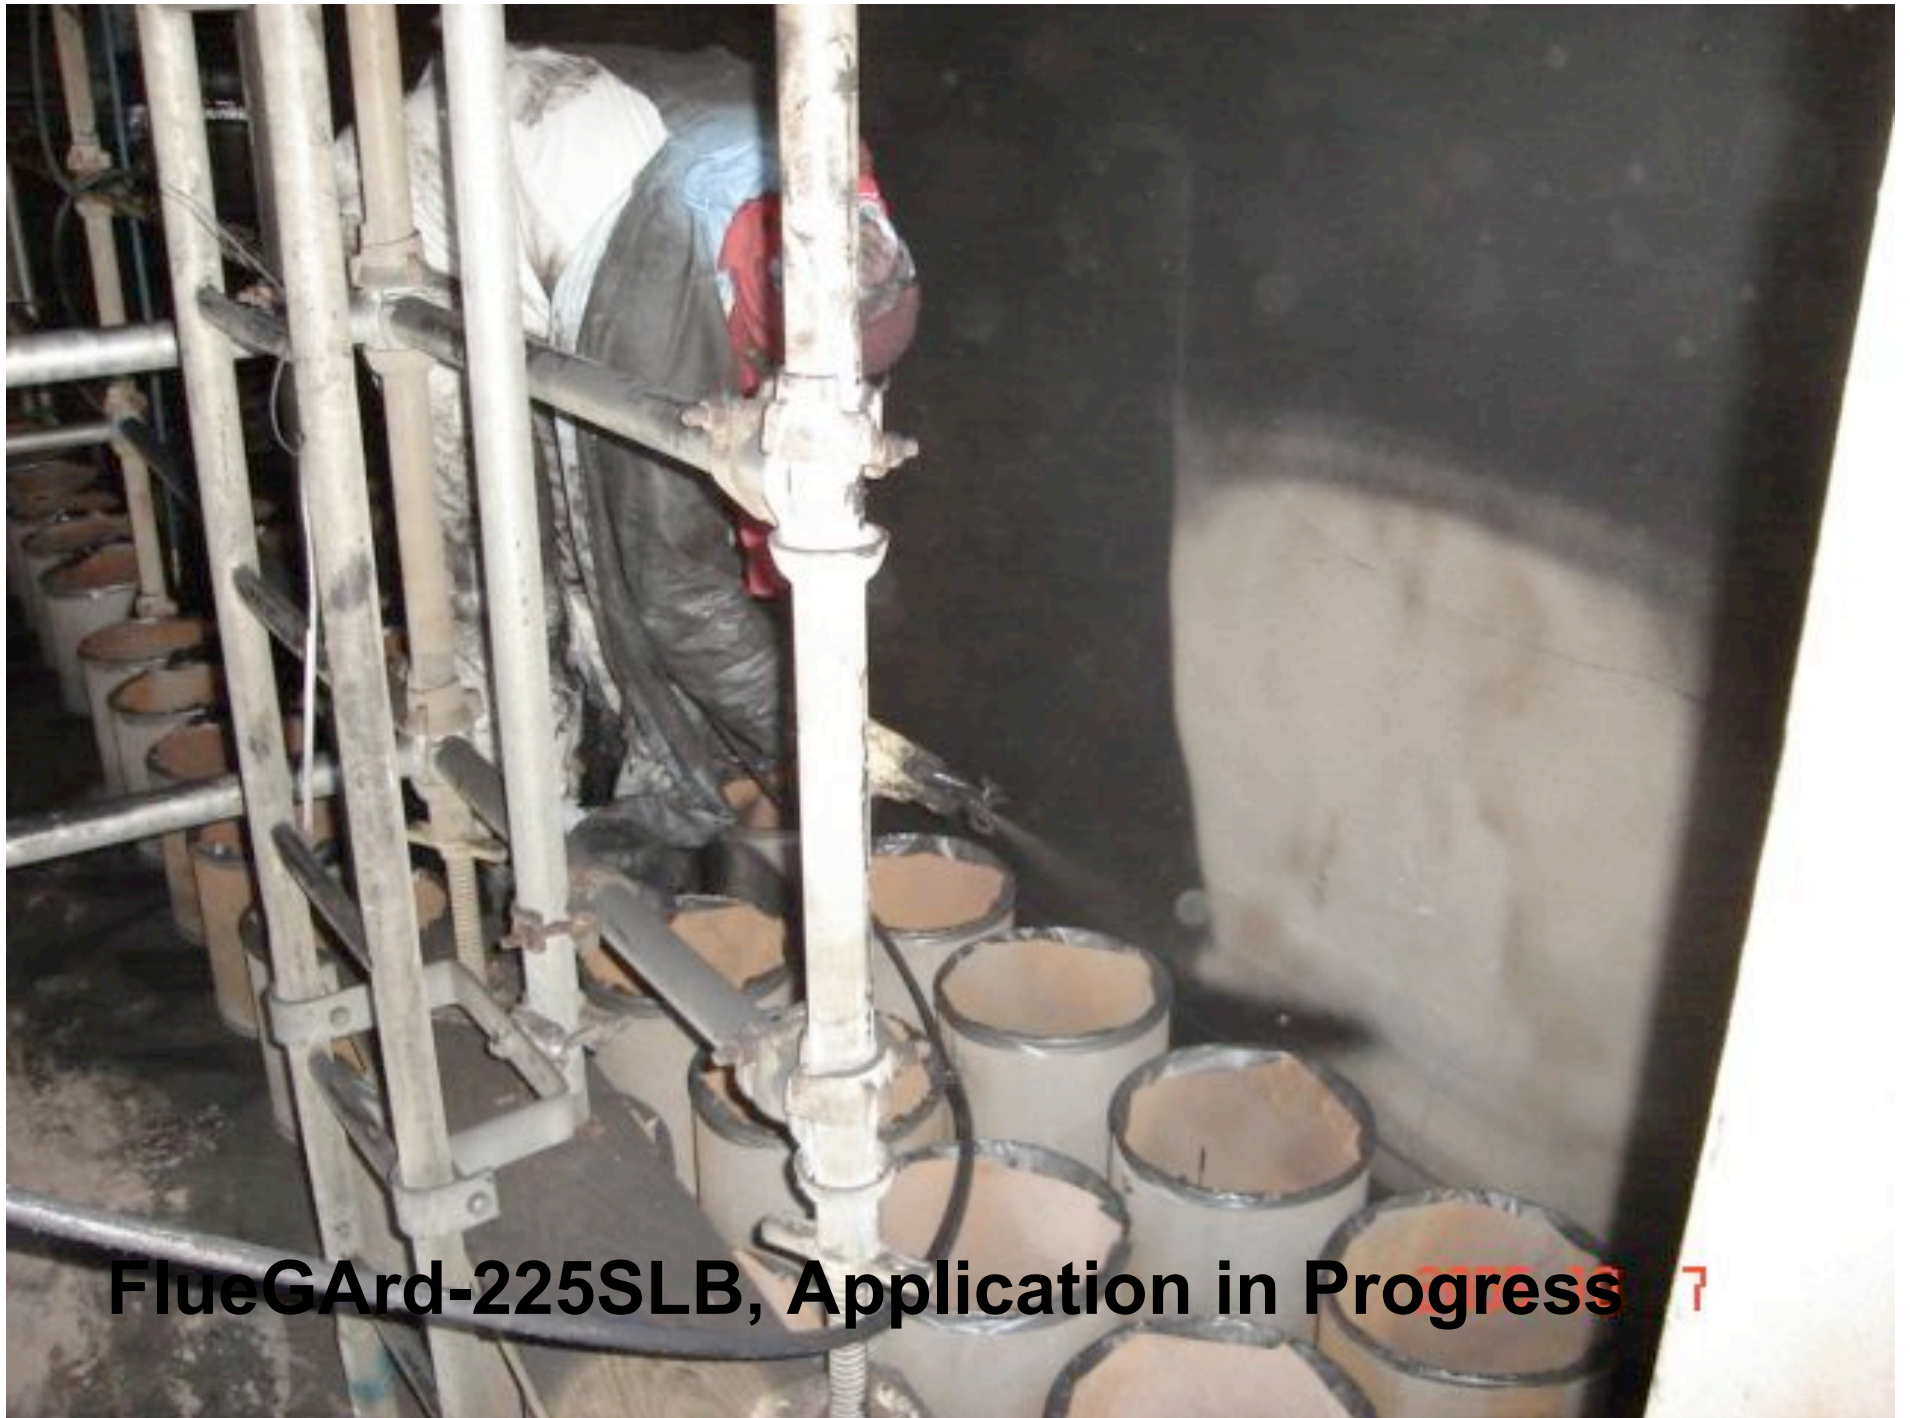
**Corroded Tube Sheet**

**FlueGard-225SLB, Application in Progress 7**

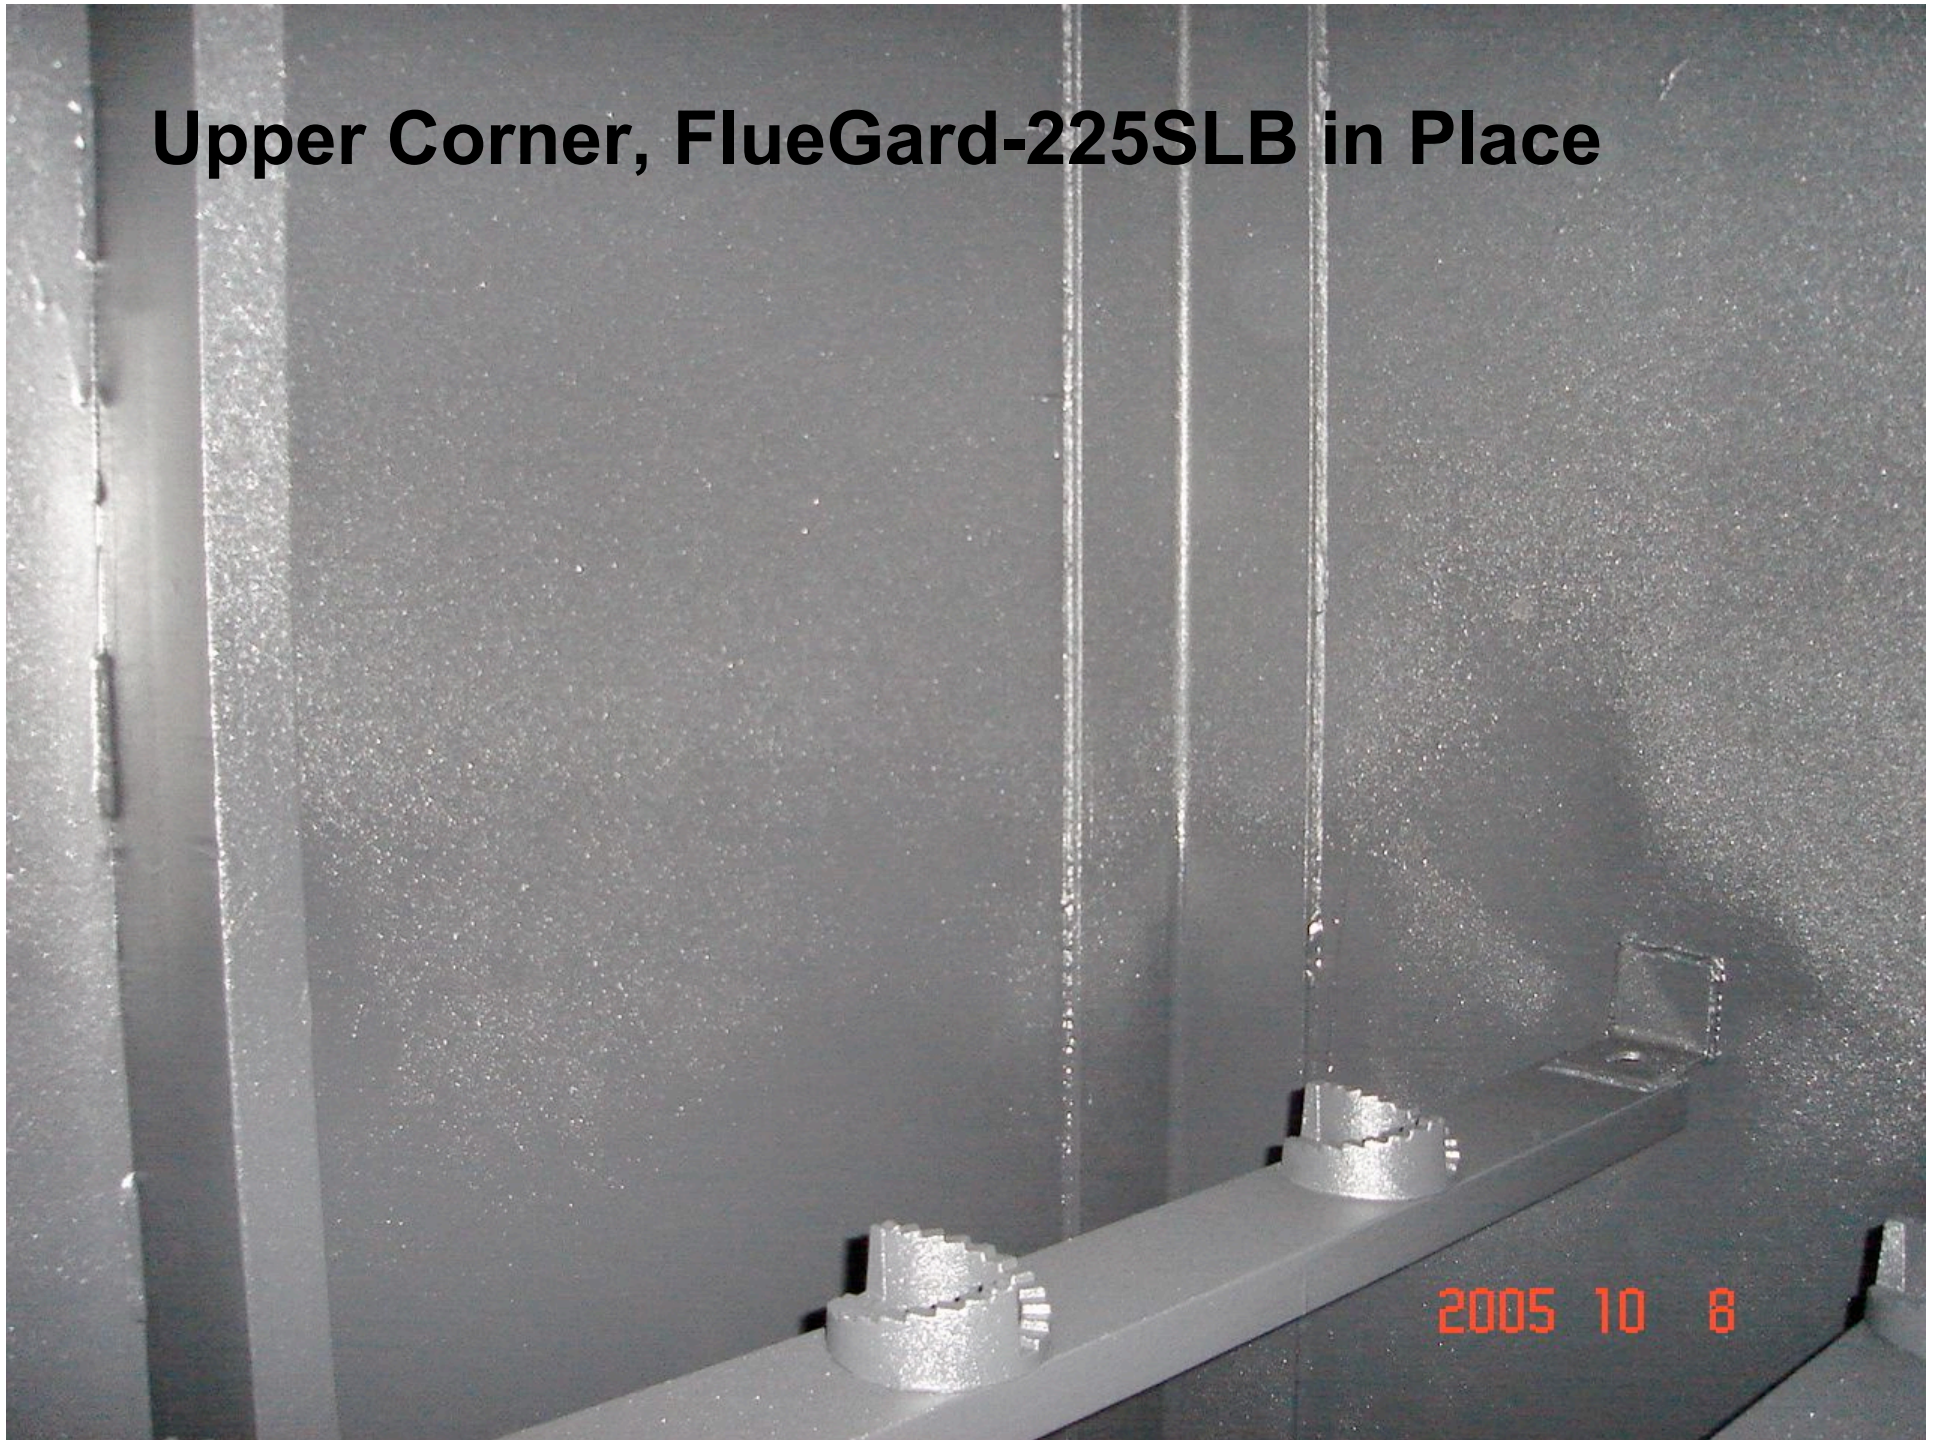
**Upper Corner, FlueGard-225SLB in Place**

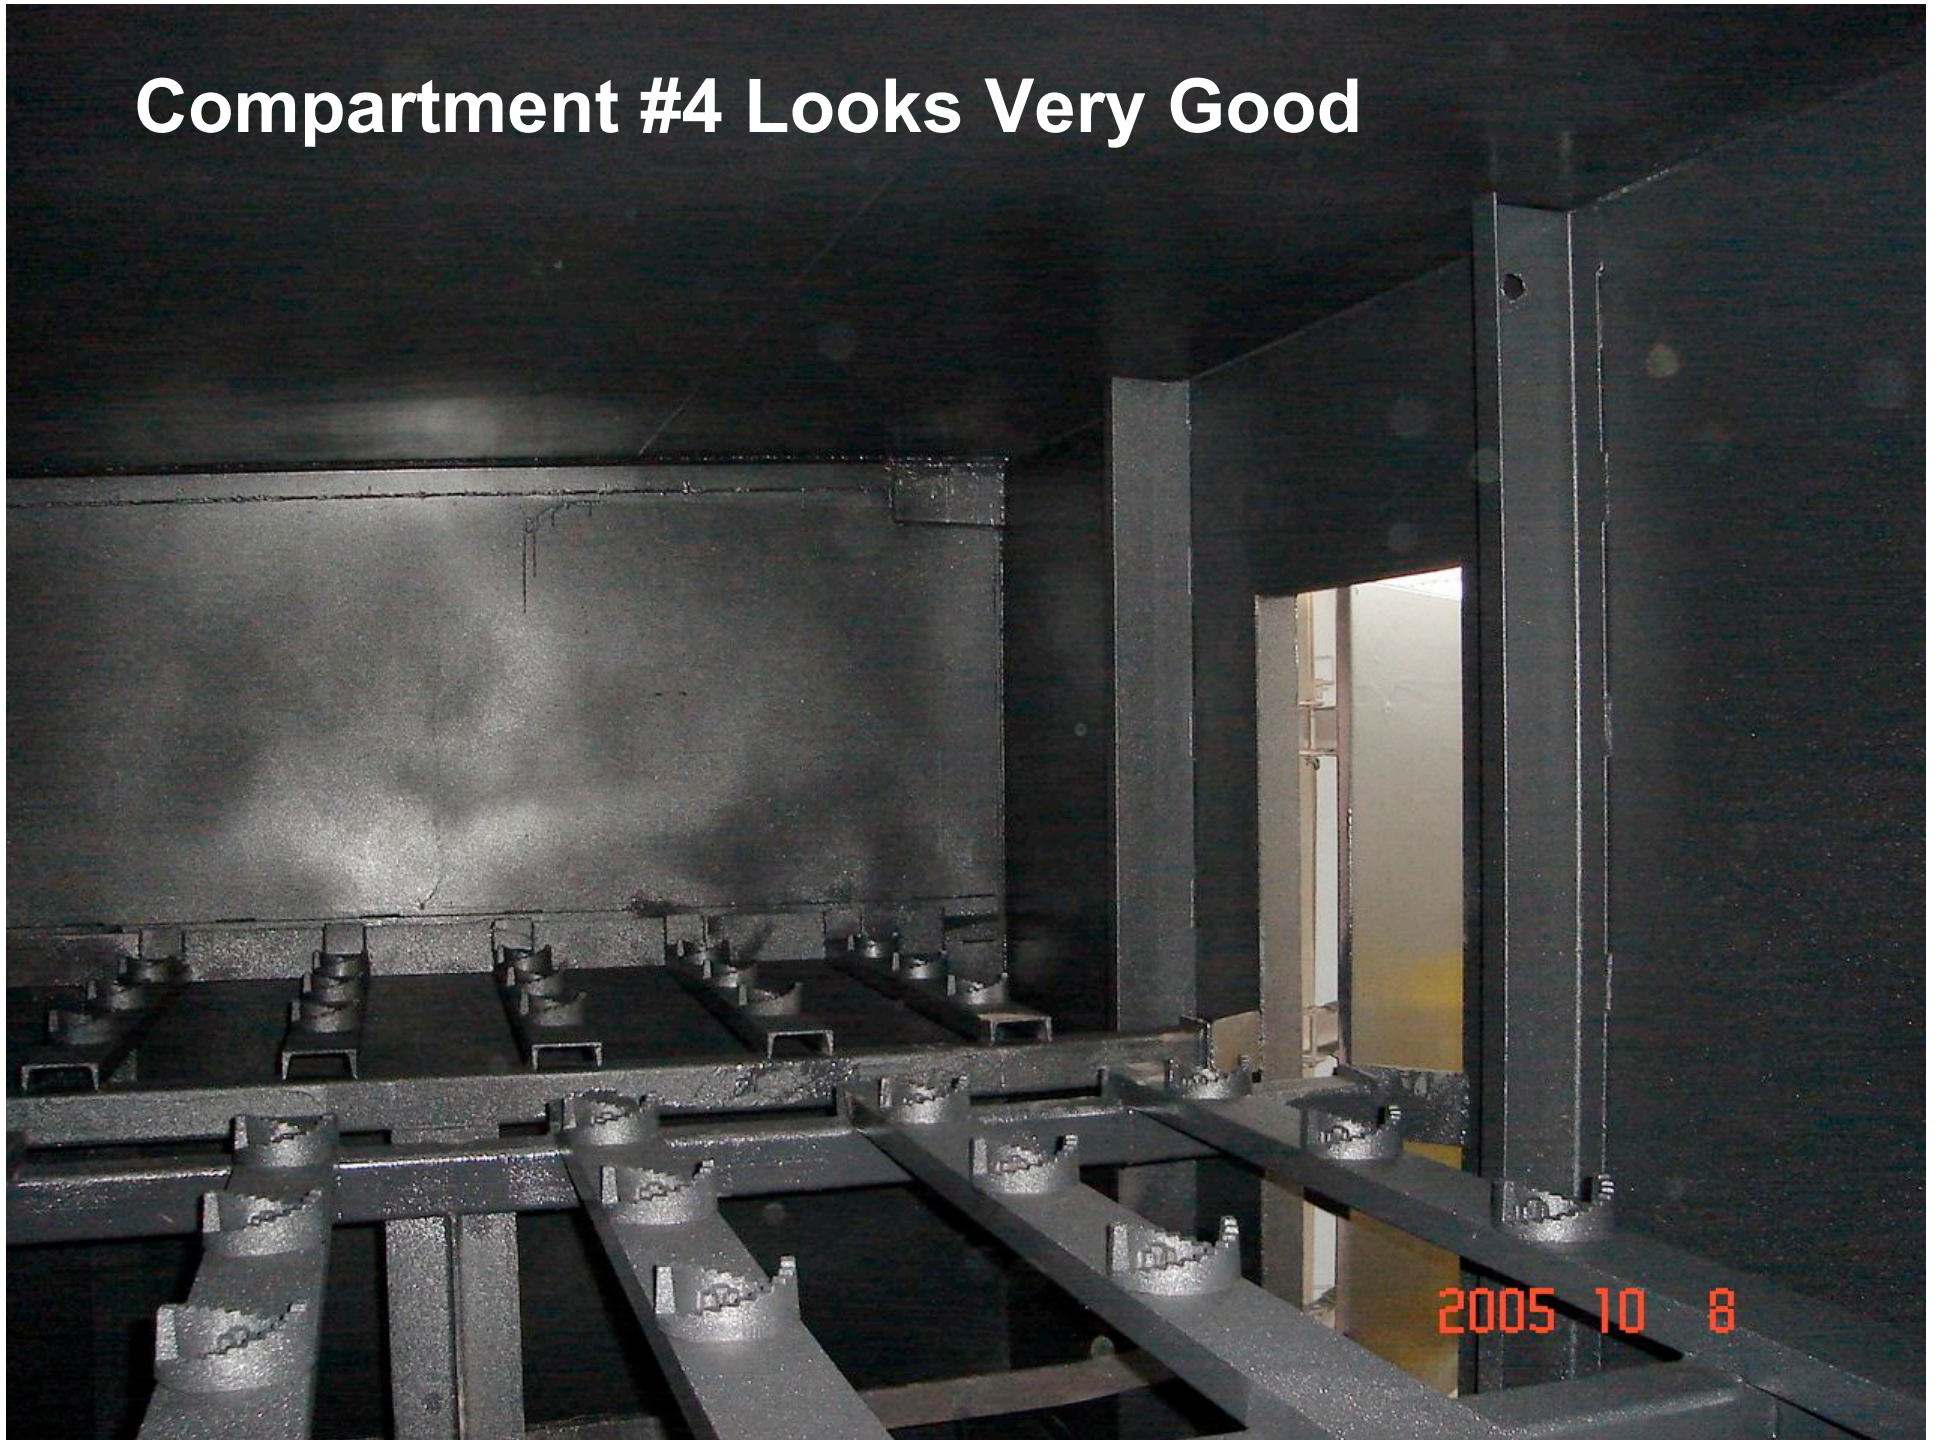
**Compartment #4 Looks Very Good**

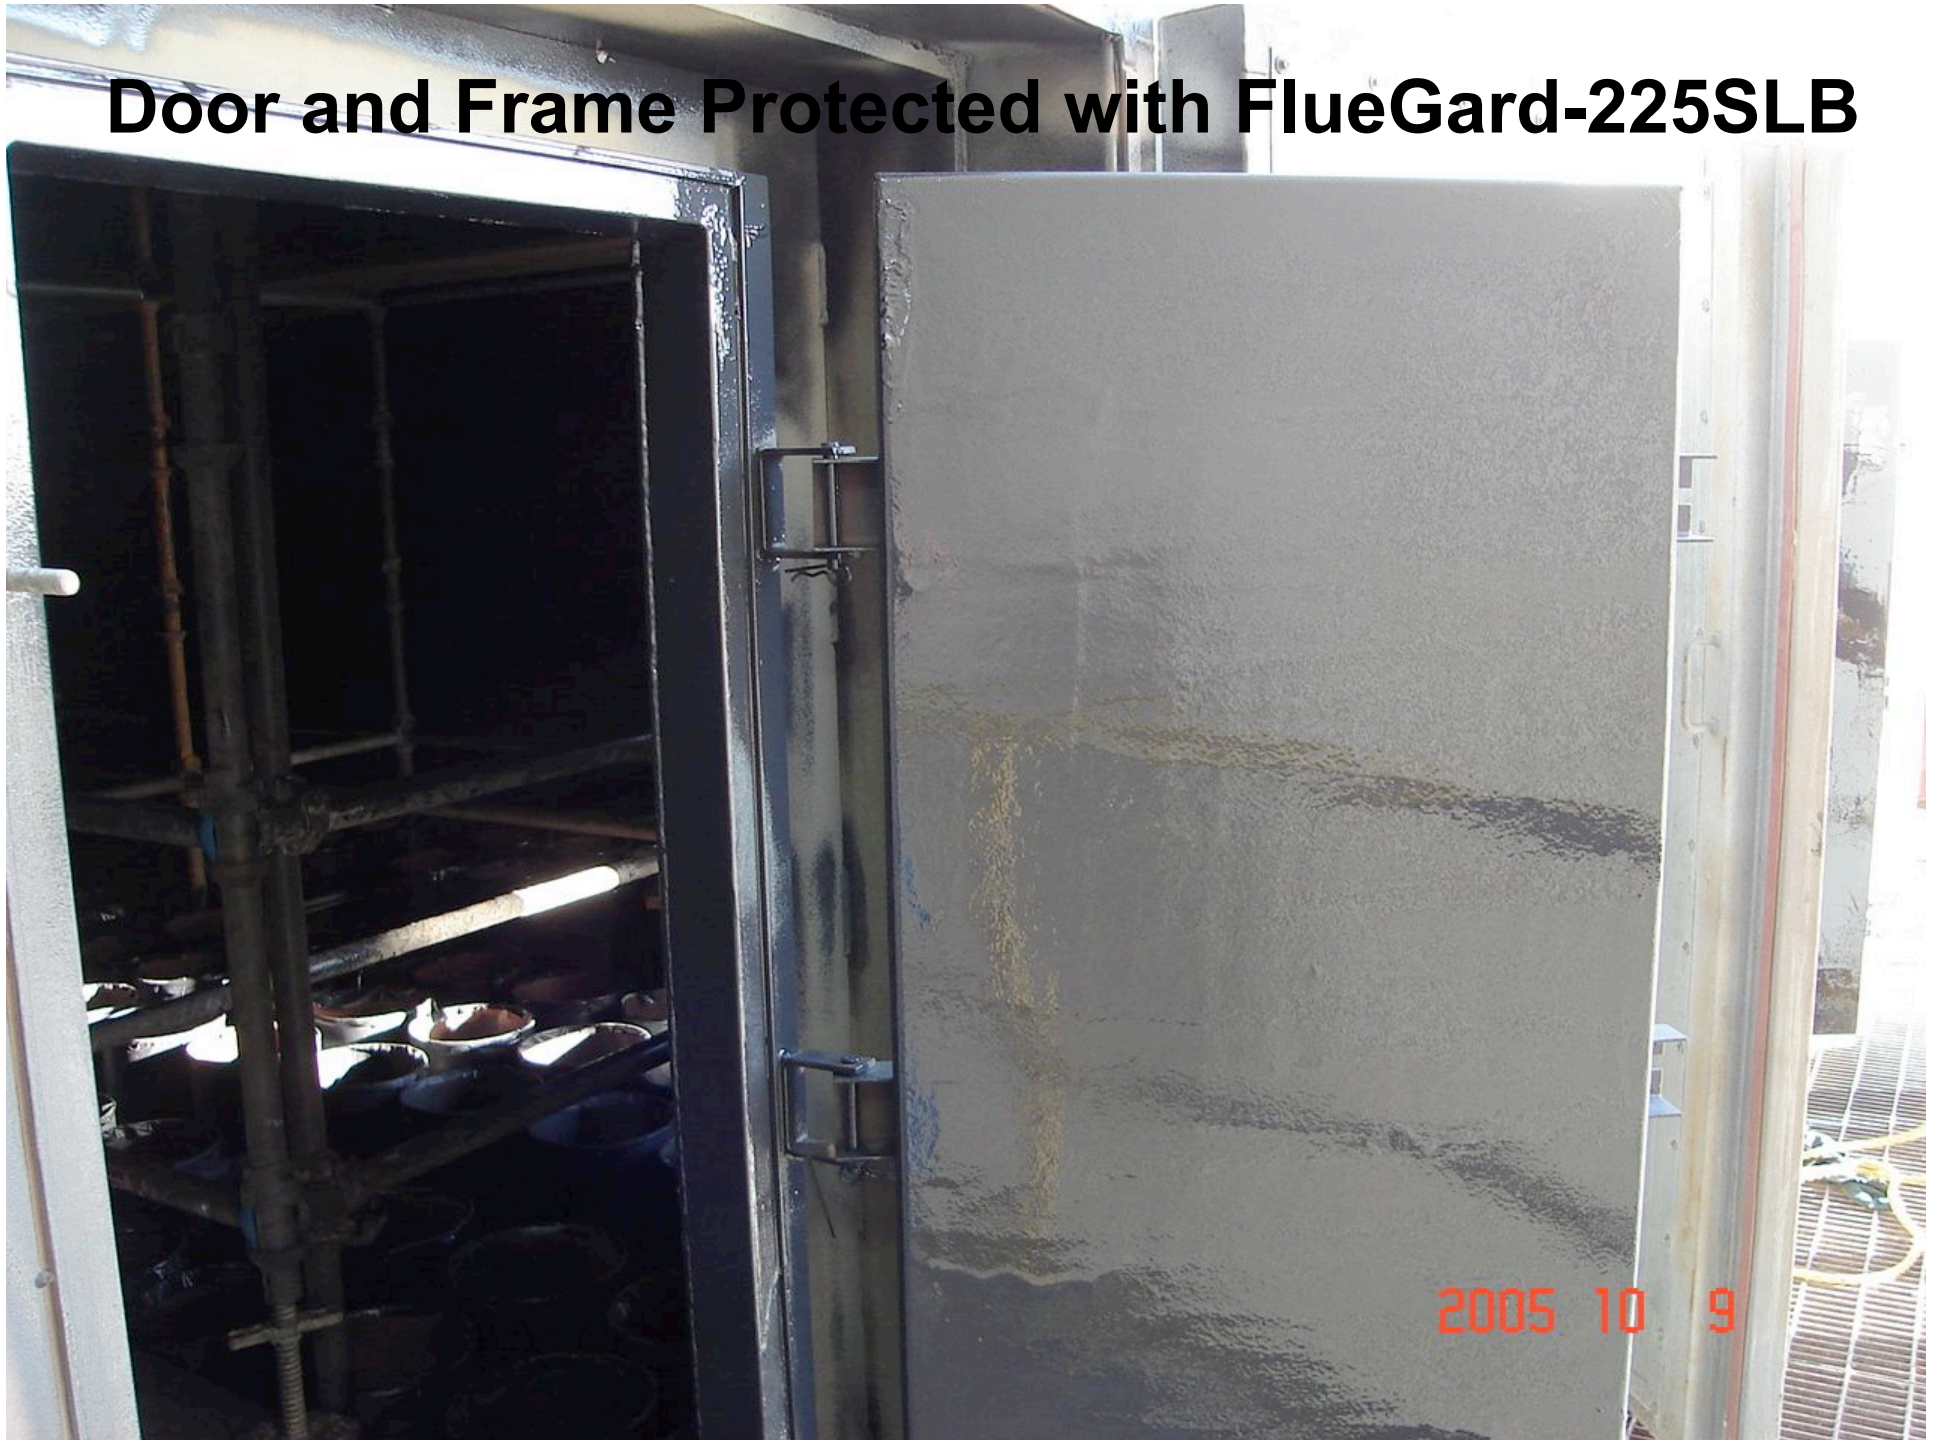
# Door and Frame Protected with FlueGard-225SLB
