FlueGard™-225

Corrosion Protection Coating for Flue Gas Systems

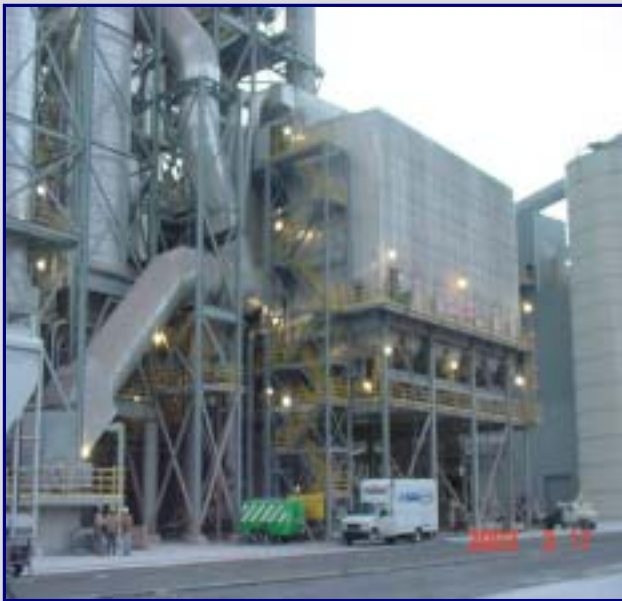
Kiln Baghouse

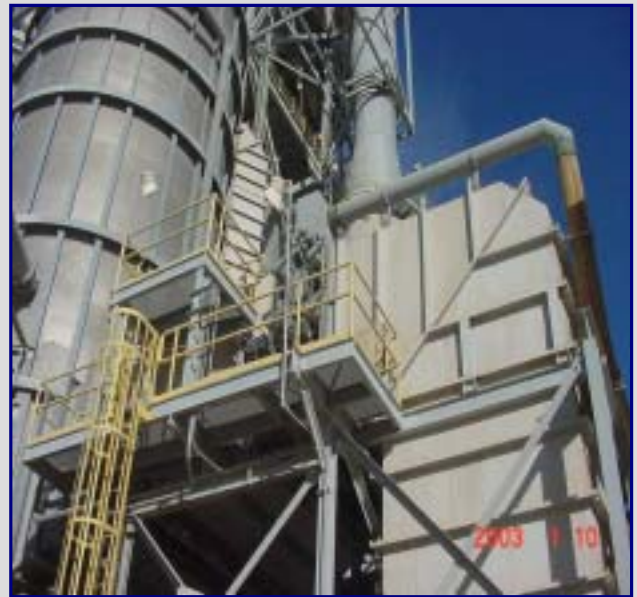
Process Ductwork

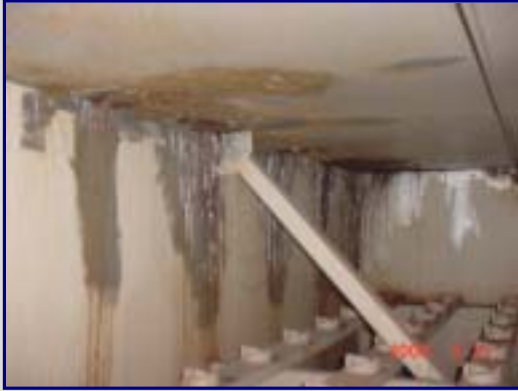
Corrosion in baghouse

- There is high condensation inside the equipment
 - Lower gas temperature due to new EPA requirement
 - Seasonal external temperatures
 - Frequent shut downs and start ups
- High sulfur in the fuels or limestone
- Use of alternative fuels
- High efficiency filters, less alkaline dust

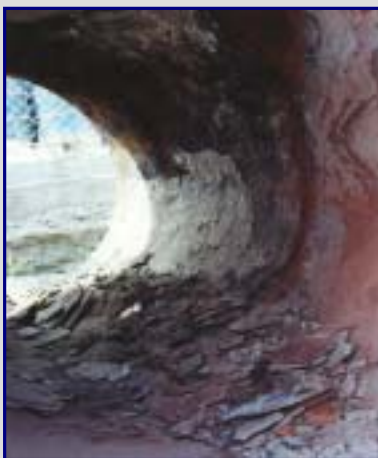
Corrosion in a duct

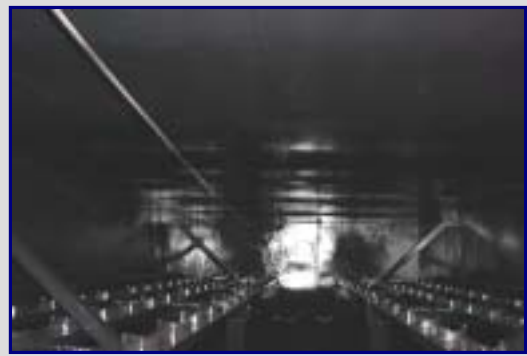
Completed installation of FlueGard™-225S

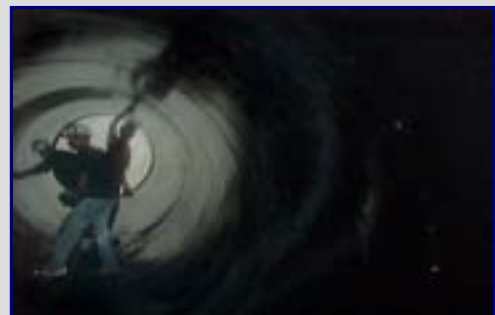
Application of FlueGard™-225S in stack

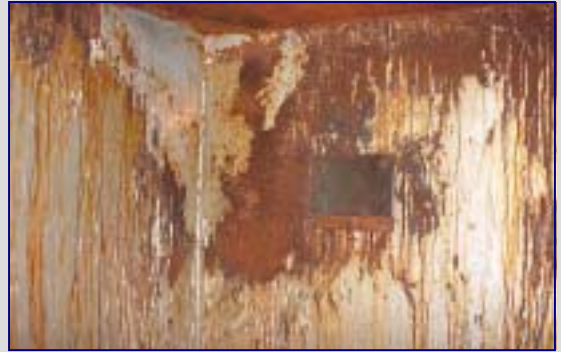
FlueGard™-225S test plate in baghouse

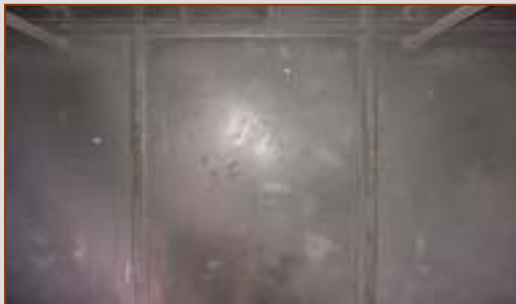
New baghouse coated, one year later

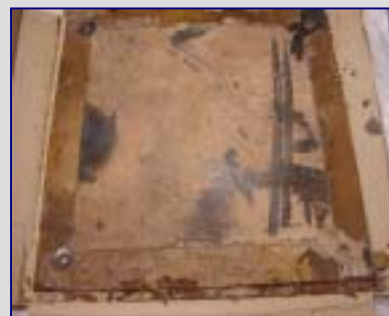
Test sample after five months in a baghouse

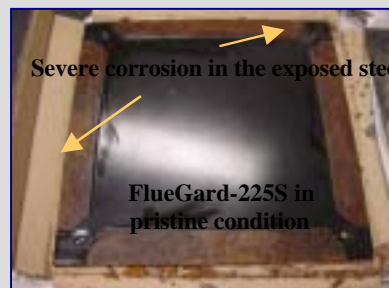
Test sample cleaned after five months in a baghouse

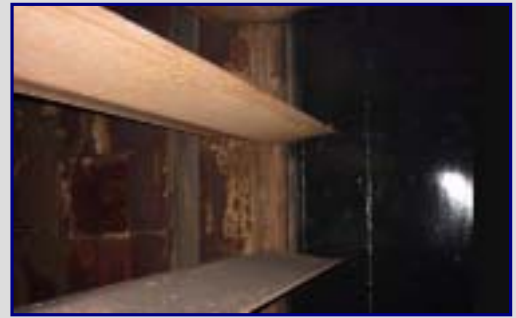
Left side corroded, right side coated

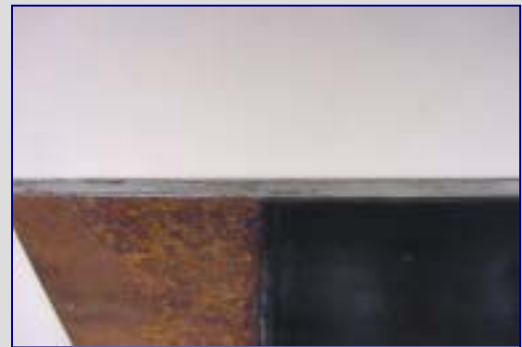
Test sample slice
no delamination
